Region 6 - Enforcement & Compliance Assurance Division
INSPECTION REPORT

Inspection Date(s):	10/07/2025 – 10/09/2025	
Media Program:	RCRA	
Regulatory Program(s)	Hazardous Waste, Used Oil	
Company Name:	Smitty's Supply, Inc.	
Facility Name:	Smitty's Supply Roseland	
Facility Physical Location:	63399 Highway 51 N	
(city, state, zip code)	Roseland LA 70456	
Mailing address:	PO Box 530	
(city, state, zip code)	Roseland LA 70456	
County/Parish:	Tangipahoa	
Facility Phone Number	1-800-256-7575	
Facility Contact:	Craig Ellison craigellison@smittysinc.net	
FRS Number:	110016753075	
EPA ID Number:	LAR000078691	
NAICS:	324191 - PETROLEUM LUBRICATING OIL AND GREASE MANUFACTURING	
SIC:	2992 – LUBRICATING OILS AND GREASES 4952 – SEWERAGE SYSTEMS	
Personnel participating in inspection:		
Angela Hays	U.S. EPA – Region 6	Inspector
Erin Young-Dahl	U.S. EPA – Region 6	Inspector
AD Talton	U.S. EPA – Region 6	Inspector
Jimbo Earles	LDEQ	Senior Environmental Scientist
Craig Easley	LDEQ	Senior Environmental Scientist

Section I – INTRODUCTION

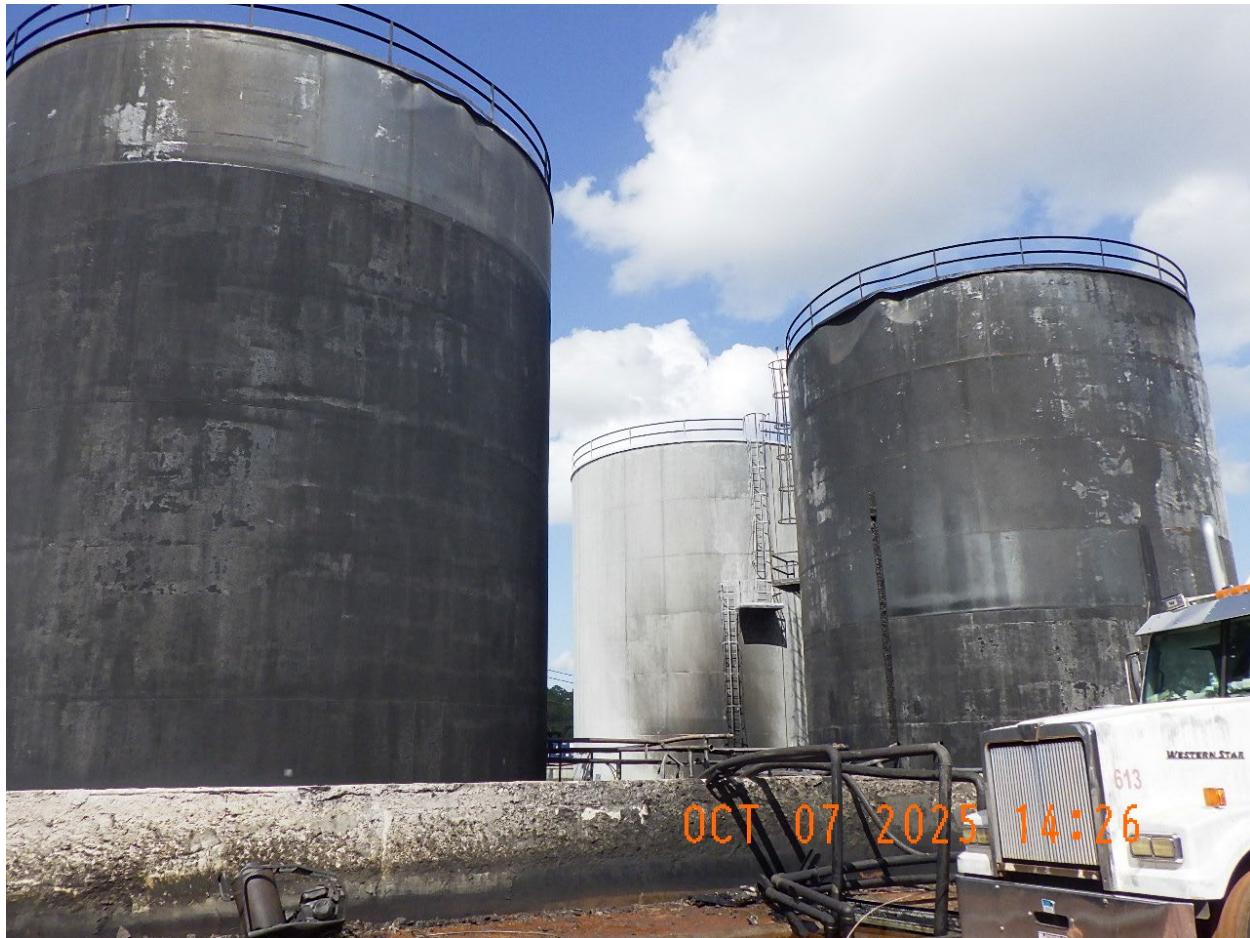
Photo No. 1

Description:	Tank Farm 11: buckling at the top of tanks 180 and 183	
Latitude:		Longitude:

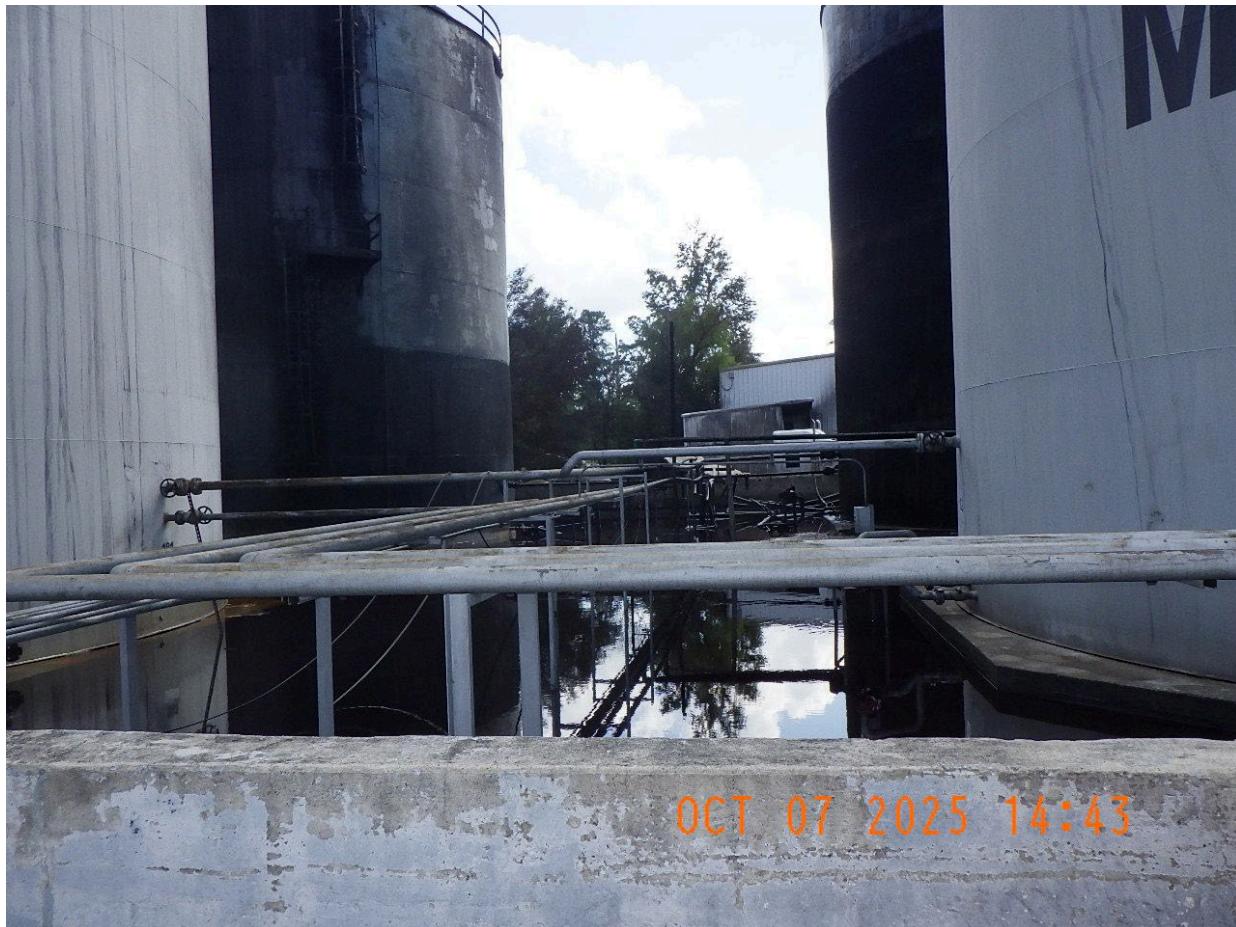
Photo No. 2

Description:	Tank Farm 11 (Secondary Containment): Standing oily water inside of the secondary containment.	
Latitude:		Longitude:

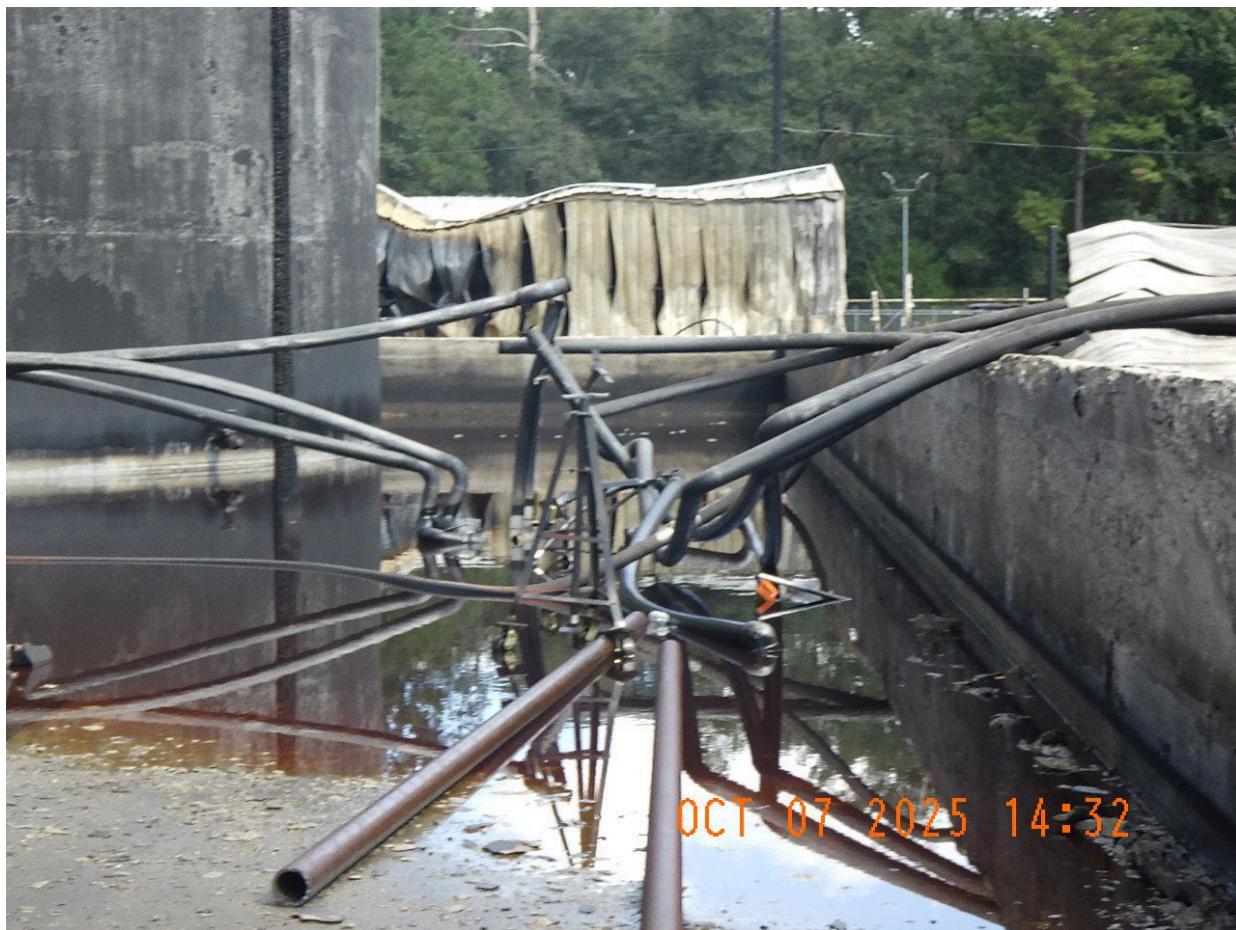
Description:	Tank Farm 11 (Secondary Containment): standing oily liquid inside of secondary containment with view of damaged ancillary equipment.	
Latitude:		Longitude:

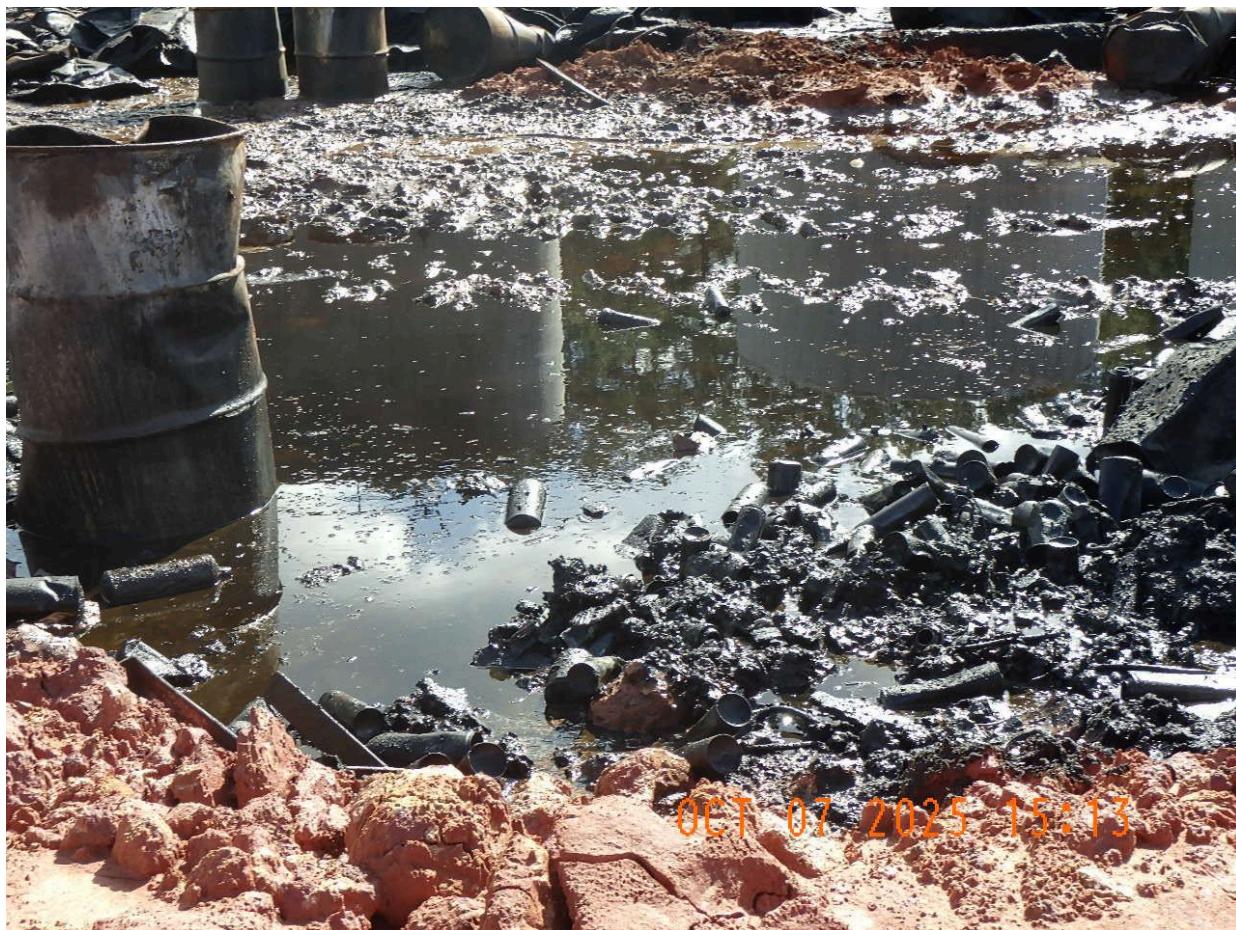
Description:	Berm Perimeter Area: Burnt aerosol cans and other containers.	
Latitude:		Longitude:

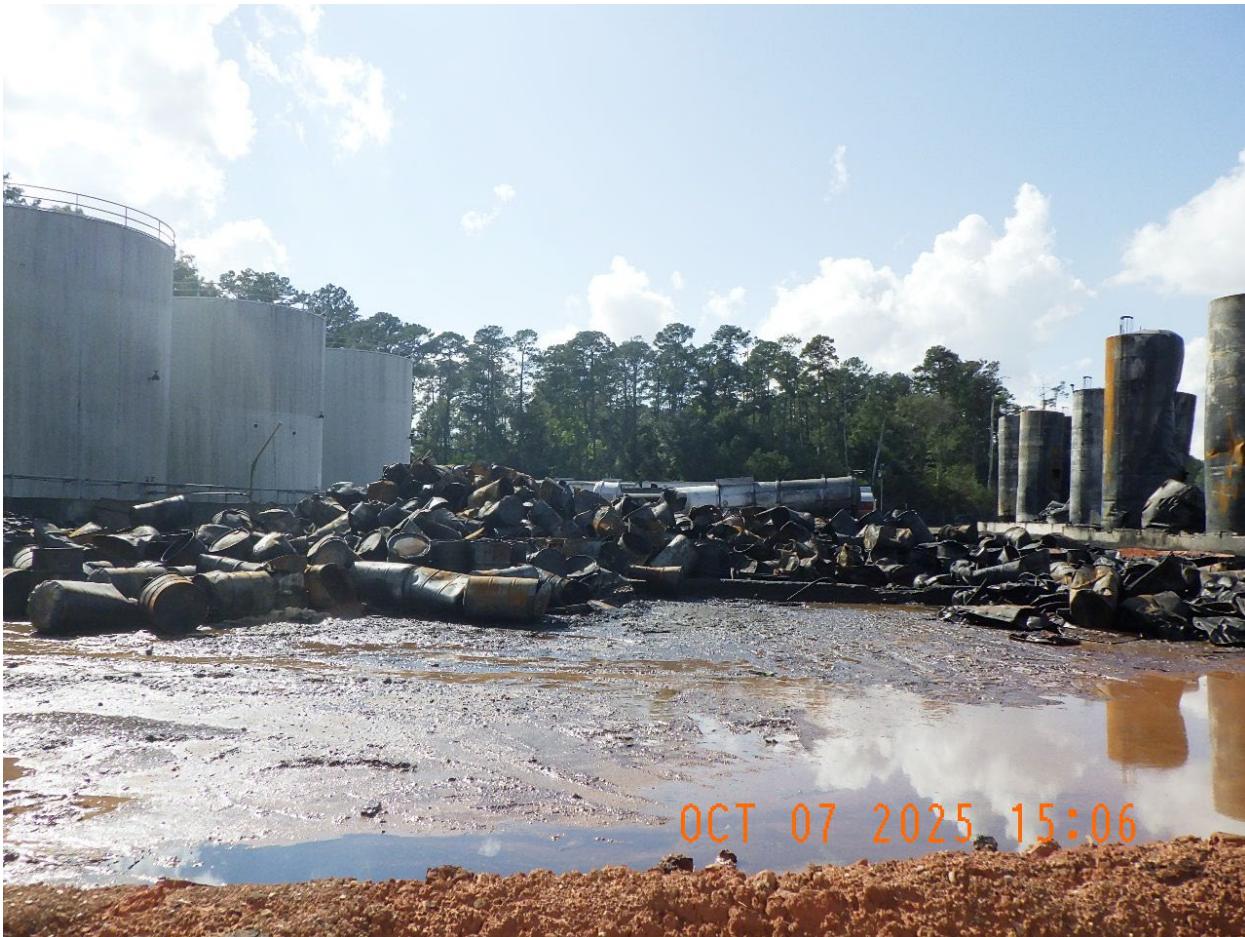
Description:	Berm Perimeter Area: Overview of burnt drums and burnt aerosol cans between TF-13 (left) and the destroyed central tank farm area (right).	
Latitude:		Longitude:

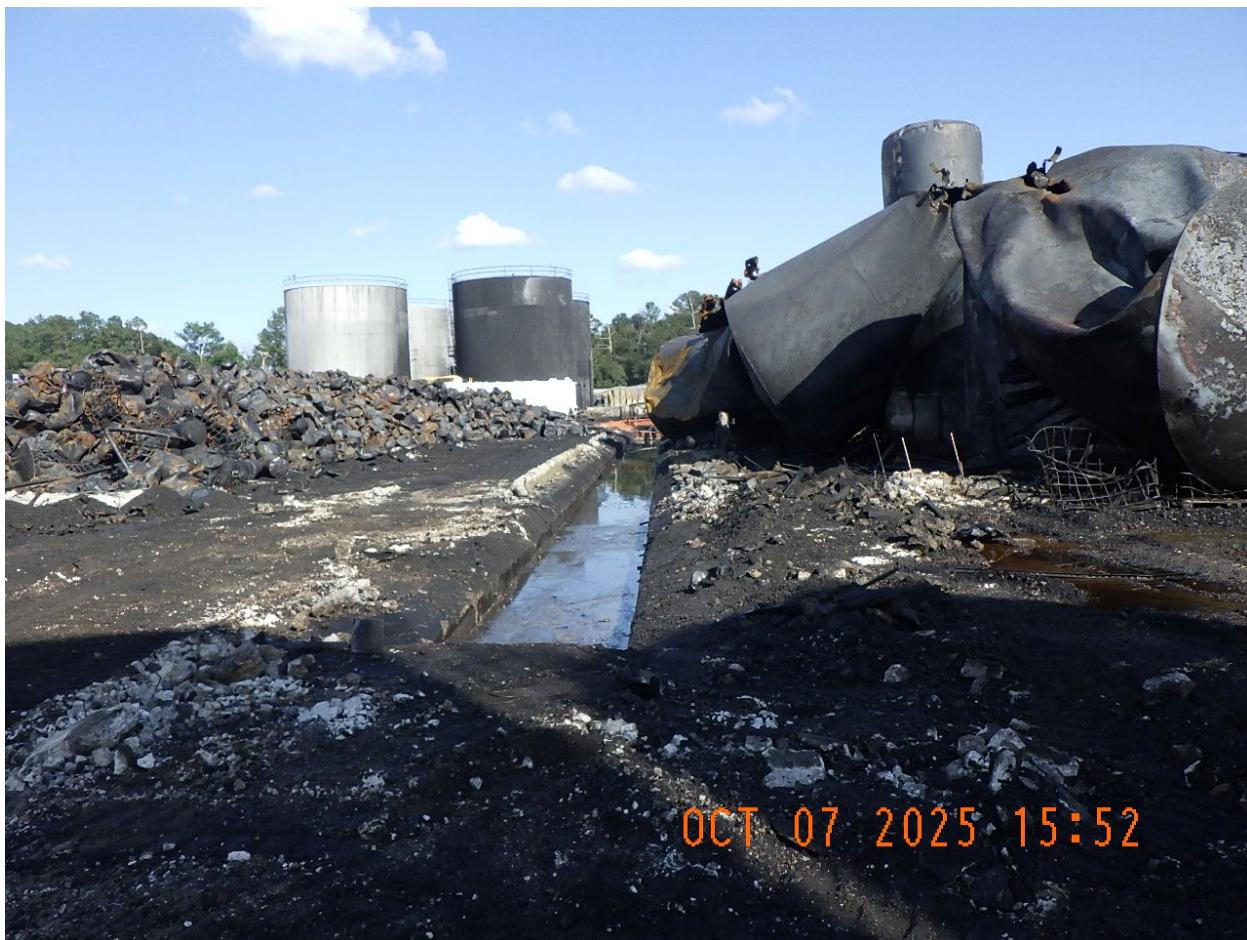
Photo No. 6

Description:	Central Tank Farm Area: Destroyed tanks and drums. Oily sheen on water in sump and on ground (right side of photo).		
Latitude:		Longitude:

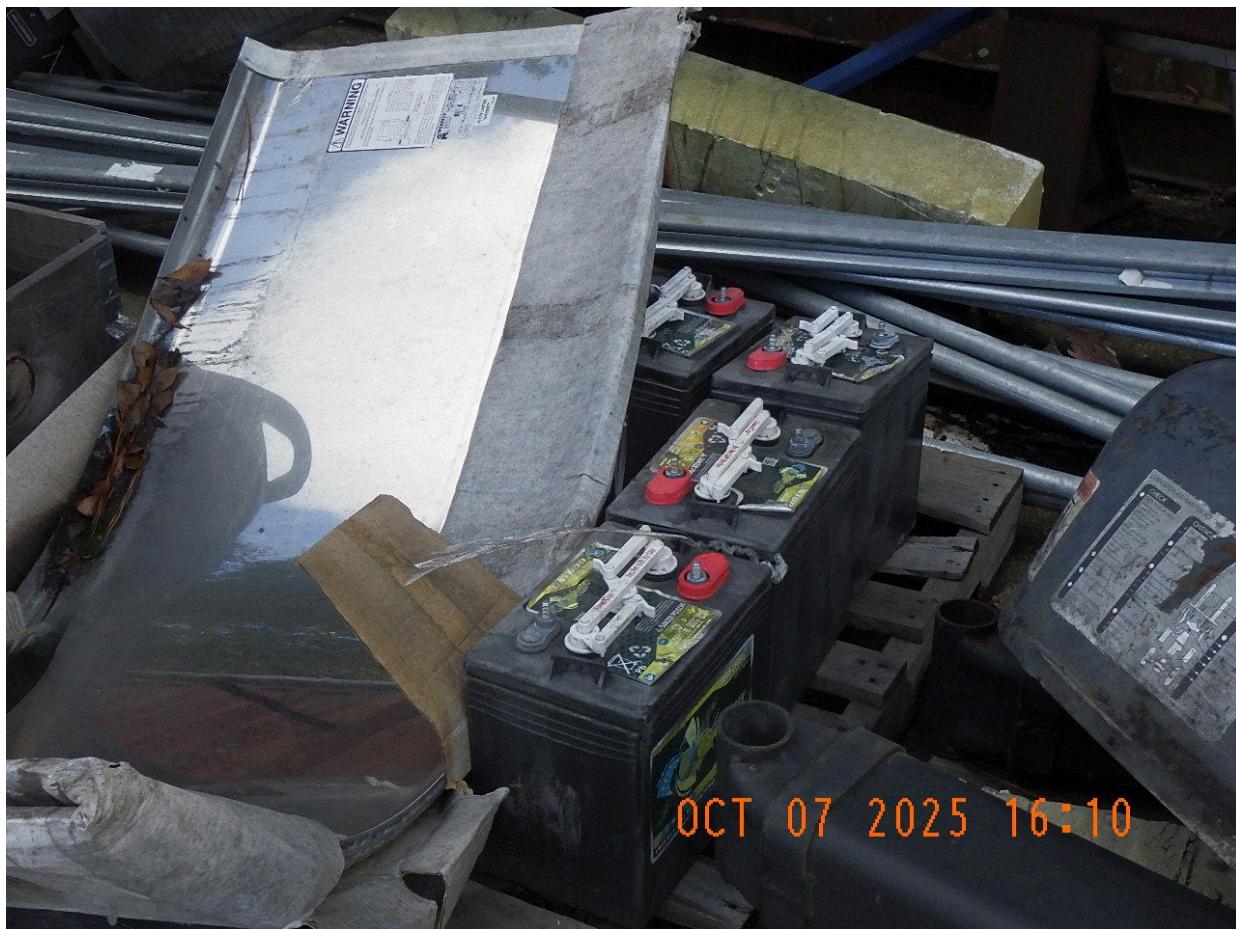
Description:	Truck Shop: 4 unlabeled lead-acid batteries on broken pallet outside. Batteries did not have adequate containment to capture potential leaks.	
Latitude:		Longitude:

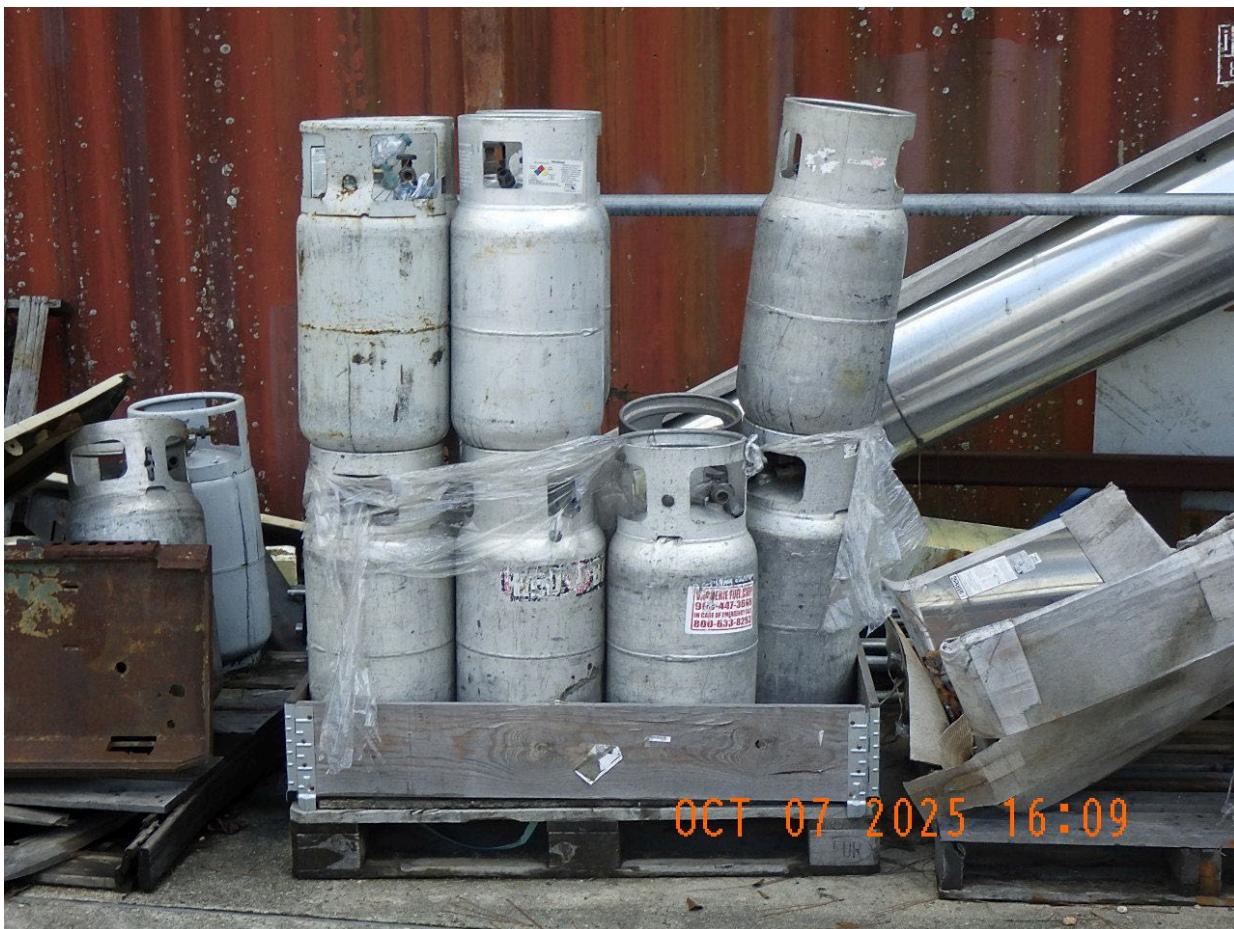
Photo No. 8

Description:	Truck Shop: A pallet of 10 gas cylinders. Unknown contents due to lack of labeling.	
Latitude:		Longitude:

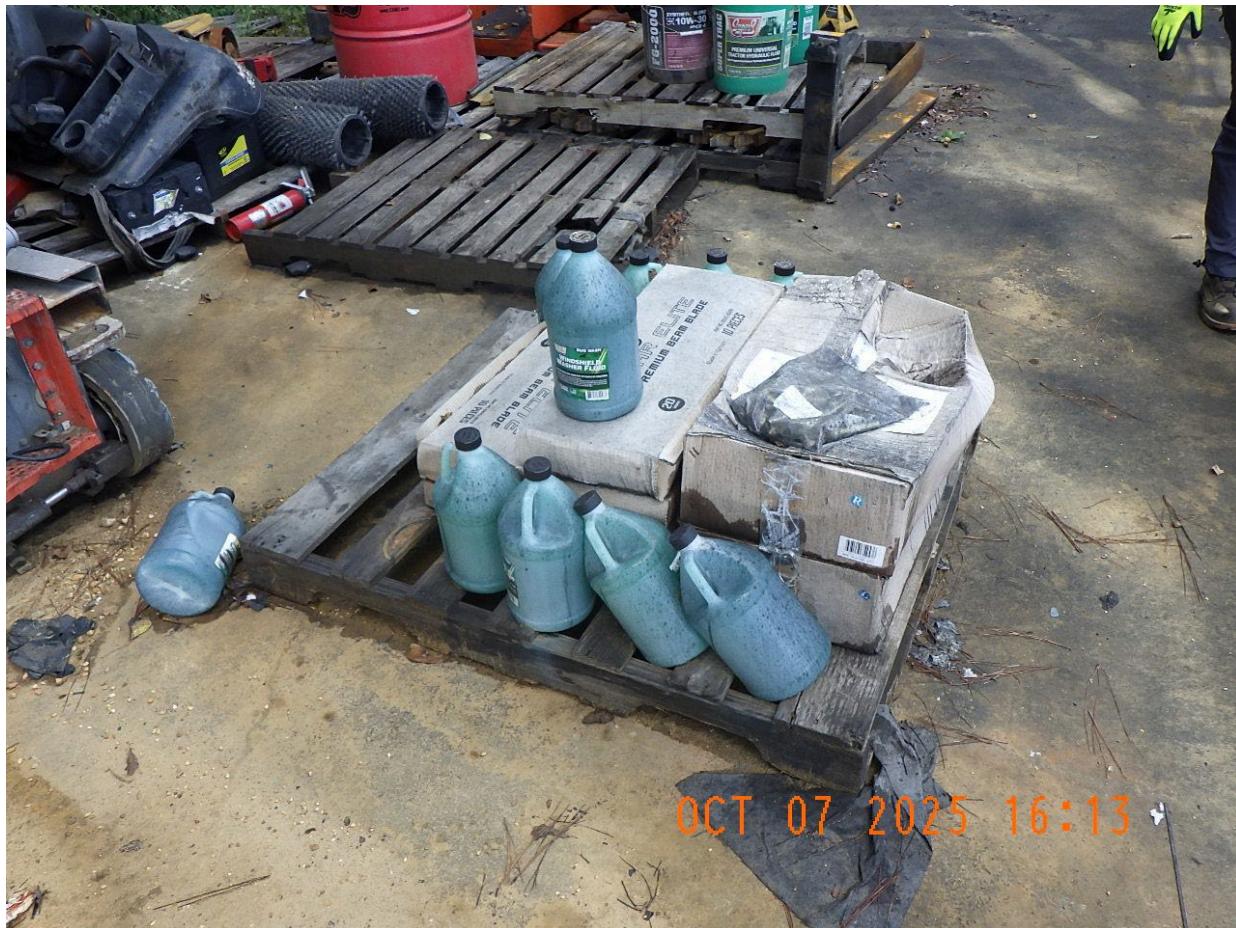
Photo No. 9

Description:	Truck Shop: A pallet of 5 boxes of windshield wiper fluid, 11 gallon-size jugs of windshield wiper fluid. One wiper fluid jug has tipped onto the cement. The windshield wiper fluid has flashpoint of 95°F.	
Latitude:		Longitude:

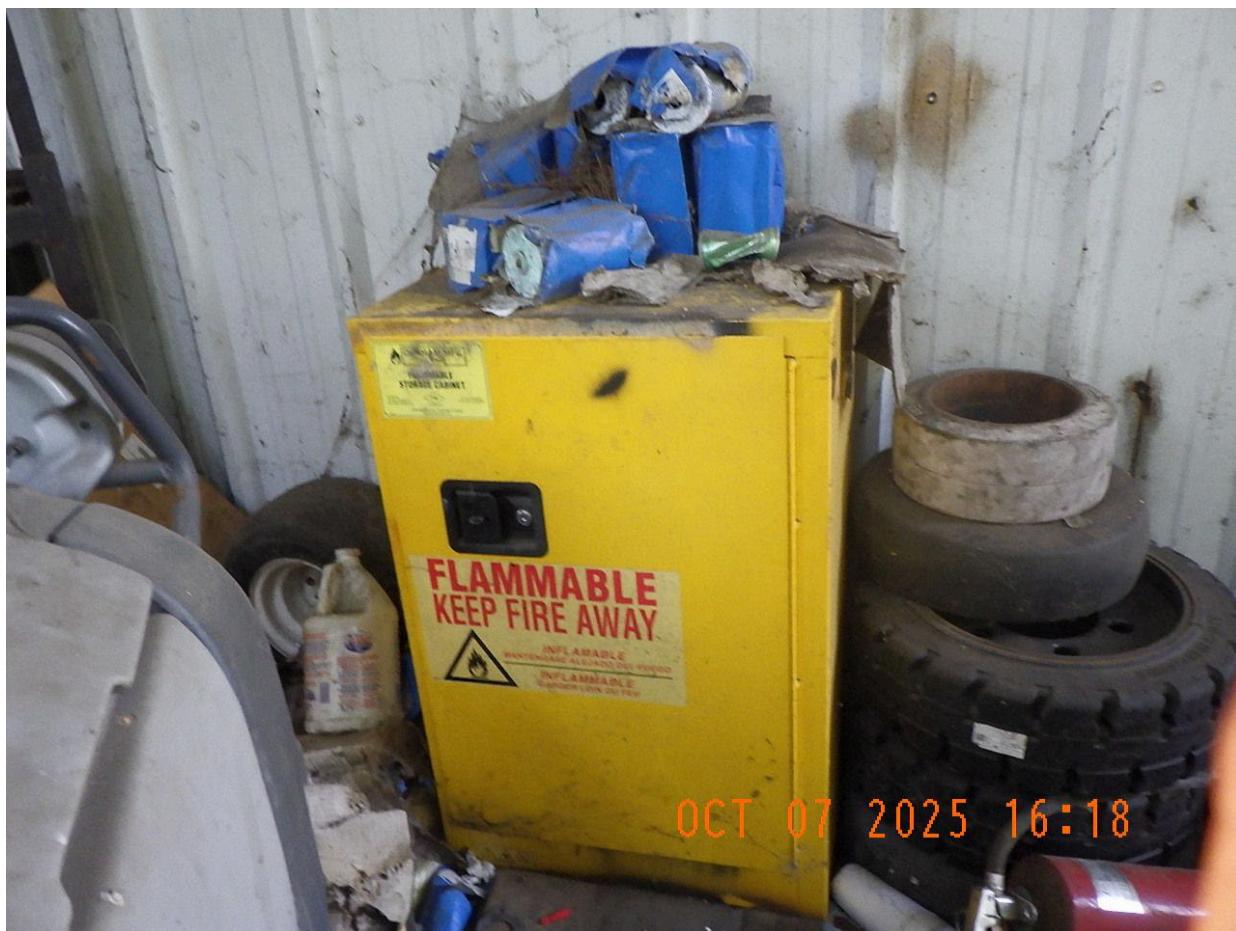
Description:	Truck Shop: Corroded oil filters stored on top of a metal flammables cabinet.	
Latitude:		Longitude:

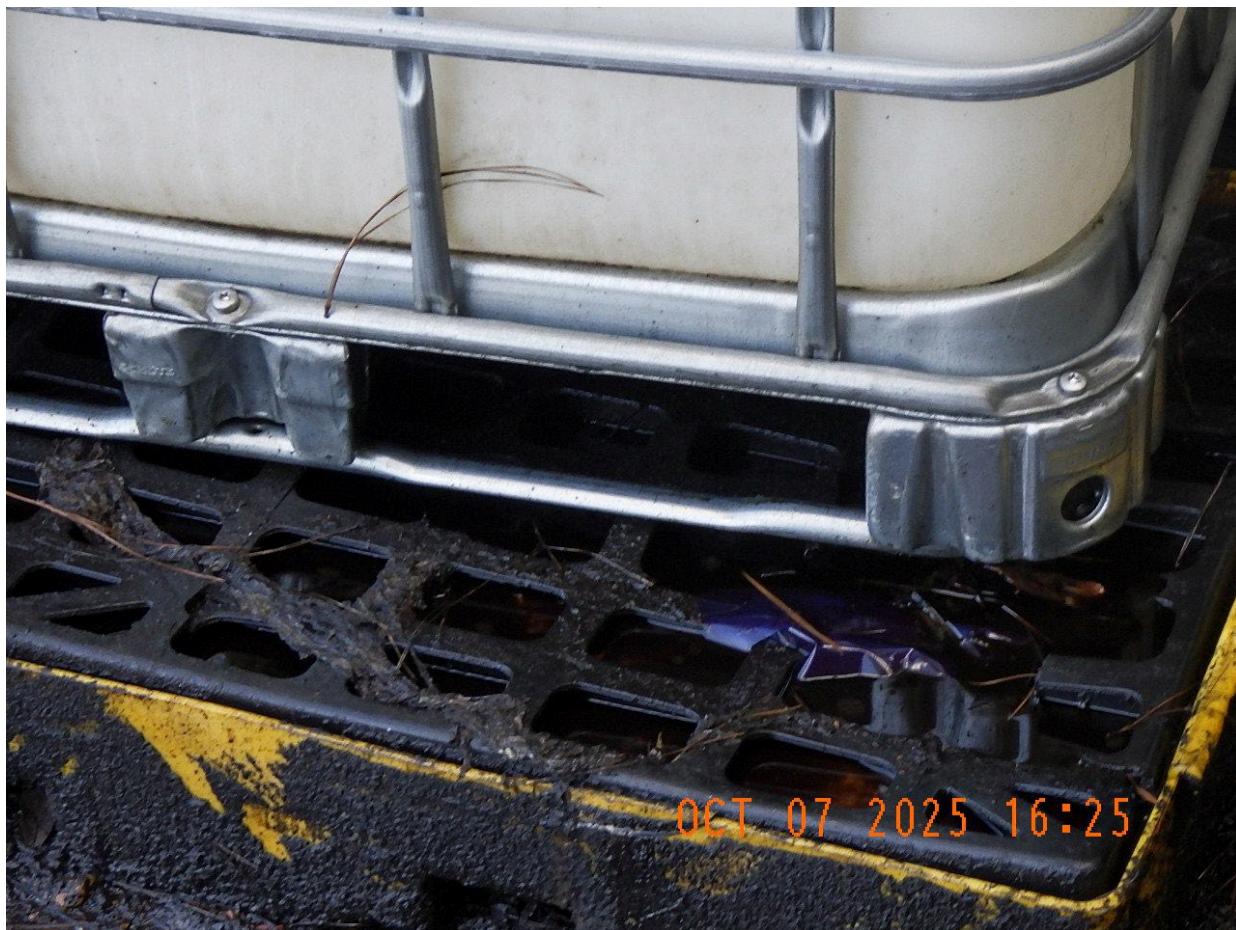
Photo No. 11

Description:	Truck Shop: A plastic secondary containment container overflowing with an unknown oily liquid material unto the ground.	
Latitude:		Longitude:

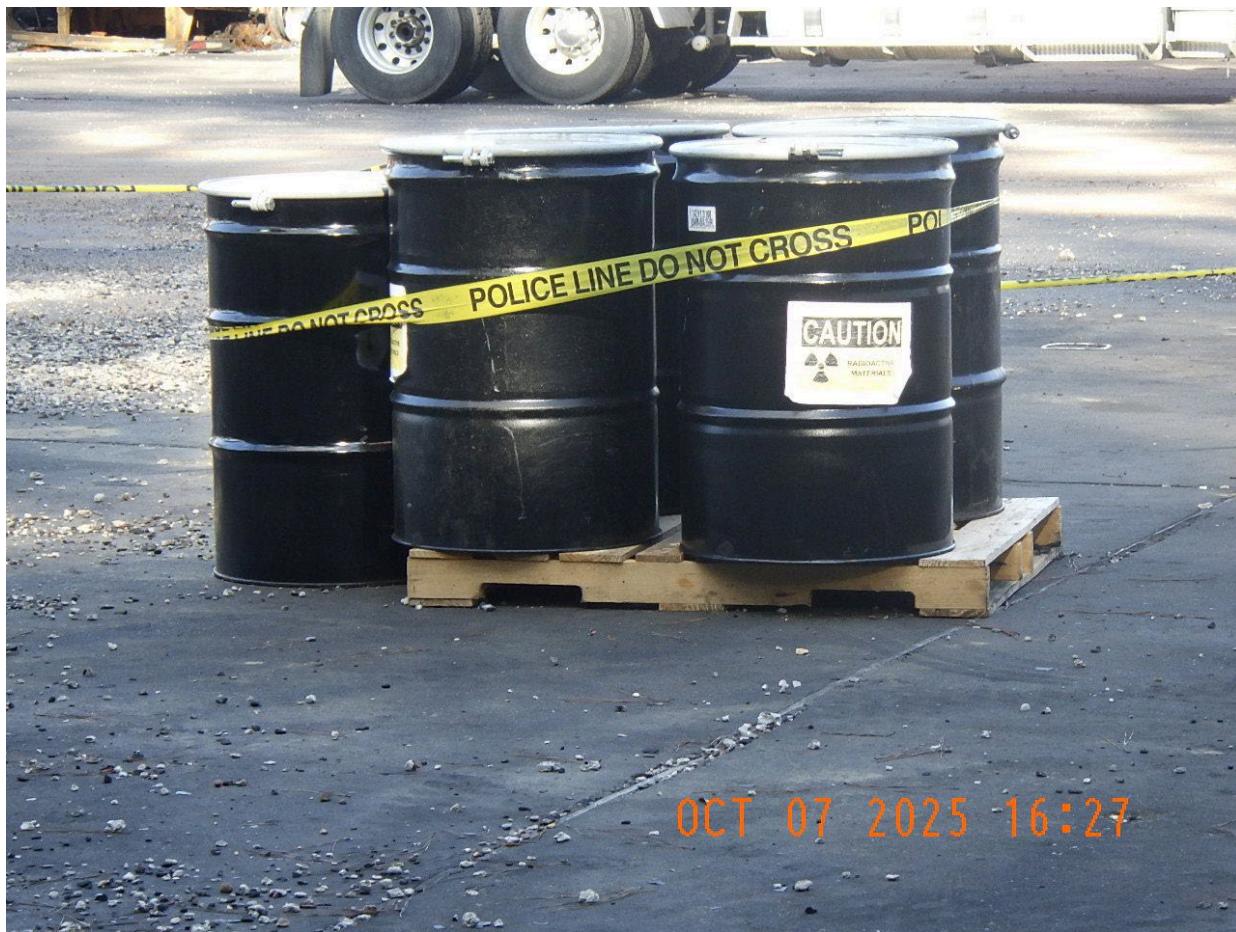
Photo No. 12

Behind the western wall of the truck shop, inspectors discovered an additional discarded, unlabeled, and undated lead-acid battery on a wooden pallet. Additional damaged and/or unidentified totes, containers, and pallets were also present. One tote rested on top of a plastic secondary containment pallet tray that was overflowing with an unknown oily material onto the ground (Appendix 1: Photo 11). On the north side of the building, a large puddle over a blocked drain was roped off with yellow "POLICE LINE DO NOT CROSS" tape wrapped around metal drums with "radioactive" hazard labels visible (Appendix 1: Photo 12). No other labeling identifying the contents were visible on the drums.

Description:	Truck Shop: Five 55-gal drums of unknown material labeled as "radioactive. None of the drums are labeled to indicate their contents.		
Latitude:		Longitude:

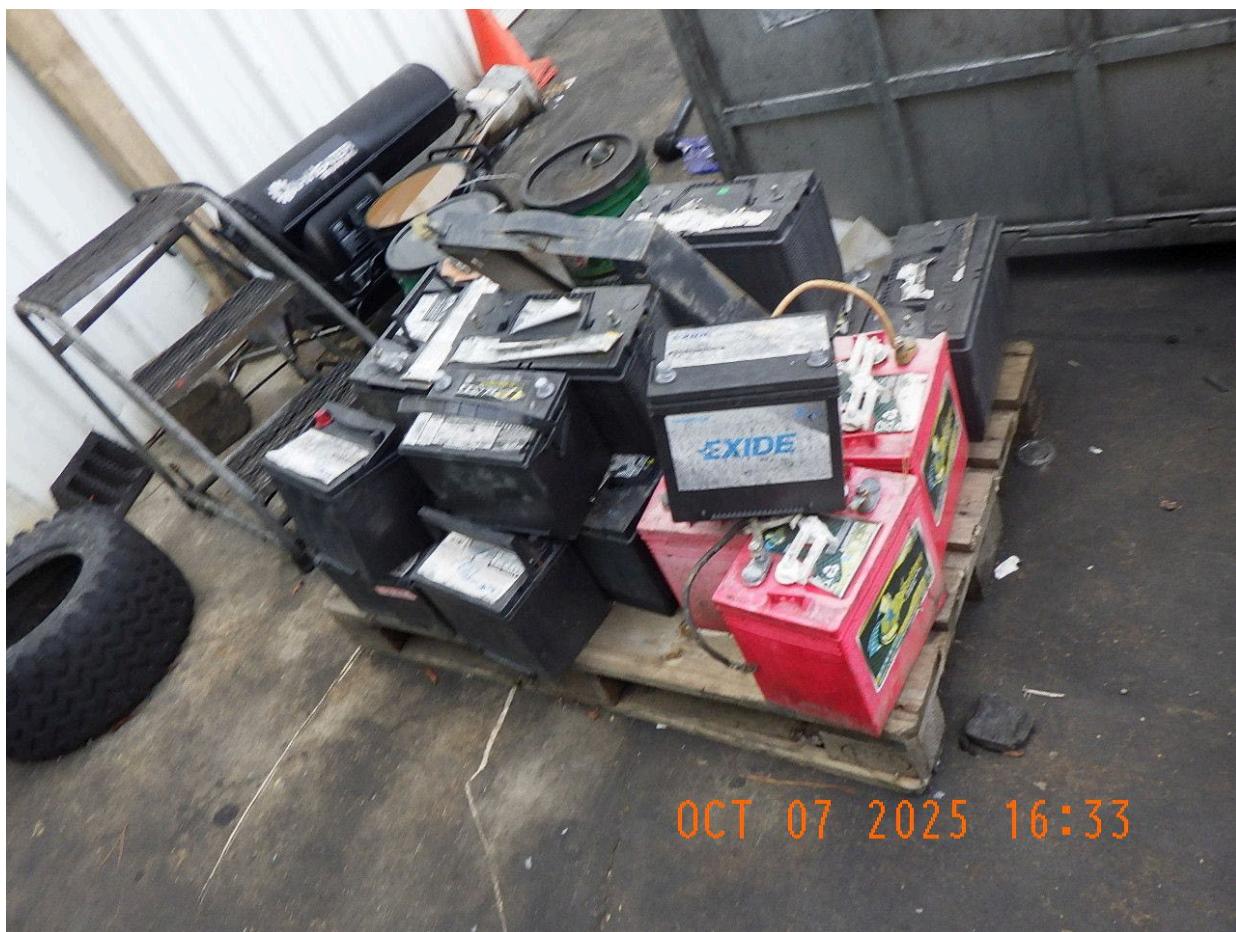
Description:	Truck Shop: 20 unlabeled lead batteries outside of the truck shop. Batteries were unlabeled and did not have adequate containment to capture potential leaks.		
Latitude:		Longitude:

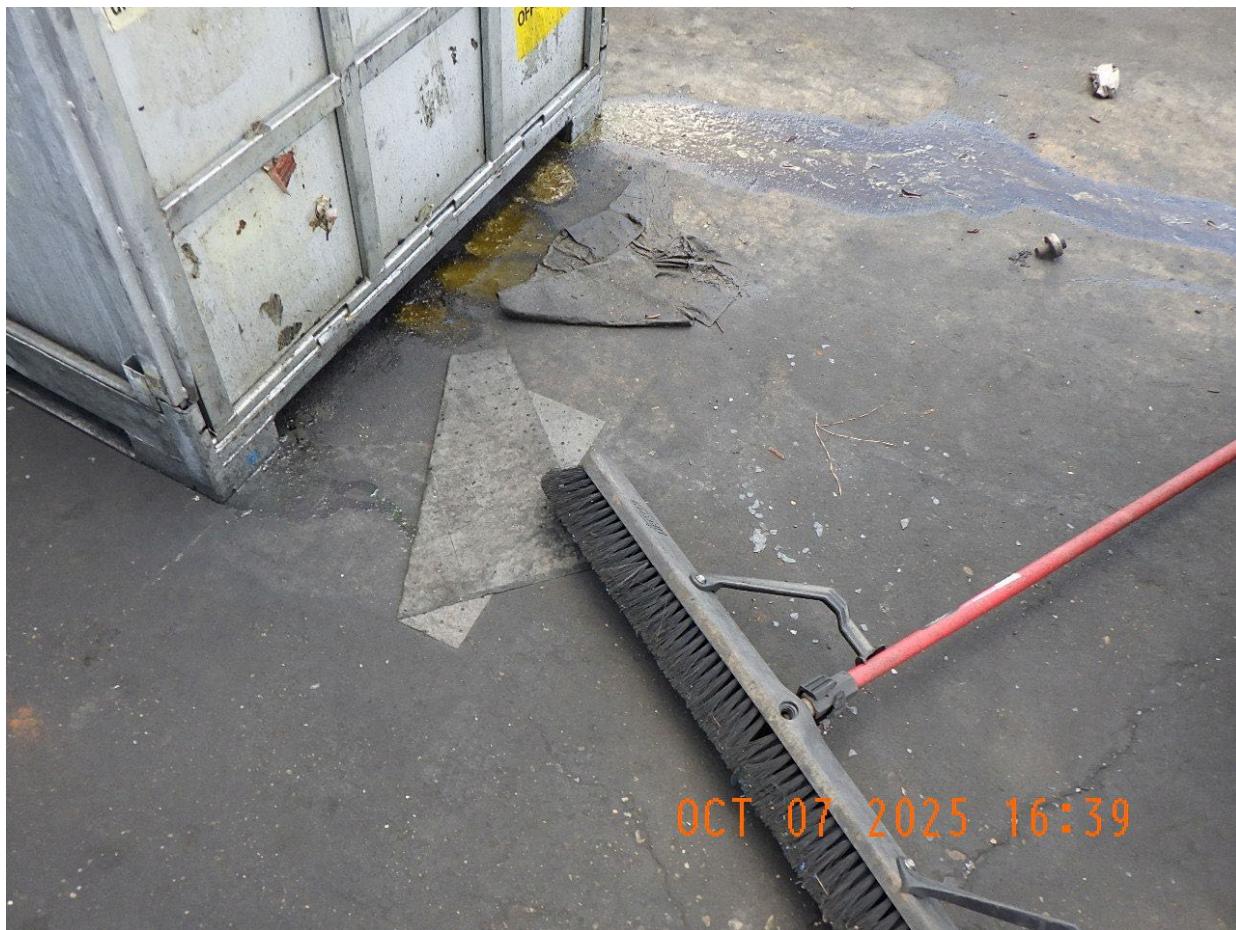
Description:	Truck Shop: A metal trash box leaking an emulsified oily liquid. Saturated absorbent pads are on the ground near the leak.	
Latitude:		Longitude:

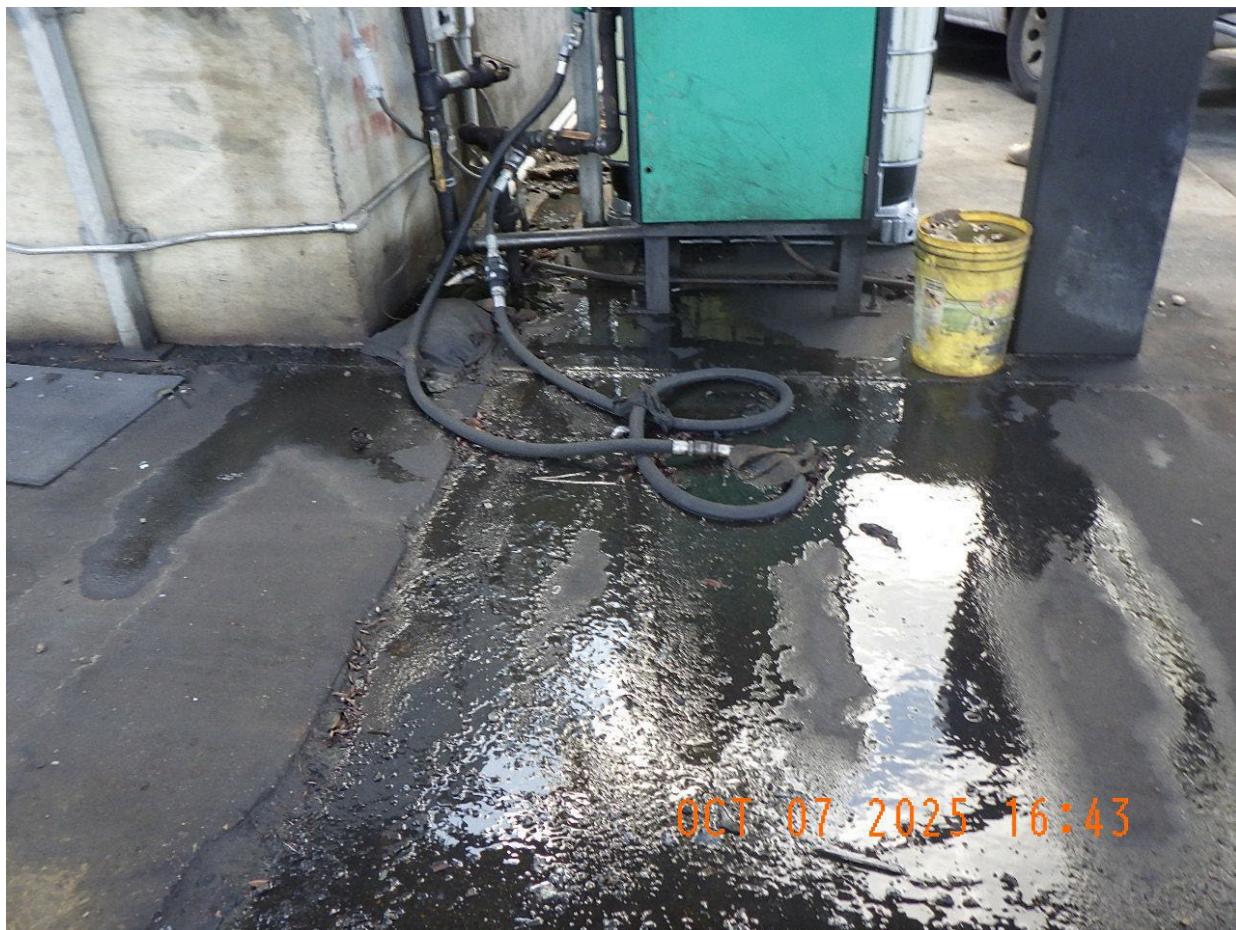
Photo No. 15

Inspectors then walked to the diesel pump station, where diesel fuel is pumped from two 5,000-gallon tanks located in TF-8, adjacent to the pump. An active release originated from the pump area and flowed downslope. Inspectors could not definitively identify the source of the release (Appendix 1: Photo 15). A five-gallon bucket of oily debris and liquid was open and unlabeled next to the pump station. Four totes of diesel exhaust fluid were staged under a canvas tent cover, and one of the totes was open.

Description:	Tank Farm 8: A release of unknown oily, green liquid near the diesel pump. Yellow bucket is unlabeled and contains absorbent pads and a greenish liquid.		
Latitude:		Longitude:

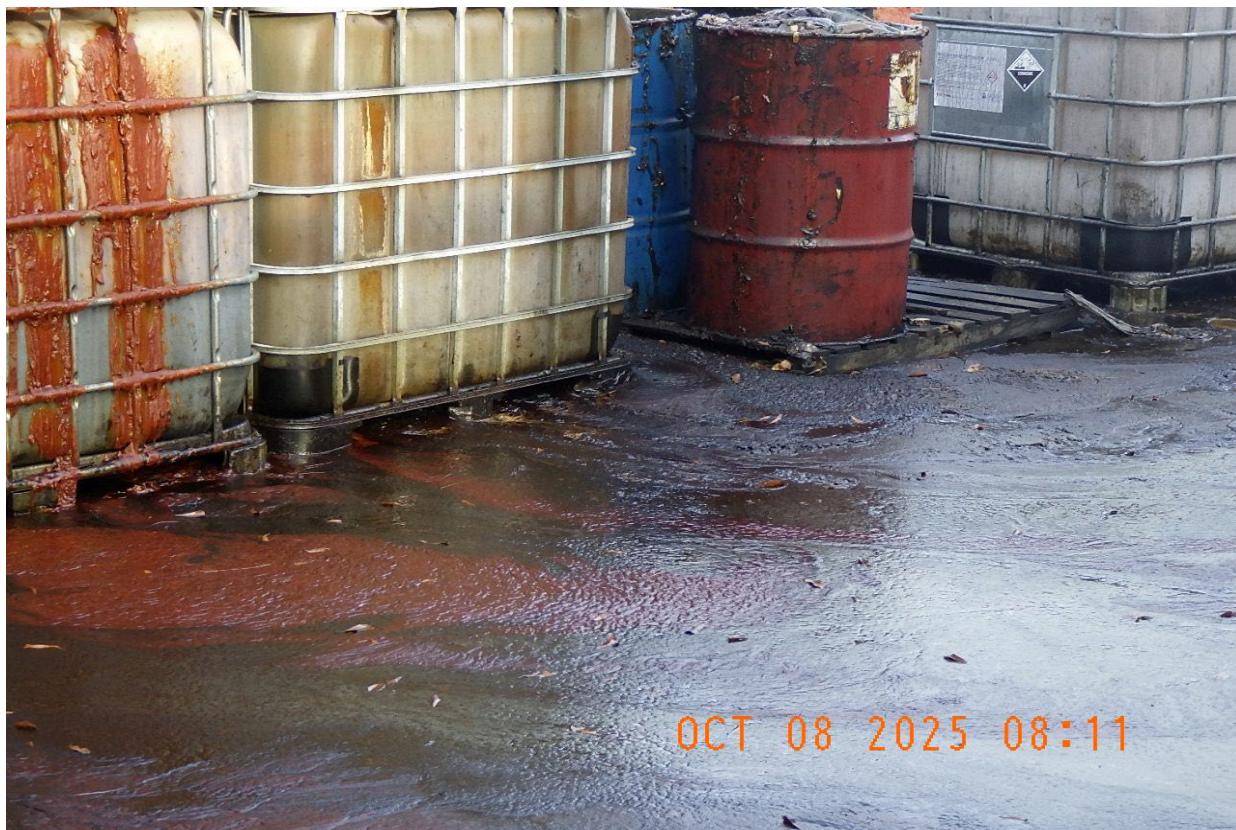
Description:	Grease Plant (Outside): Release of grease on the ground of the storage container area up to 3 inches deep. Source unknown. Separately, an oily liquid saturates the wooden pallet used to store a red drum of unknown material (center right). The drum is open and not labeled identifying its contents. One of the totes has a red oily substance on the outside (far left) and another tote has a corrosive label (right). There is no evidence of cleanup of the releases/spills.		
Latitude:	N/A	Longitude:	N/A

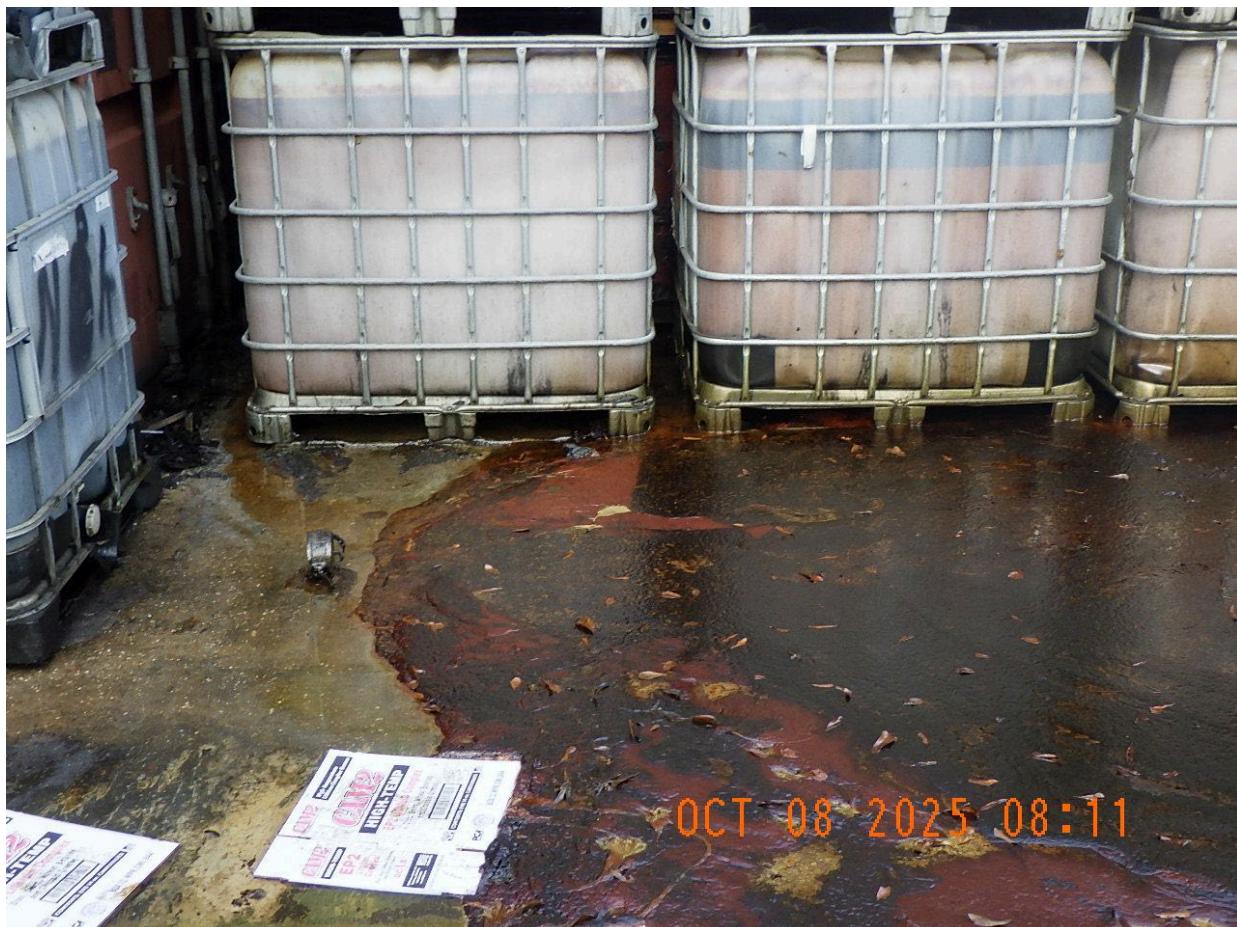
Photo No. 18

Description:	Grease Plant (Outside): Grease release on the ground of the storage container area up to 3 inches deep. The source of the release is unknown. There is no evidence of cleanup of the releases/spills. The totes are not labeled to identify contents.		
Latitude:	N/A	Longitude:	N/A

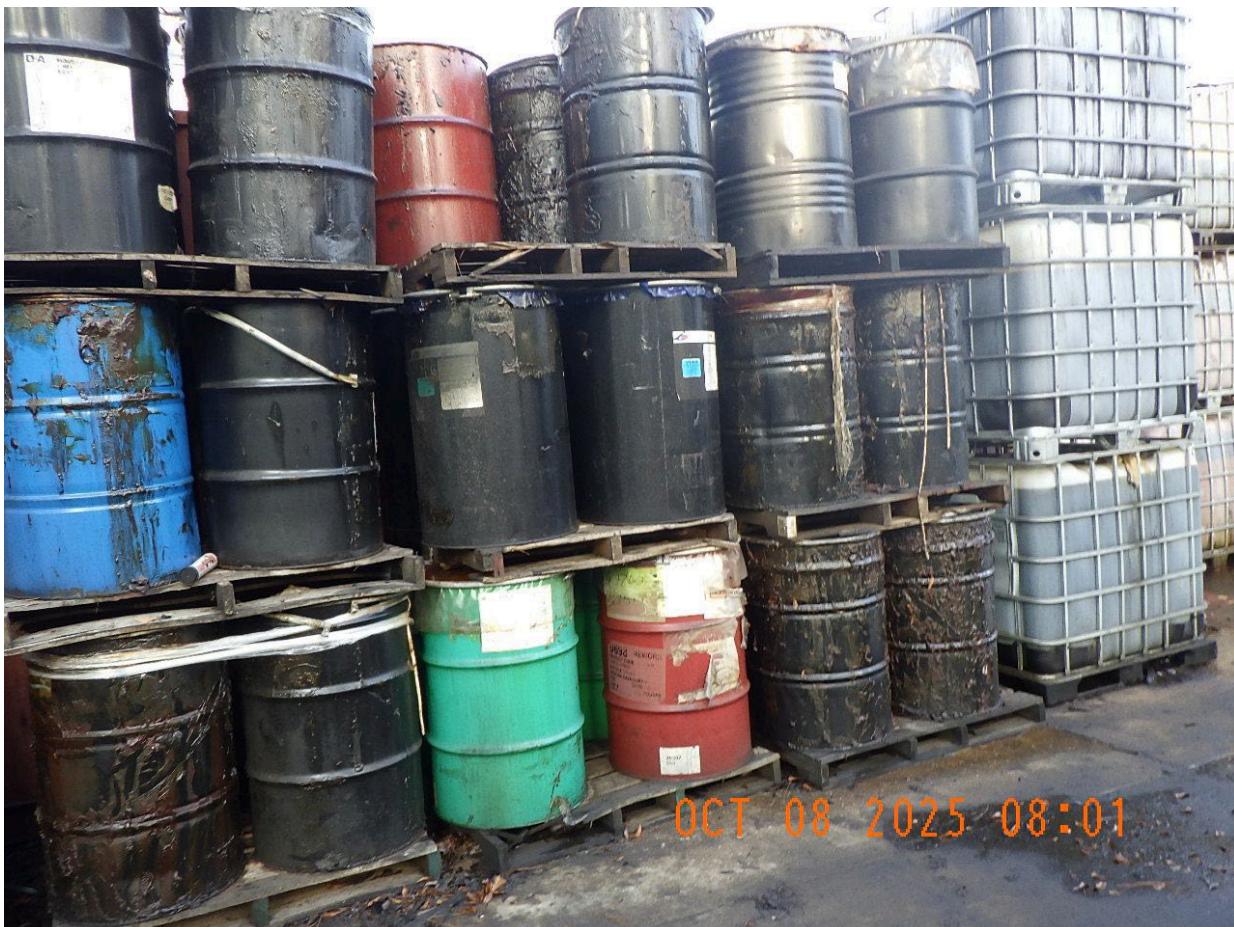
Photo No. 19

In the accessible portion of the storage area, closest to TF-10, the team noted multiple pallets in poor condition, upon which layers of containers were stacked three totes high and up to four pallets high of drums (Appendix 2: Photos 19 – 21). Among the containers on broken or cracked pallets, there were 64 blue poly drums in good condition with labels indicating they held acetic acid, 19 unidentified totes containing a stratified liquid, and 44 drums of grease, at least two of which were labeled "line flush grease mixture" or "grease for rework." The team observed dozens of open and unsecured drums, many of which were tipped or otherwise damaged (Appendix 2: Photo 21). Many were coated in layers of grease. Active and historic spills covered the cement pad, and discoloration observed outside the cement pad boundaries indicated past and present releases to the surrounding environment.

Description:	Grease Plant (Outside): View of drums and totes stored in the container storage area outside of the grease plant. Containers are not labeled identifying contents. Residues of oily releases on the outside of the containers and spills/releases on the concrete pad in the area. There is no evidence of cleanup of the releases/spills.		
Latitude:	N/A	Longitude:	N/A
