Region 6 - Enforcement & Compliance Assurance Division
INSPECTION REPORT

Inspection Date(s):	10/07/2025 – 10/09/2025	
Media Program:	RCRA	
Regulatory Program(s)	Hazardous Waste, Used Oil	
Company Name:	Smitty's Supply, Inc.	
Facility Name:	Smitty's Supply Roseland	
Facility Physical Location:	63399 Highway 51 N	
(city, state, zip code)	Roseland LA 70456	
Mailing address:	PO Box 530	
(city, state, zip code)	Roseland LA 70456	
County/Parish:	Tangipahoa	
Facility Phone Number	1-800-256-7575	
Facility Contact:	Craig Ellison craigellison@smittysinc.net	
FRS Number:	110016753075	
EPA ID Number:	LAR000078691	
NAICS:	324191 - PETROLEUM LUBRICATING OIL AND GREASE MANUFACTURING	
SIC:	2992 – LUBRICATING OILS AND GREASES 4952 – SEWERAGE SYSTEMS	
Personnel participating in inspection:		
Angela Hays	U.S. EPA – Region 6	Inspector
Erin Young-Dahl	U.S. EPA – Region 6	Inspector
AD Talton	U.S. EPA – Region 6	Inspector
Jimbo Earles	LDEQ	Senior Environmental Scientist
Craig Easley	LDEQ	Senior Environmental Scientist

Section I – INTRODUCTION

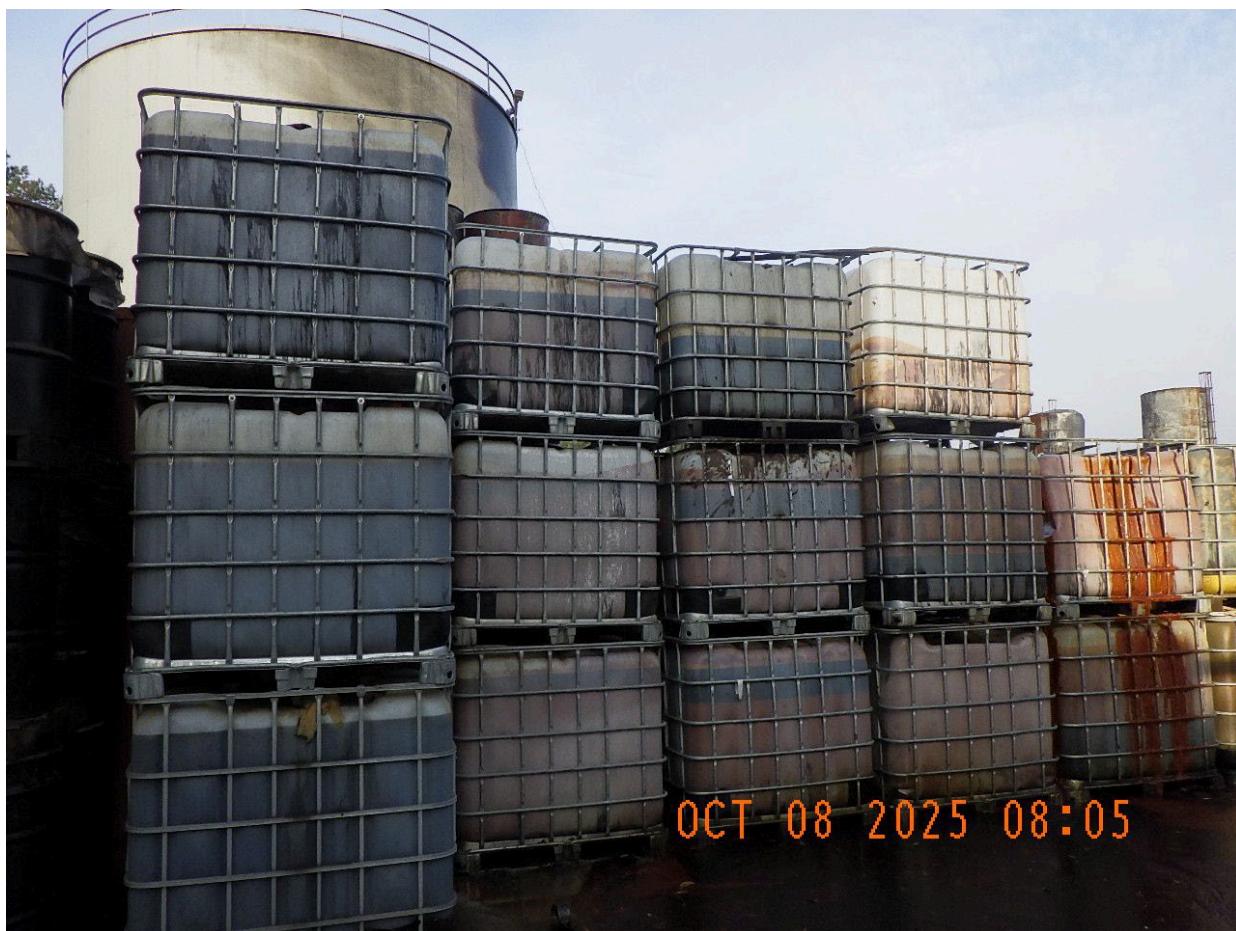
Photo No. 20

In the accessible portion of the storage area, closest to TF-10, the team noted multiple pallets in poor condition, upon which layers of containers were stacked three totes high and up to four pallets high of drums (Appendix 2: Photos 19 – 21). Among the containers on broken or cracked pallets, there were 64 blue poly drums in good condition with labels indicating they held acetic acid, 19 unidentified totes containing a stratified liquid, and 44 drums of grease, at least two of which were labeled "line flush grease mixture" or "grease for rework." The team observed dozens of open and unsecured drums, many of which were tipped or otherwise damaged (Appendix 2: Photo 21). Many were coated in layers of grease. Active and historic spills covered the cement pad, and discoloration observed outside the cement pad boundaries indicated past and present releases to the surrounding environment.

Description:	Grease Plant (Outside): Several totes stored in the container storage area with residue of oily substance on the outside of the totes. The totes are not labeled identifying the contents of the containers.		
Latitude:	N/A	Longitude:	N/A

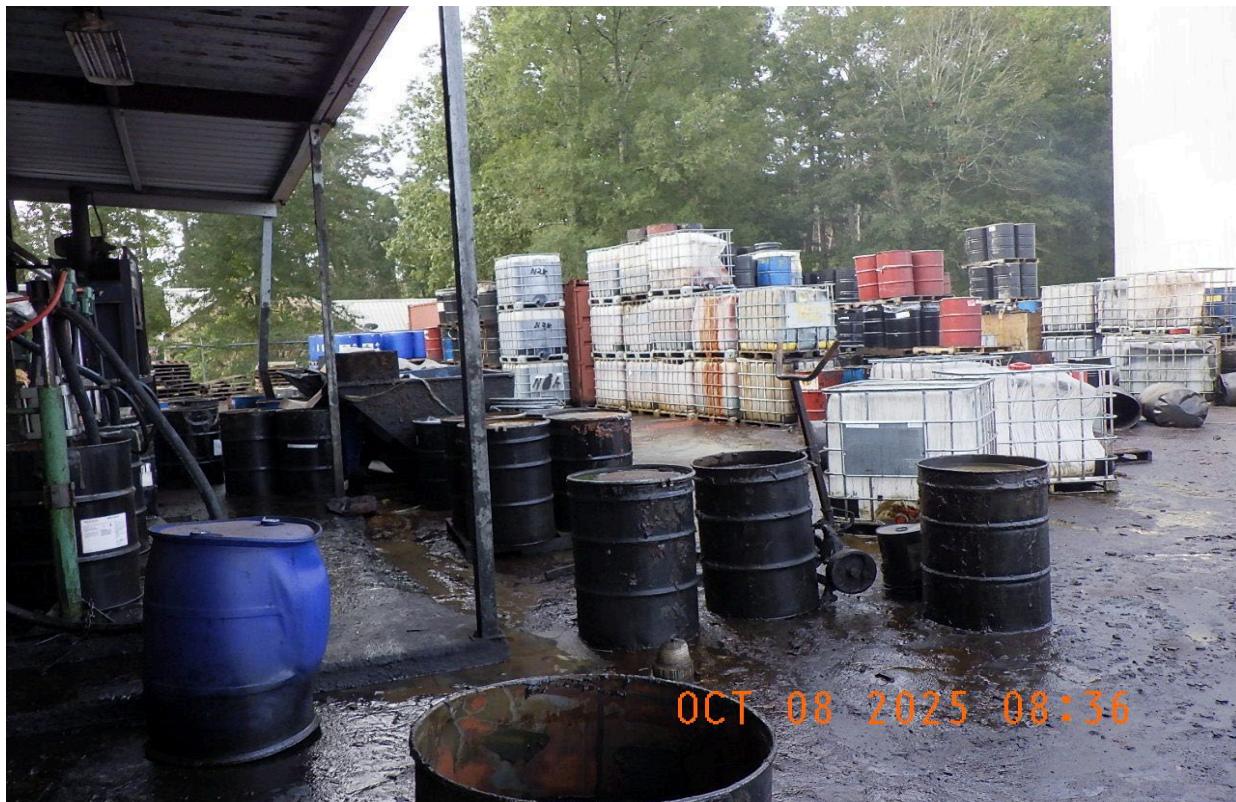
Description:	Grease Plant (Outside): Drum storage area showing release/spills of oily liquids and grease on the floor. There is no evidence of cleanup. Containers in the area are not labeled identifying the contents of each container. Pallet of red drums (center right) is leaning due to a damaged underlying pallet.		
Latitude:	N/A	Longitude:	N/A

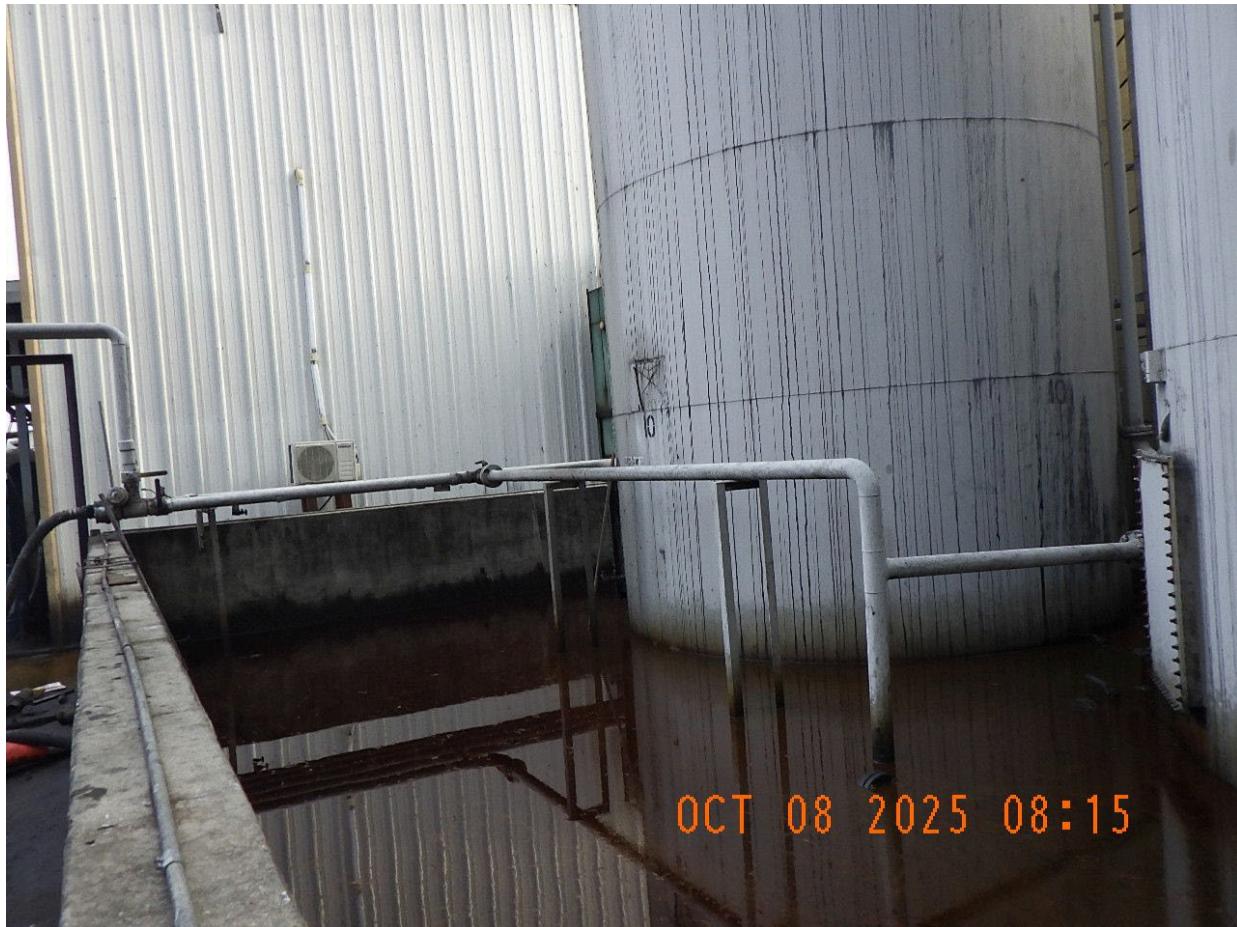
Photo No. 23

Description:	Tank Farm 10: Standing brown oily liquid in the secondary containment. View towards the south wall of the grease plant. Approximately 6" to 8" deep.		
Latitude:	N/A	Longitude:	N/A

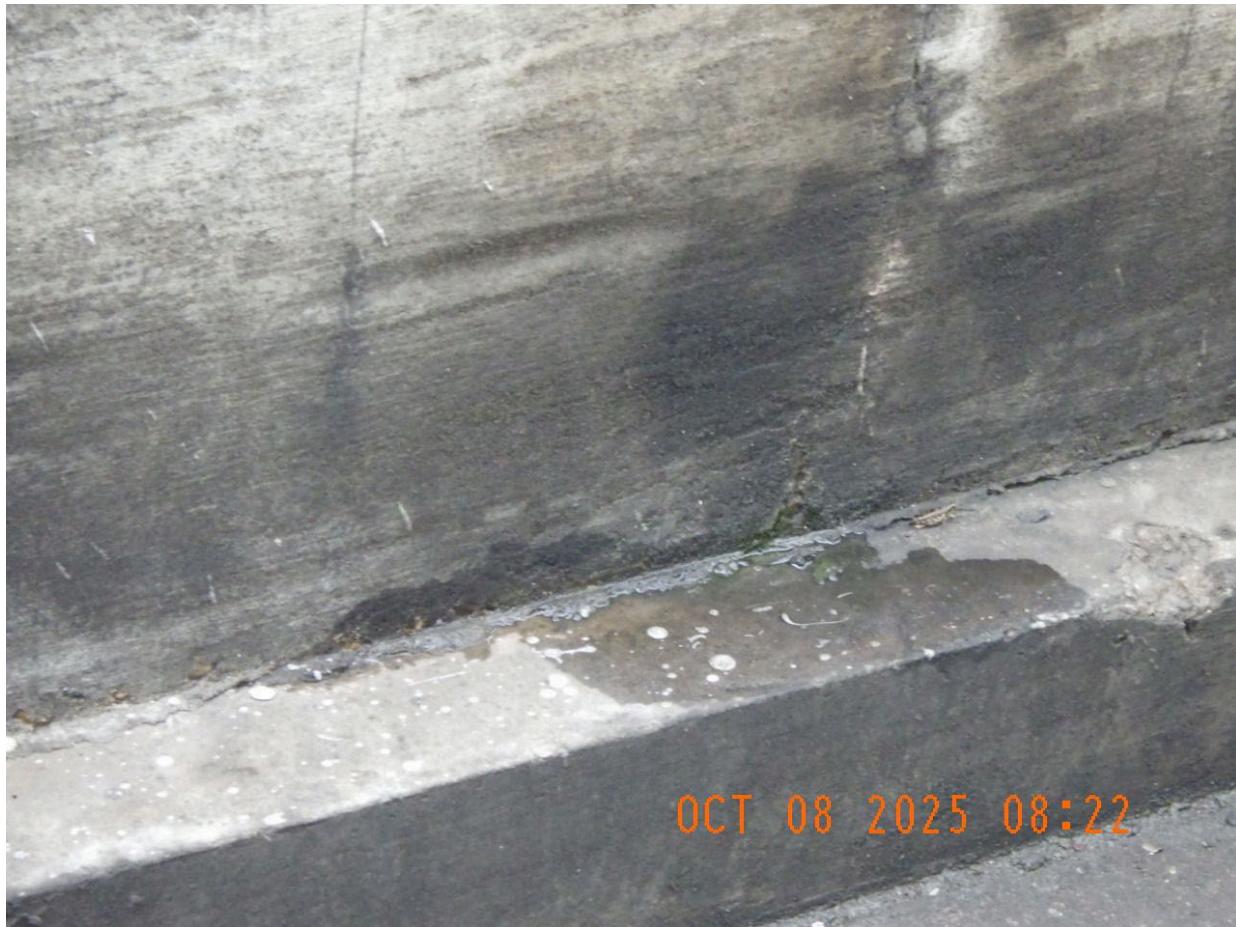
Description:	Tank Farm 10: An active release of liquid seeping from a crack in the outside wall of the secondary containment. There is no evidence of repair.		
Latitude:	N/A	Longitude:	N/A

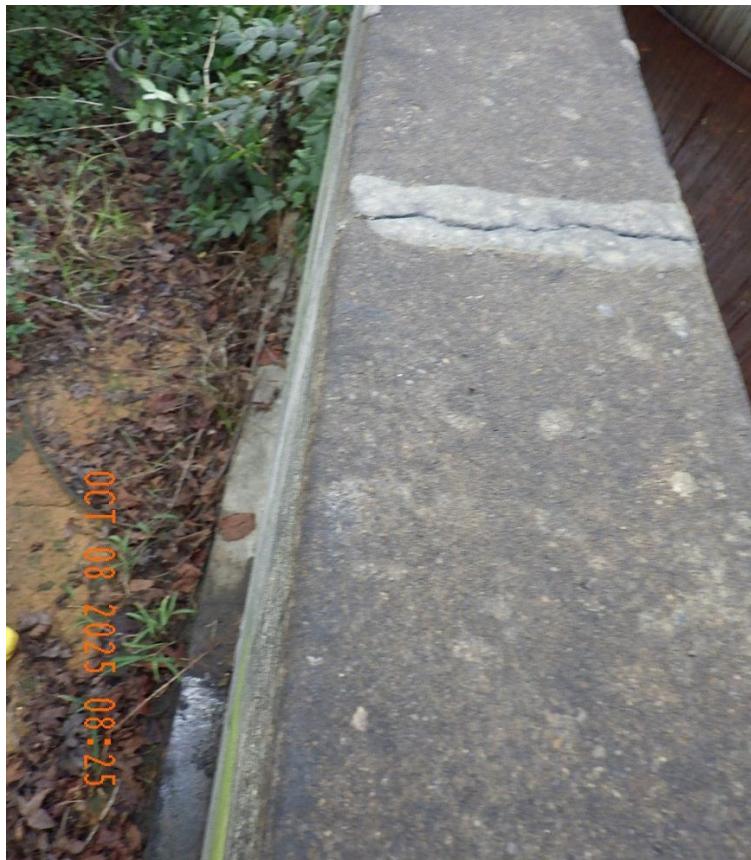
Description:	Tank Farm 10: A crack in the outside wall of the secondary containment. Arrows spray painted on the outside of wall identifying crack.		
Latitude:	N/A	Longitude:	N/A

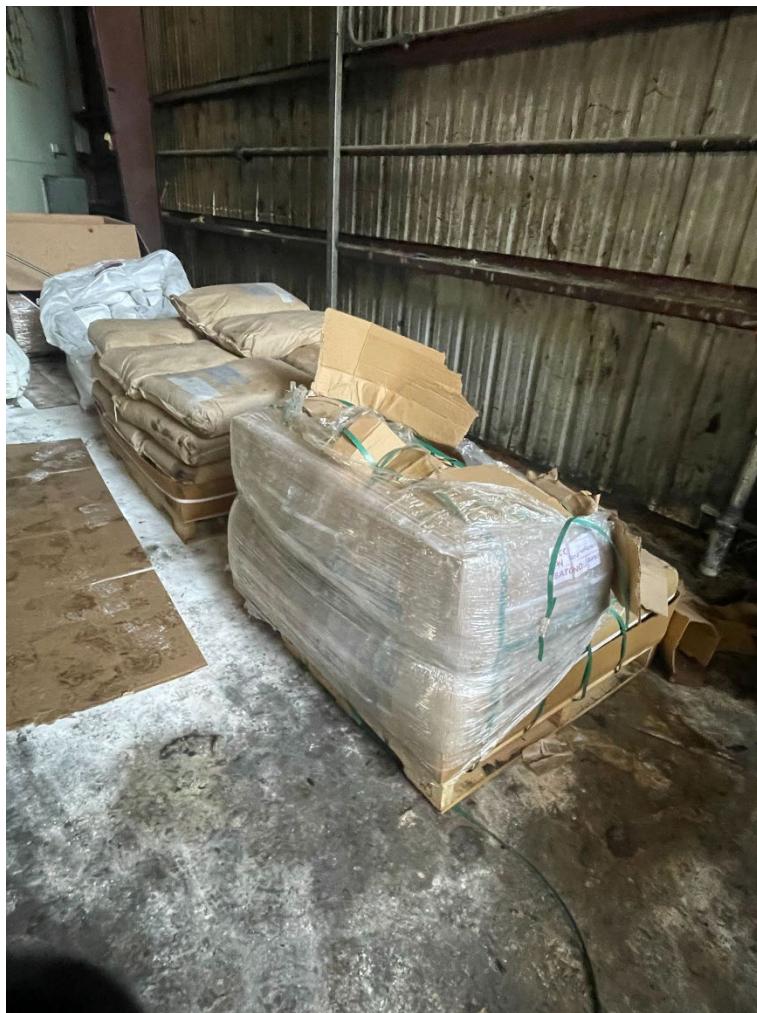
Photo No. 26

Description:	Grease Plant (Inside): Pallet of calcium carbonate bags next to a partially-wrapped pallet of stearic acid. White material on floor.		
Latitude:	N/A	Longitude:	N/A

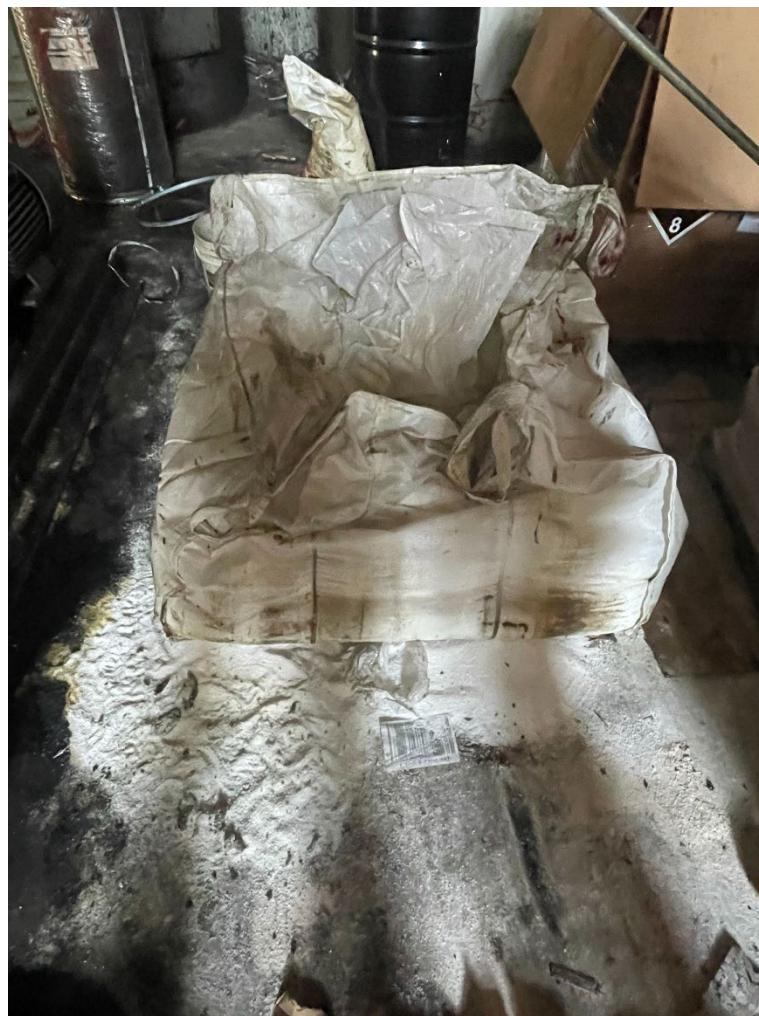
Photo No. 27

Description:	Grease Plant (Inside): Open supersack with contents spilled on the floor. Supersack is not labeled to identify its contents.		
Latitude:	N/A	Longitude:	N/A

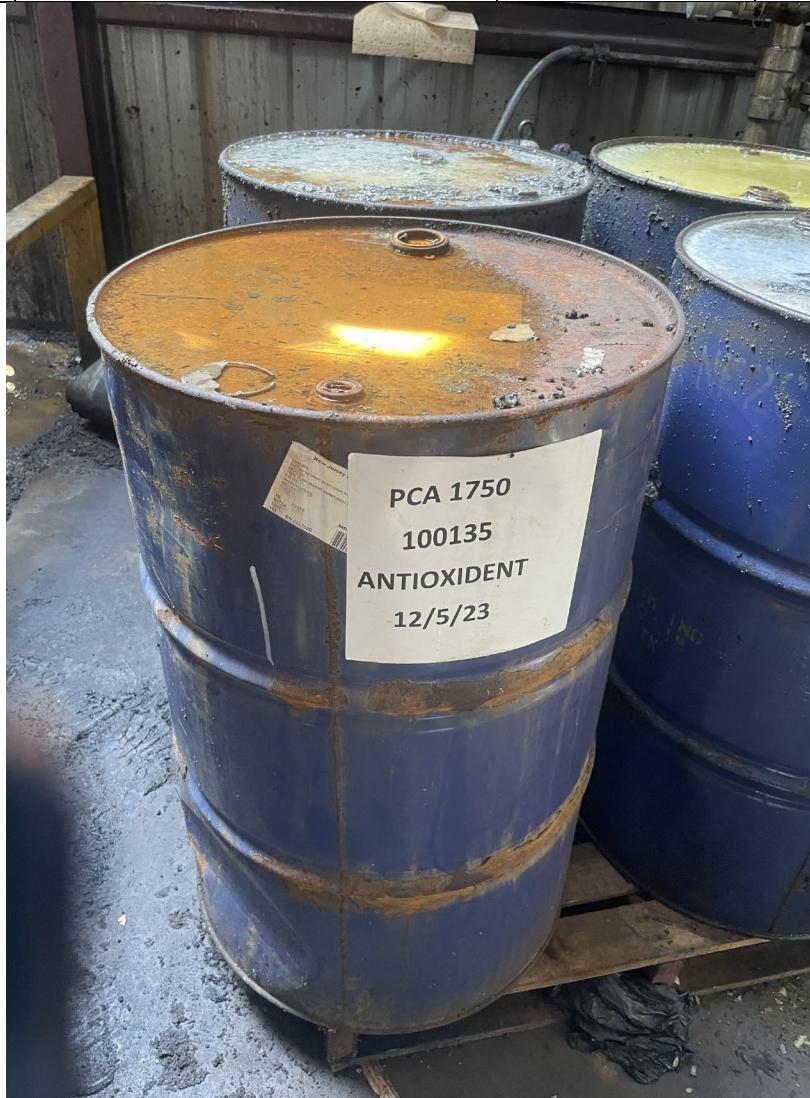
Photo No. 29

On the south wall, inspectors found 12 drums marked "NF 2920" and one relabeled "PCA 1750 100135 Antioxidant 12/5/23" [sic] in deteriorating condition (Appendix 2: Photos 29 – 31). Next to the drums, inspectors saw a partially full tote labeled "dodecylbenzenesulfonic acid" with a "corrosive" warning label (Appendix 2: Photos 31, 32). A saturated and dripping rag was stuffed into the tote spigot, and a fresh wet spot on the cardboard placed below it demonstrated active leaking from the container (Appendix 2: Photo 32). Old movement tracks through the grease deposits on the floor included cardboard "pathways" laid down by workers in the plant (Appendix 2: Photos 31, 32). The cardboard was saturated and moldy in places, indicating consistent wetness and housekeeping issues (Appendix 2: Photo 32). The sulfonic acid tote sat less than four feet away from three metal drums labeled "Navipol" with "flammable" warning placards on each. The drums were tipped and stored on their sides for ease of dispensing through a spigot. The drip pan beneath the three drums was mostly full of the active dripping from the contents of the three drums. The inspectors found four boxes of universal hazardous waste lamps in a small closet. All of the lamp boxes were unlabeled, and one was open (Appendix 2: Photo 33).

Description:	Grease Plant (Inside): Label on drum of PCA 1750 Antioxidant.		
Latitude:	N/A	Longitude:	N/A

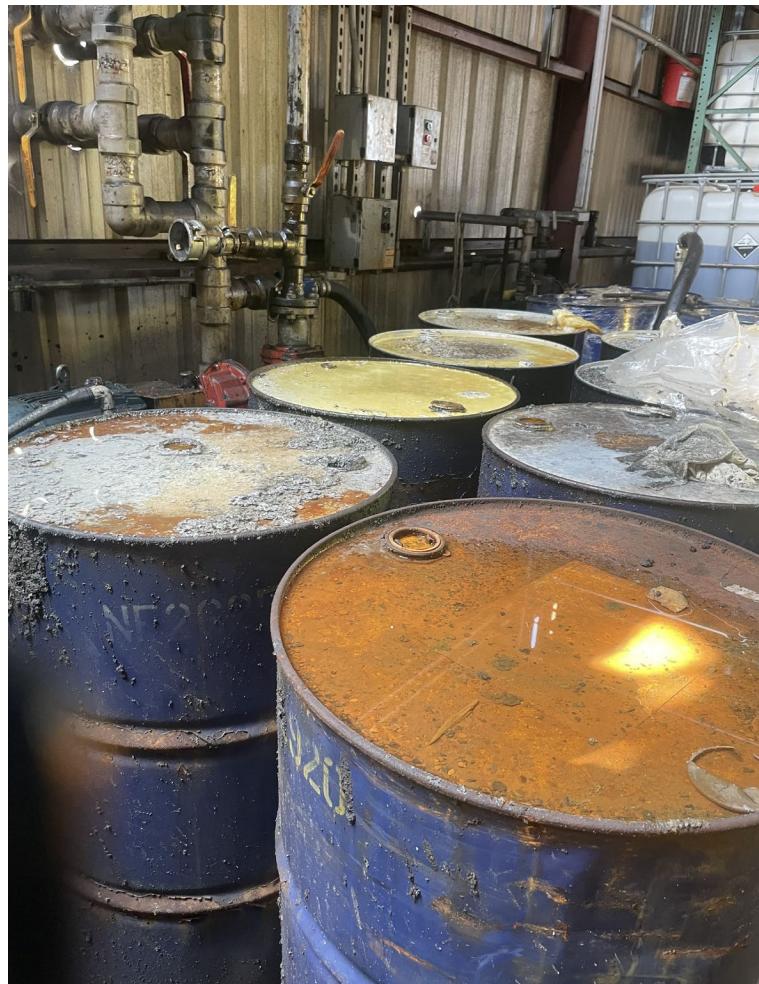
Description:	Grease Plant (Inside): Close up of drums from photo 29. All have "NF2920" spraypainted on outside. Corroded, open bung, and leaking drum on the left. Damaged drum on the right.		
Latitude:	N/A	Longitude:	N/A

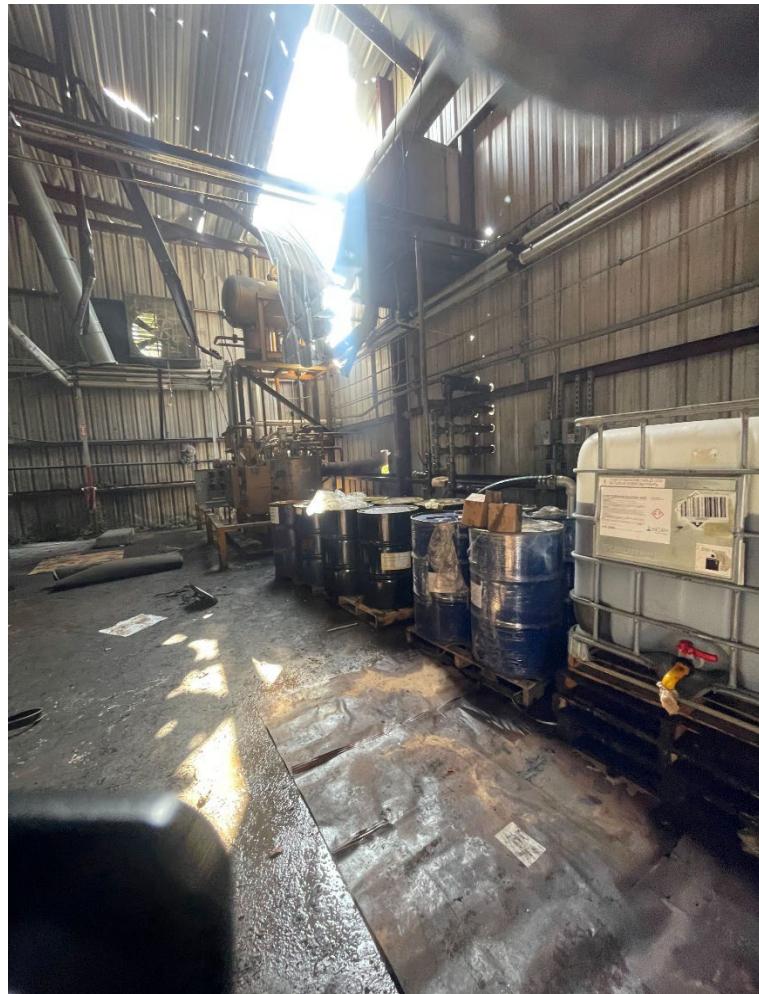
Photo No. 31

Description:	Grease Plant (Inside): Overview of south wall of production area with release of oily liquid. Absorbents and cardboard on the floor were saturated with the oily liquid. Tote of sulfonic acid has rag stuffed in spigot (right). Hole in the ceiling of warehouse from tank lid coming through the roof.		
Latitude:	N/A	Longitude:	N/A

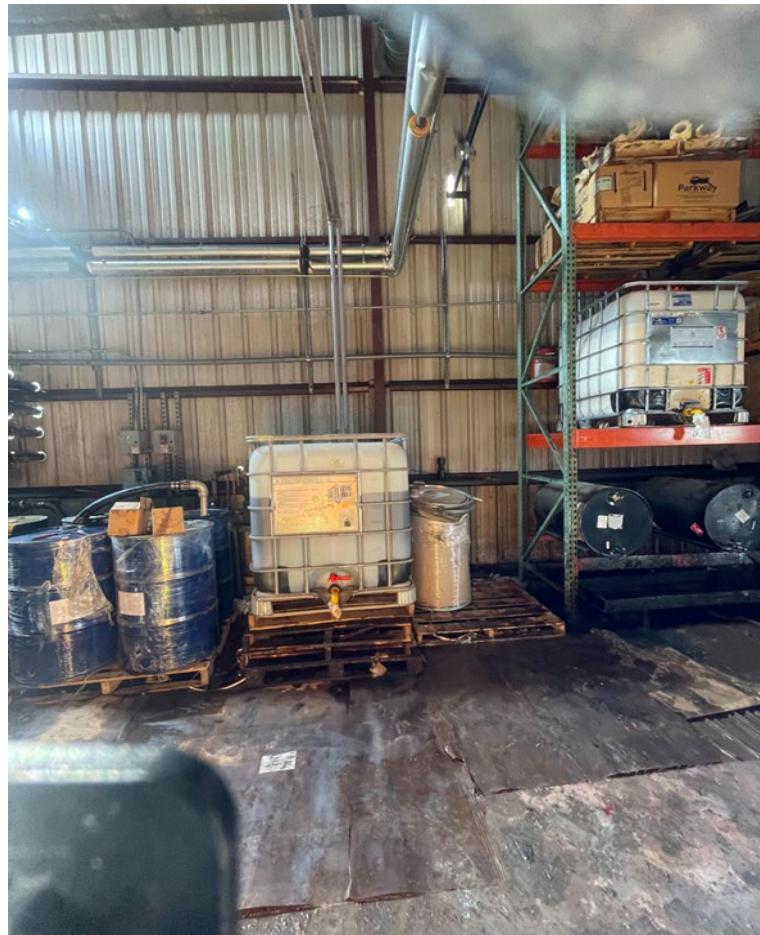
Description:	Grease Plant (Inside): Overview of tote of sulfonic acid with rag stuffed in spigot (center). Fresher, dark spot on cardboard indicates recent leaks. Black drums marked flammable to the right. Drip tray underneath black drums is holding liquid. Tote above black drums also has rag in spigot (right).		
Latitude:	N/A	Longitude:	N/A

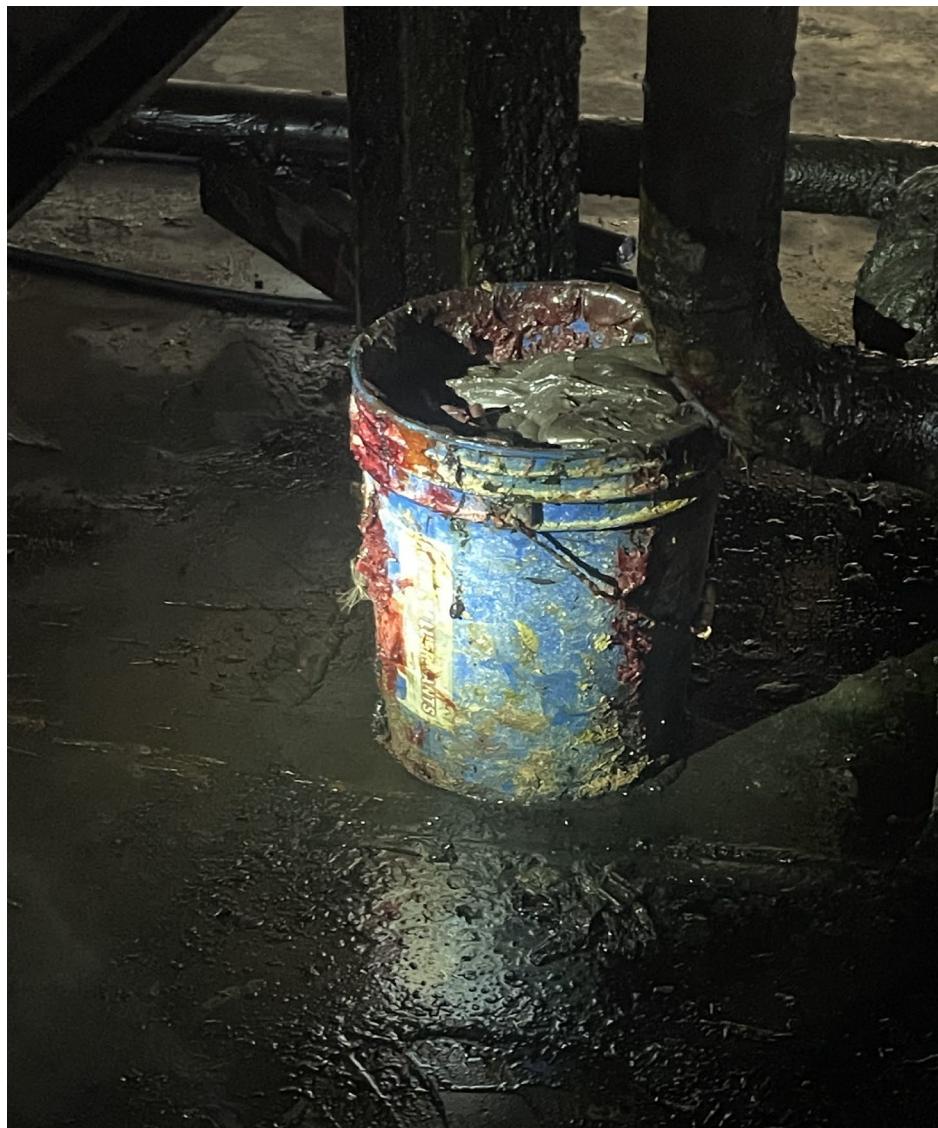
Photo No. 34

Description:	Grease Plant (Inside): Production area, oily releases on ground. 5-gallon bucket unlabeled and filled with grease.		
Latitude:	N/A	Longitude:	N/A

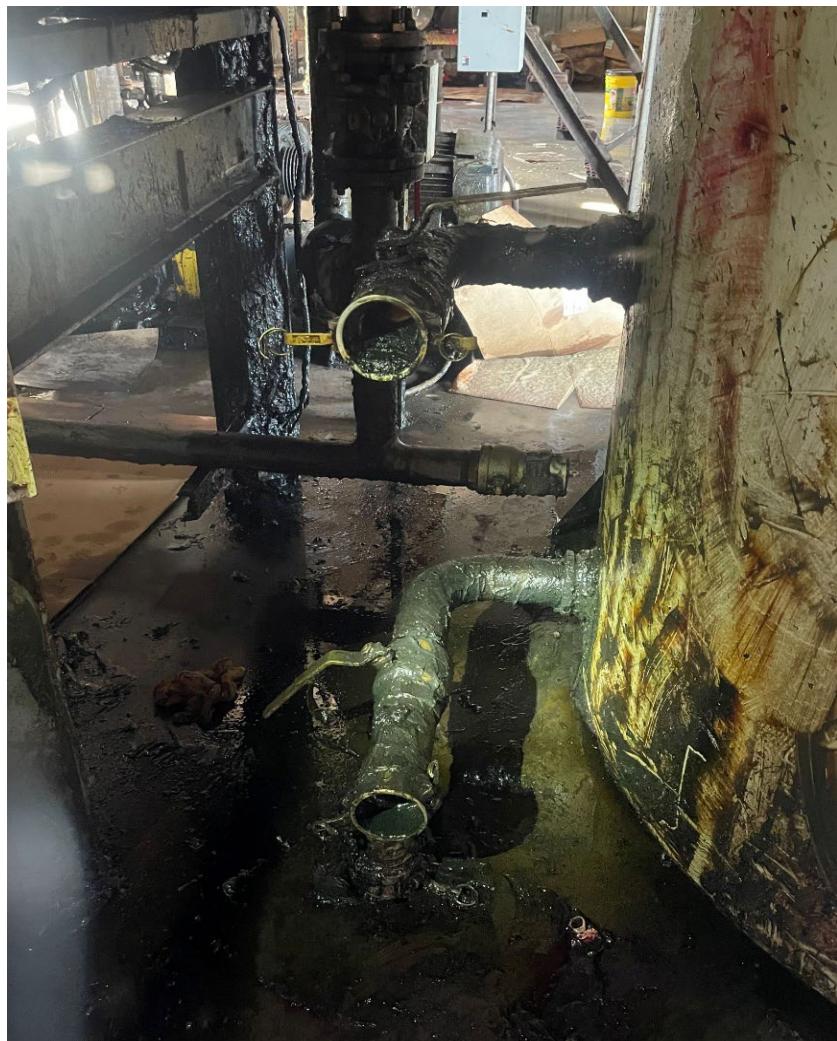
Photo No. 36

Description:	Grease Plant (Inside): Connections, pipes, tanks and floor are covered with deposits of grease.		
Latitude:	N/A	Longitude:	N/A

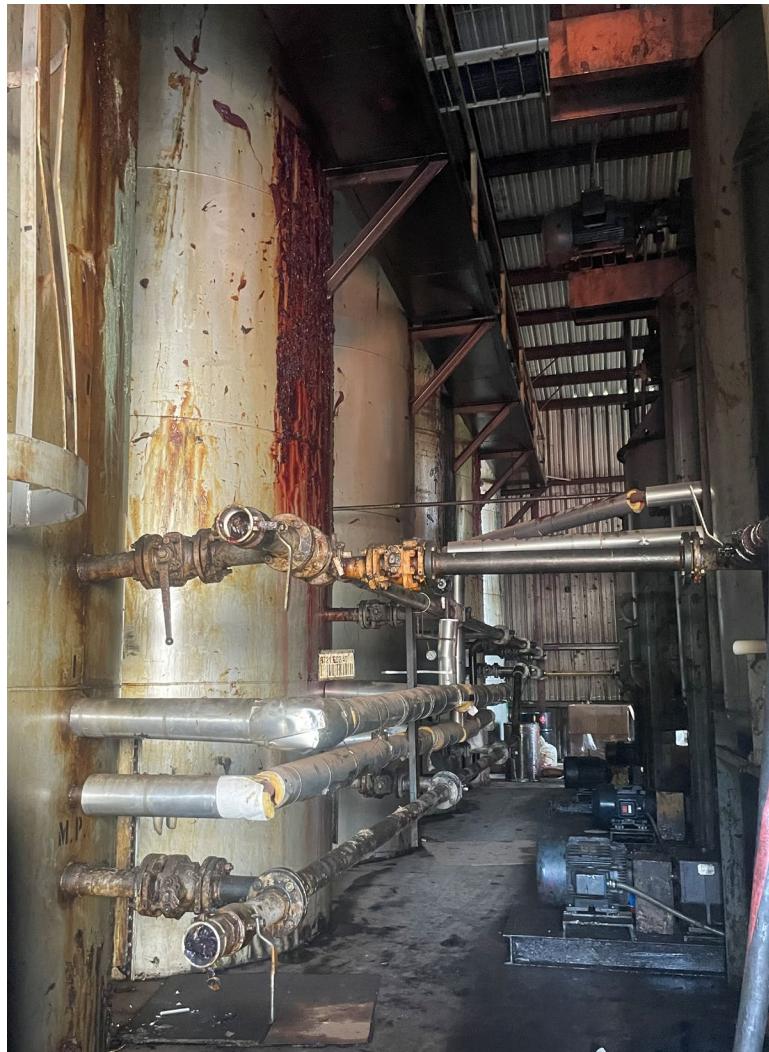
Photo No. 37

Description:	Grease Plant (Inside): Spills from tanks and ancillary equipment visible on floor and tank walls. Cardboard on ground. Evidence of historic releases on walkway.		
Latitude:	N/A	Longitude:	N/A

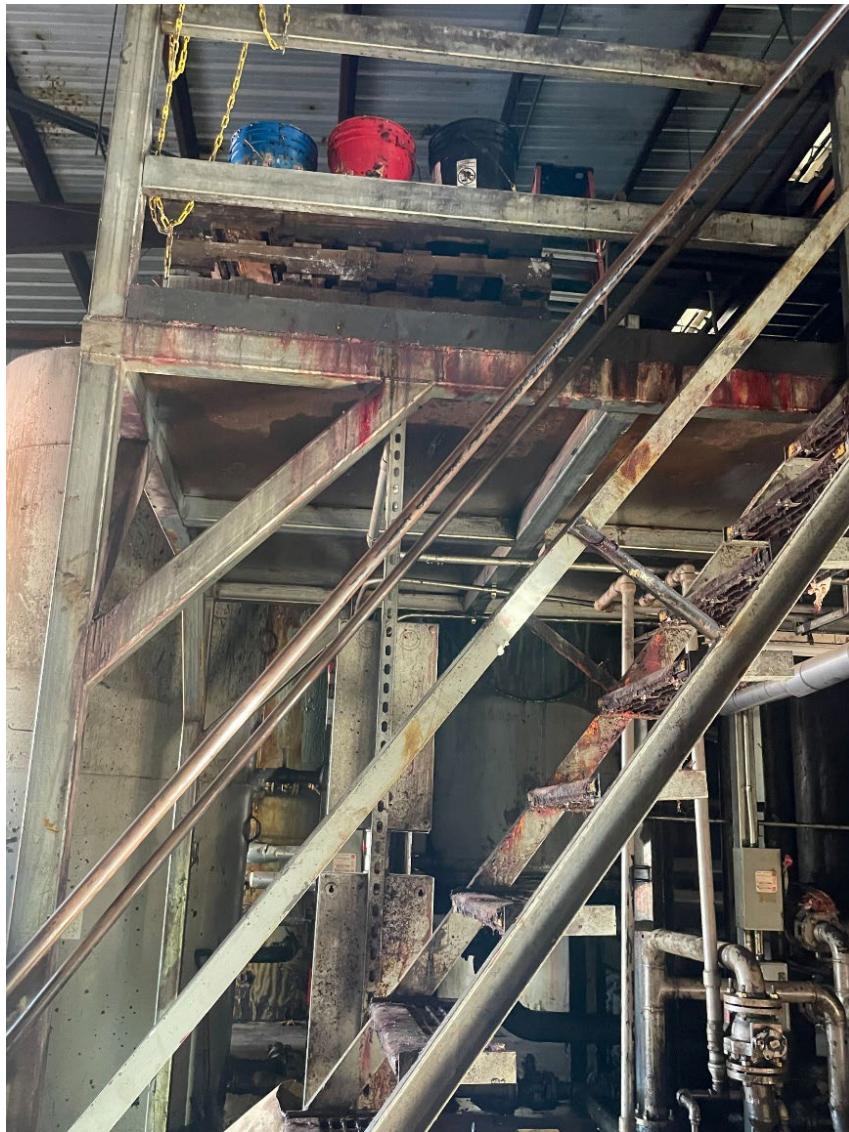
Photo No. 38

Description:	Grease Plant (Inside): Open and unlabeled containers stored on the platform at the top of the stairs. Stairs are covered with grease drips.		
Latitude:	N/A	Longitude:	N/A

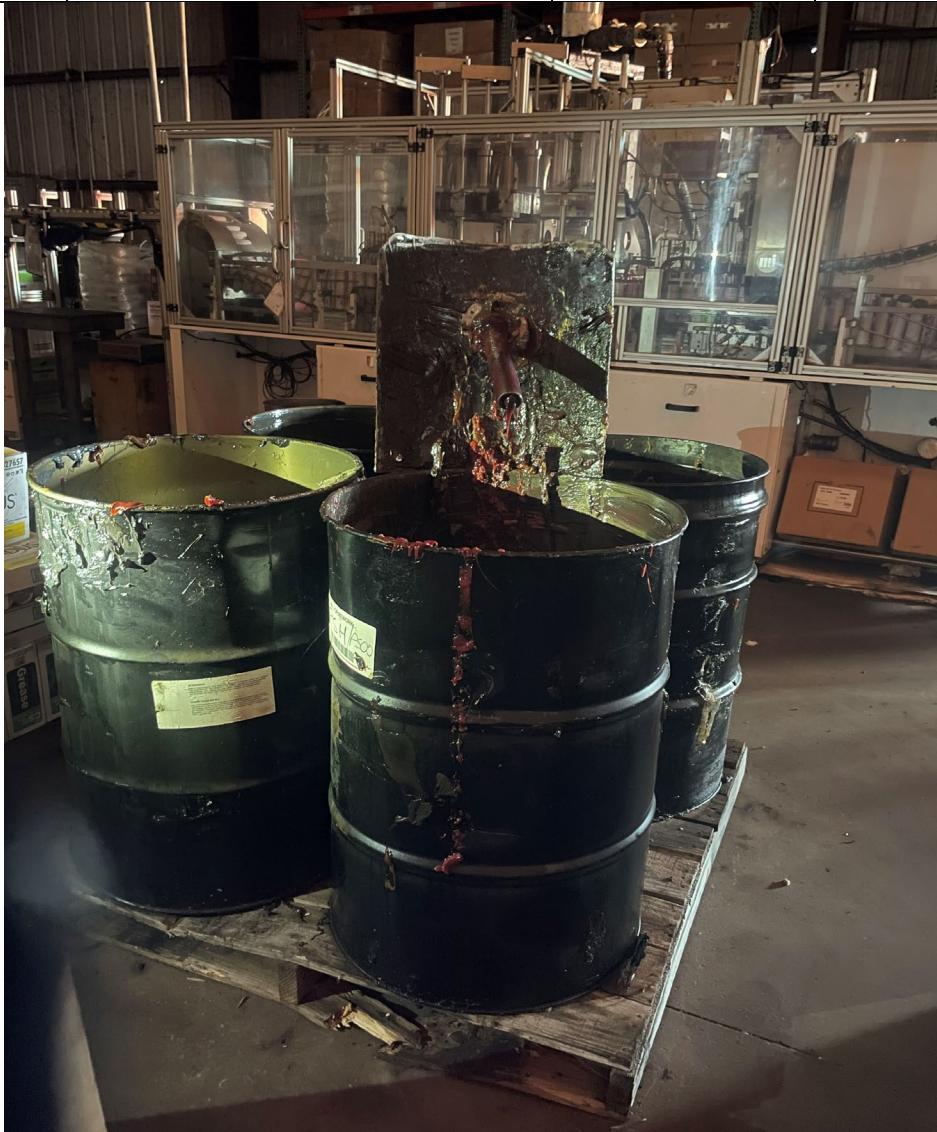
Photo No. 39

Description:	Grease Plant (Inside): Open, unlabeled, drums of grease in packaging area. Splatter on outside of drums.		
Latitude:	N/A	Longitude:	N/A

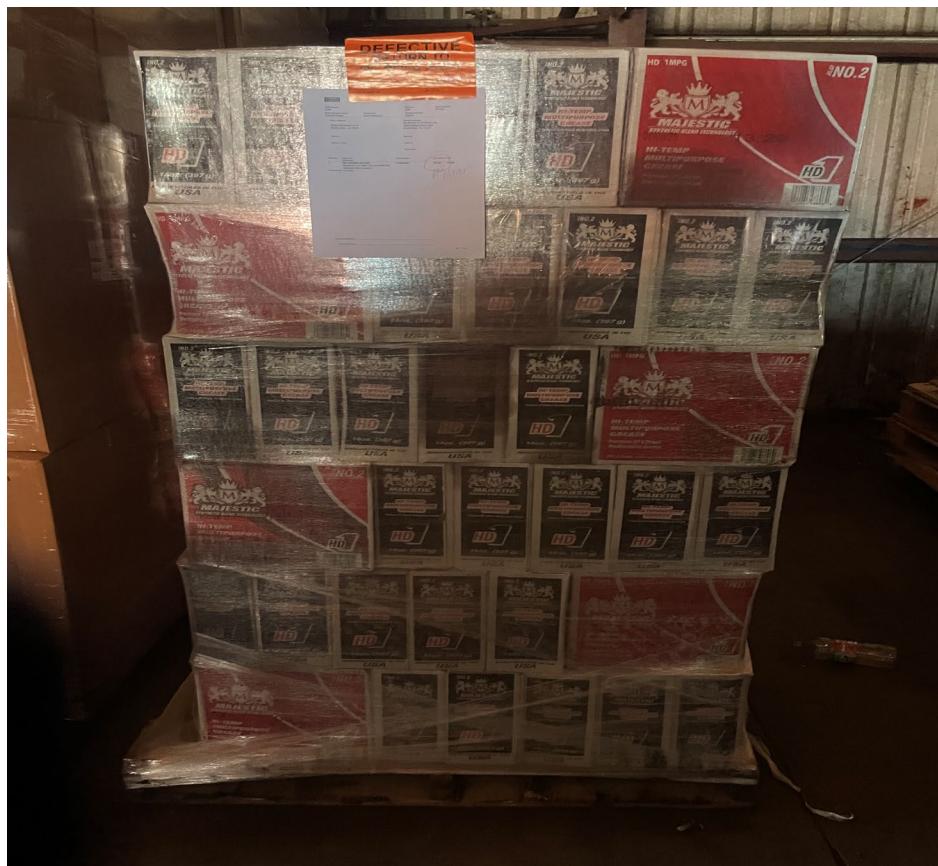
Description:	Grease Plant (Inside): Pallet of oil product in packaging area labeled "defective."		
Latitude:	N/A	Longitude:	N/A

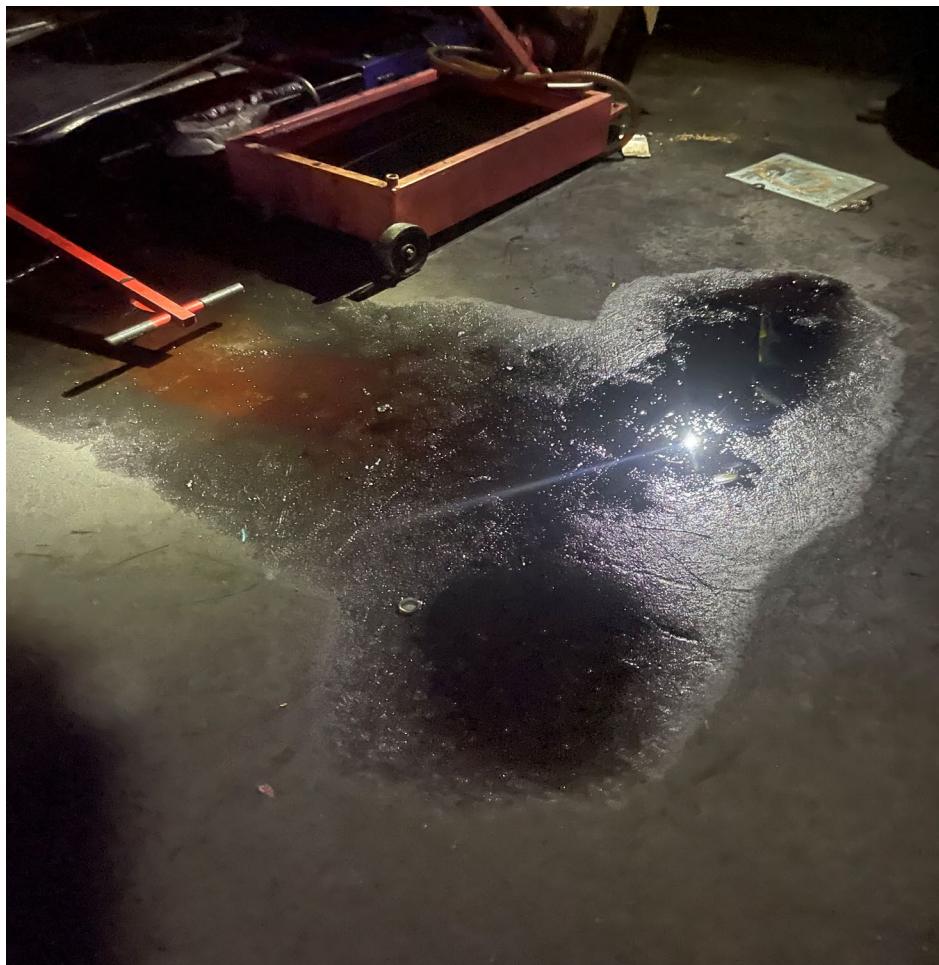
Photo No. 42

Description:	Truck Shop: Used oil spill.		
Latitude:	N/A	Longitude:	N/A

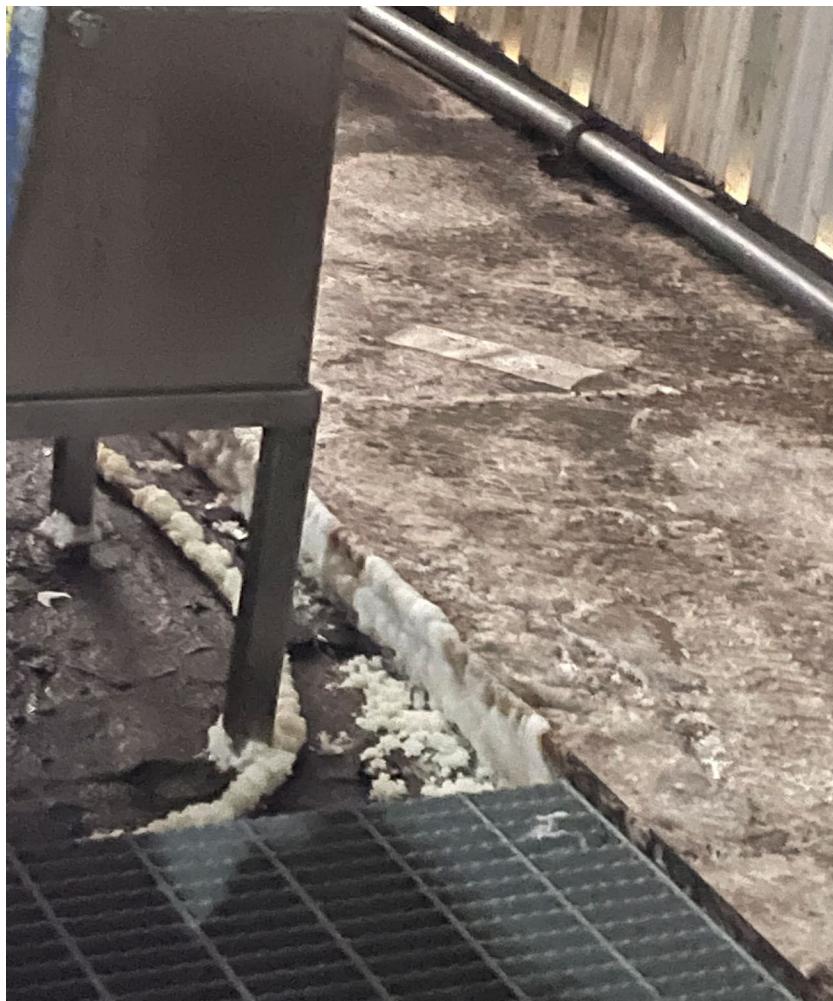
Photo No. 44

In the packaging area, inspectors noted deposits of crystallized DEF on the ground, on drum lids, and around the equipment (Appendix 2: Photo 44). Secondary containment pallets holding oily materials was overfilled and had spilled onto the floor (Appendix 2: Photo 45). Inspectors noted several drums and totes that were opened and/or unlabeled (Appendix 2: Photos 46, 47). Along the western wall, inspectors found several large, compressed gas cylinders with barcodes but no clear identification labels (Appendix 2: Photo 48). Inspectors also noted openings at the base of the walls (due to the nature of the corrugated metal sidings) that do not provide containment necessary to prevent releases to the outside environment (Appendix 2: Photos 44, 49, 50)

Description:	Warehouse 10 (Inside): Openings in corrugated metal walls do not provide containment of potential spills. Crystallized material deposited on floor from equipment.		
Latitude:	N/A	Longitude:	N/A

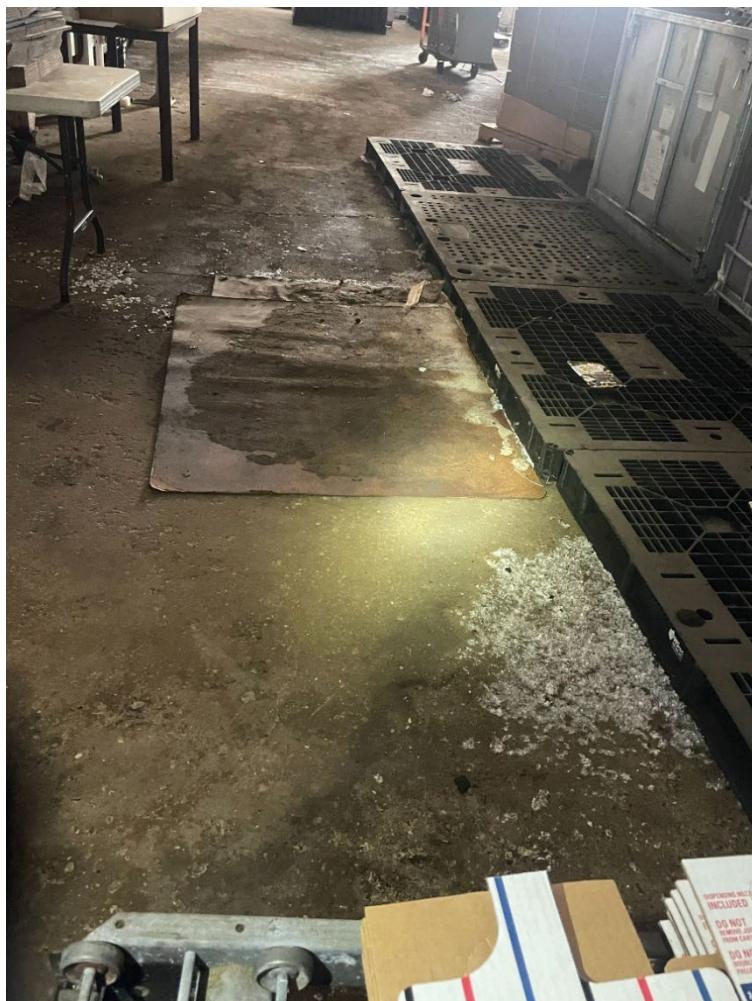
Photo No. 45

Description:	Warehouse 10 (Inside): Release of unknown liquid with saturated absorbents and cardboard. No visible attempt at containment or identification of the spilled liquid.		
Latitude:	N/A	Longitude:	N/A

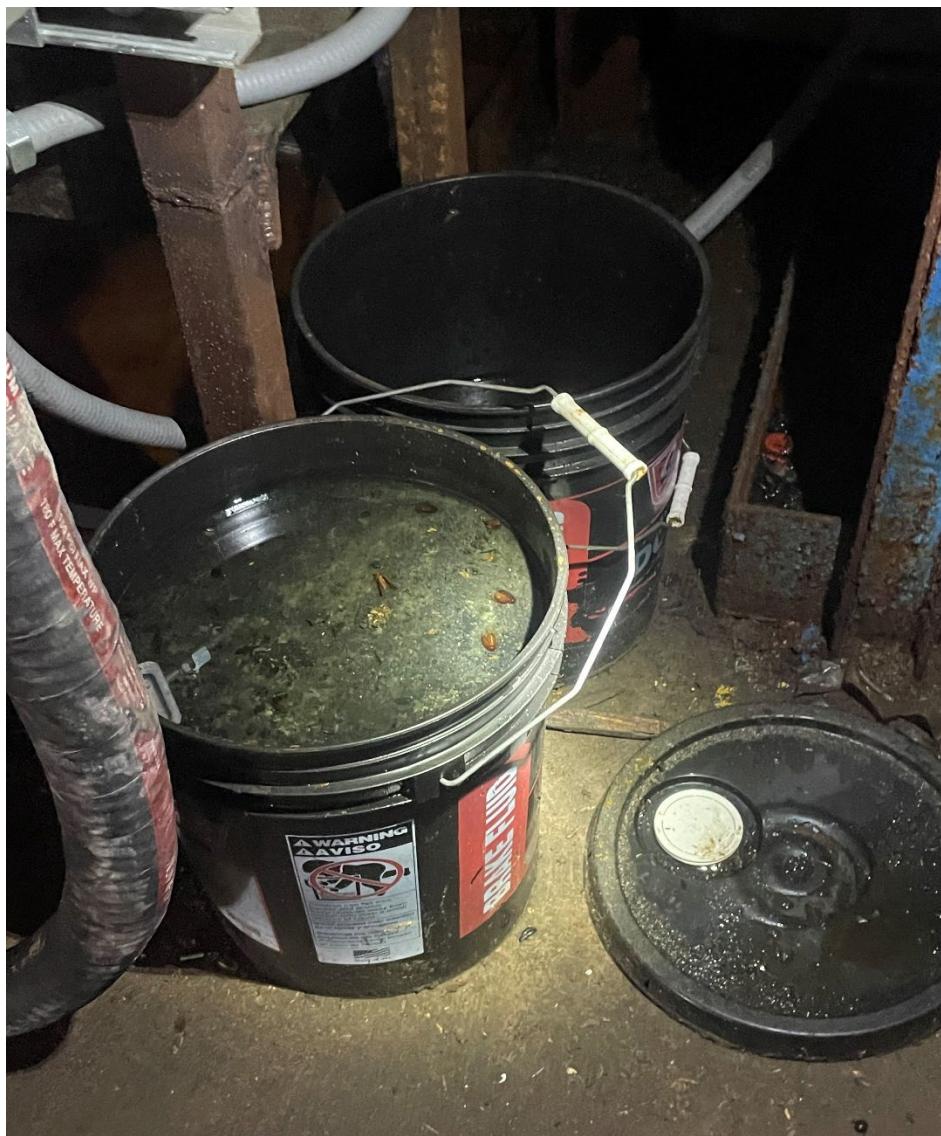
Photo No. 46

Description:	Warehouse 10 (Inside): Open containers of oily material. No labels.		
Latitude:	N/A	Longitude:	N/A

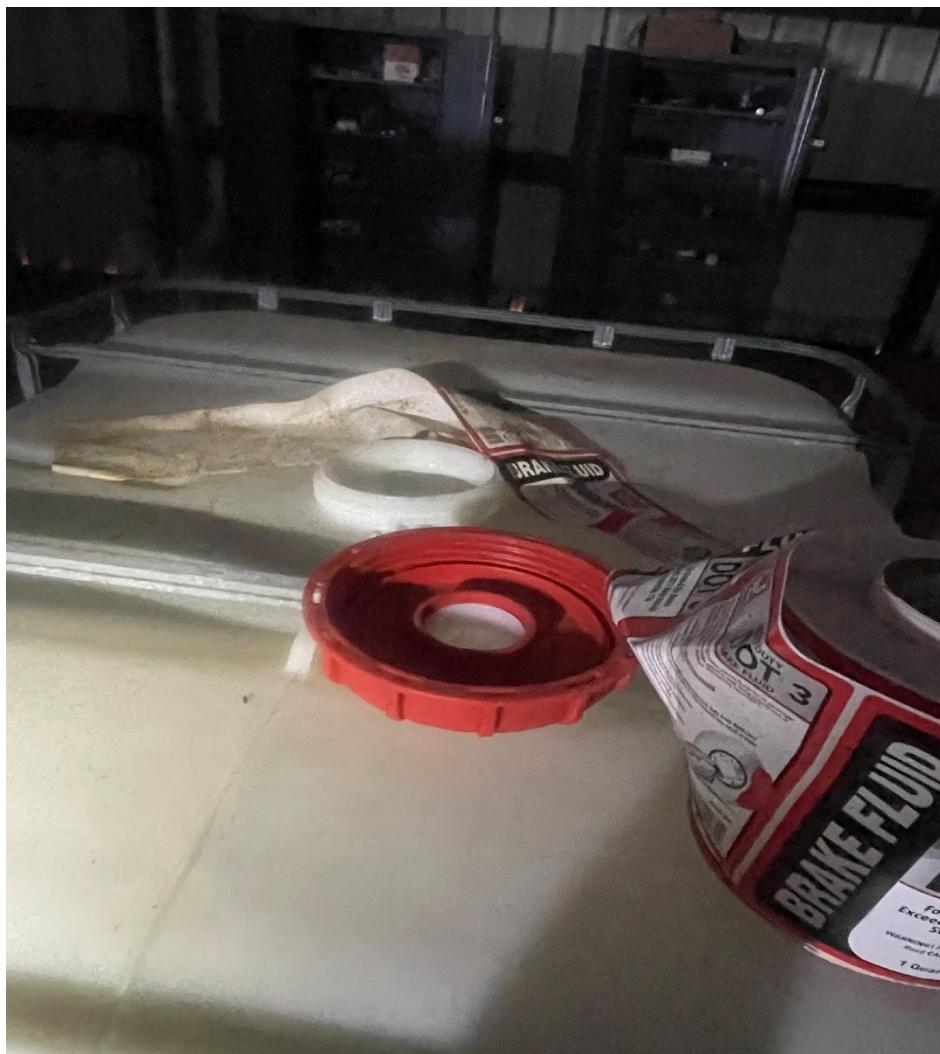
Photo No. 47

Description:	Warehouse 10 (Inside): Open container in packaging area.		
Latitude:	N/A	Longitude:	N/A

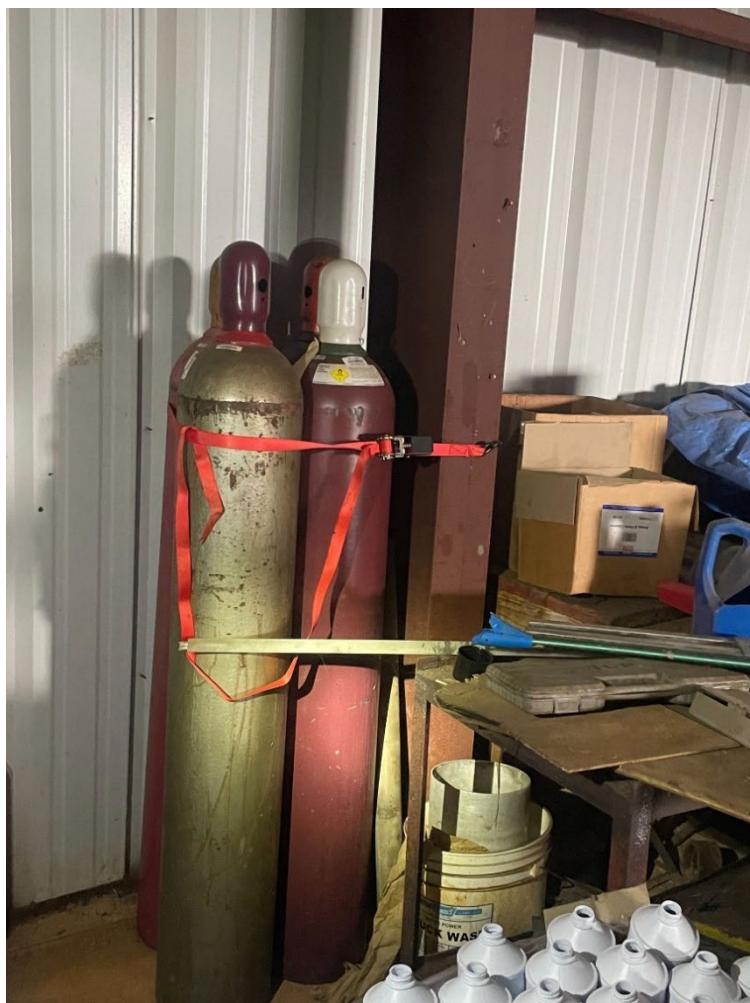
Photo No. 48

Description:	Warehouse 10 (Inside): Four (4) large cylinders of compressed gas. Barcodes but no identification labels.		
Latitude:	N/A	Longitude:	N/A
