Region 6 - Enforcement & Compliance Assurance Division
INSPECTION REPORT

Inspection Date(s):	10/07/2025 – 10/09/2025	
Media Program:	RCRA	
Regulatory Program(s)	Hazardous Waste, Used Oil	
Company Name:	Smitty's Supply, Inc.	
Facility Name:	Smitty's Supply Roseland	
Facility Physical Location:	63399 Highway 51 N	
(city, state, zip code)	Roseland LA 70456	
Mailing address:	PO Box 530	
(city, state, zip code)	Roseland LA 70456	
County/Parish:	Tangipahoa	
Facility Phone Number	1-800-256-7575	
Facility Contact:	Craig Ellison craigellison@smittysinc.net	
FRS Number:	110016753075	
EPA ID Number:	LAR000078691	
NAICS:	324191 - PETROLEUM LUBRICATING OIL AND GREASE MANUFACTURING	
SIC:	2992 – LUBRICATING OILS AND GREASES 4952 – SEWERAGE SYSTEMS	
Personnel participating in inspection:		
Angela Hays	U.S. EPA – Region 6	Inspector
Erin Young-Dahl	U.S. EPA – Region 6	Inspector
AD Talton	U.S. EPA – Region 6	Inspector
Jimbo Earles	LDEQ	Senior Environmental Scientist
Craig Easley	LDEQ	Senior Environmental Scientist

Section I – INTRODUCTION

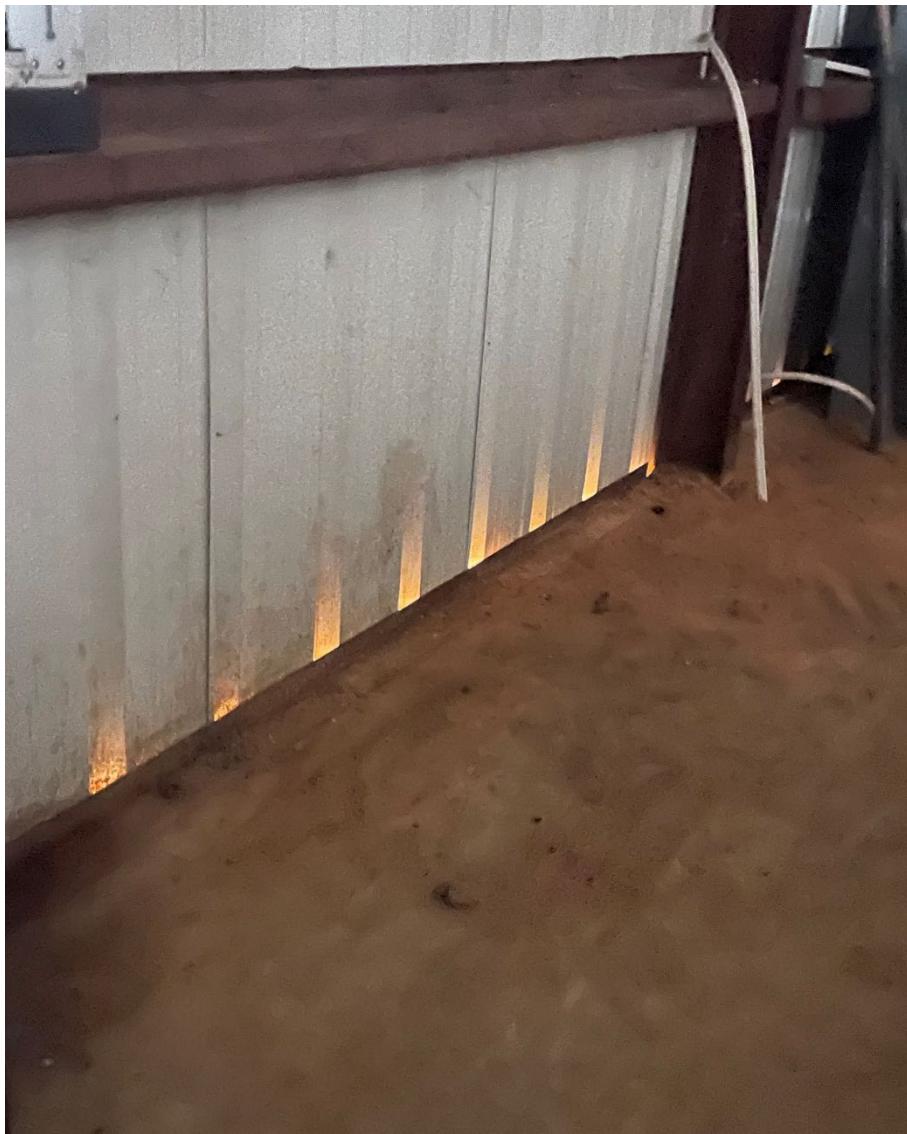
Photo No. 49

In the packaging area, inspectors noted deposits of crystallized DEF on the ground, on drum lids, and around the equipment (Appendix 2: Photo 44). Secondary containment pallets holding oily materials was overfilled and had spilled onto the floor (Appendix 2: Photo 45). Inspectors noted several drums and totes that were opened and/or unlabeled (Appendix 2: Photos 46, 47). Along the western wall, inspectors found several large, compressed gas cylinders with barcodes but no clear identification labels (Appendix 2: Photo 48). Inspectors also noted openings at the base of the walls (due to the nature of the corrugated metal sidings) that do not provide containment necessary to prevent releases to the outside environment (Appendix 2: Photos 44, 49, 50)

Description:	Warehouse 10 (Inside): Openings at the base of corrugated walls.		
Latitude:	N/A	Longitude:	N/A

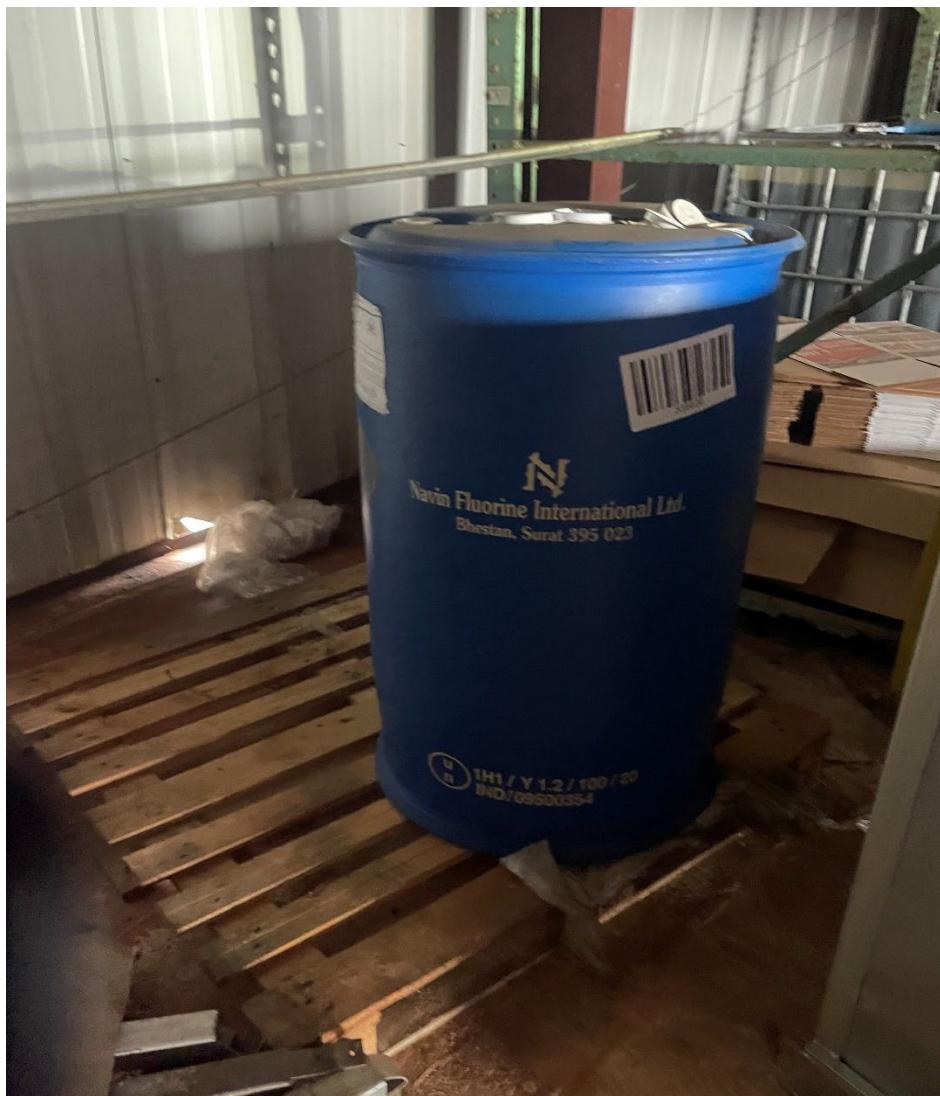
Photo No. 50

Description:	Warehouse 10 (Inside): Punch hole in wall (center-left).		
Latitude:	N/A	Longitude:	N/A

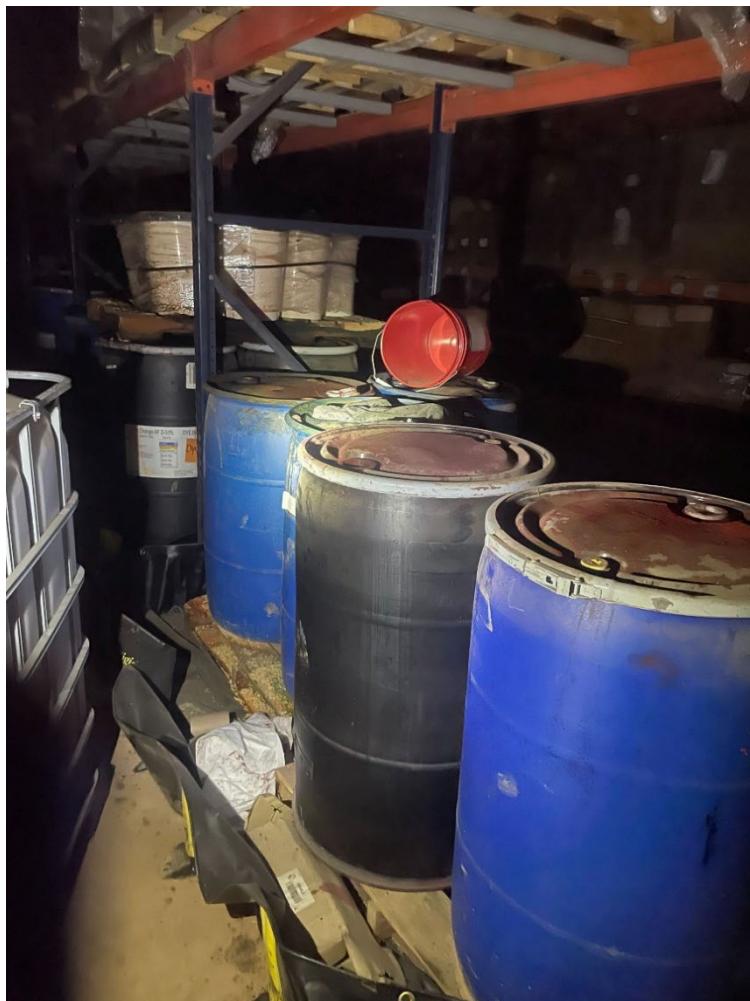
Photo No. 51

Description:	Warehouse 10 (Inside): Four 55-gal drums (four blue plastic and one black plastic) of unknown material. The drums are not labeled identifying their contents. One blue drum (third from the right) has residue on top. Remaining sawdust/absorbent pads to address what may have been a past spill.		
Latitude:	N/A	Longitude:	N/A

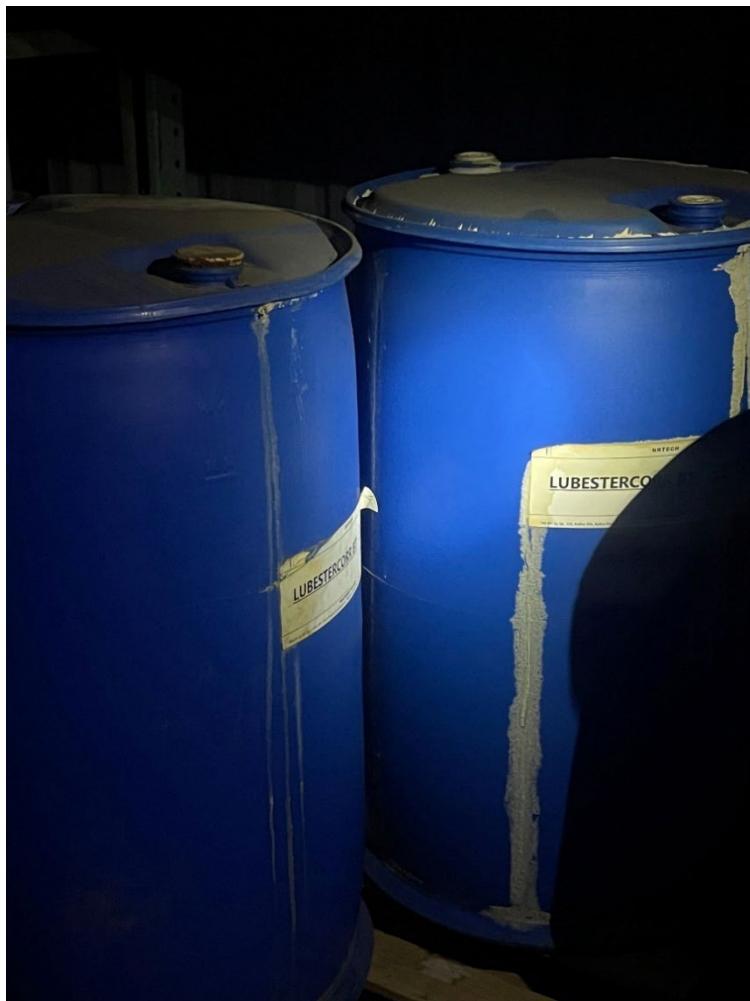
Photo No. 52

Description:	Warehouse 10 (Inside): Two (2) blue plastic 55-gallon drums of Lubesterco BT. There is evidence of a release of material from the top and residue on the outside of the drums.		
Latitude:	N/A	Longitude:	N/A

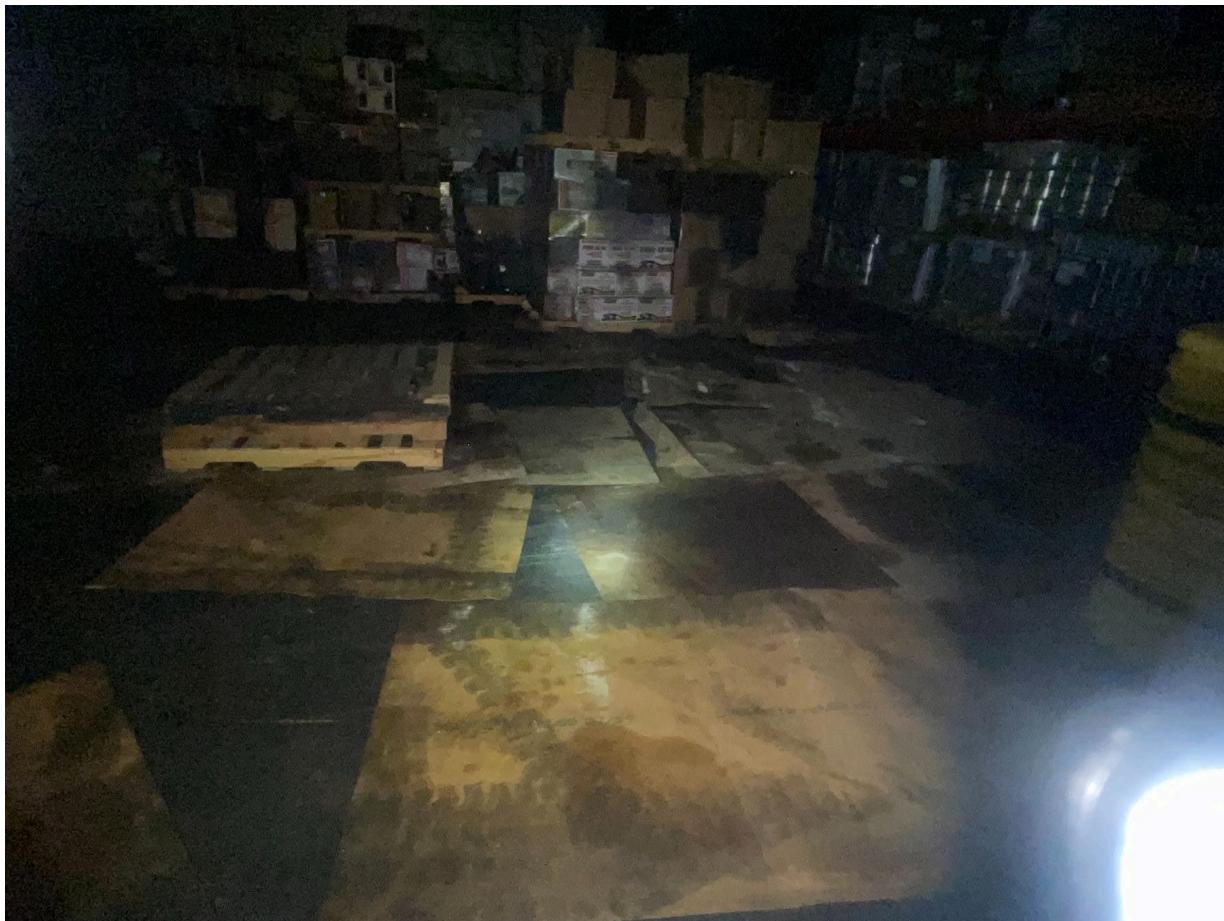
Photo No. 55

Description:	Warehouse 10 (Inside): A release of unknown liquid material from an unknown source (i.e. drum, tote, etc.) in the warehouse. There are cardboard pieces and absorbents on the floor of the warehouse that's heavily saturated with the released liquid on the floor.		
Latitude:	N/A	Longitude:	N/A

Inspectors next walked through the warehouse 10 storage area. There, pallets of totes, drums, and other packages were stacked on pallet racks up to four units high. Many of the containers seemed to contain virgin chemicals, but a large number of containers were open, unlabeled, damaged, or actively leaking onto the ground or onto underlying containers. Inspectors counted at least 40 individual spills (Appendix 2: Photos 51-62). Within the storage area and near the walkthrough to warehouse 6, Smitty's had set up a used oil filter crushing and draining station. The inspection team did not observe any labeling on the containerized used oil products and noted a large spill in the area (Appendix 2: Photo 6). In general, the traffic pathways in warehouse 10 packaging and storage areas, were heavily stained and slick from past spills (Appendix 2: Photos 55, 56, 60, 61).

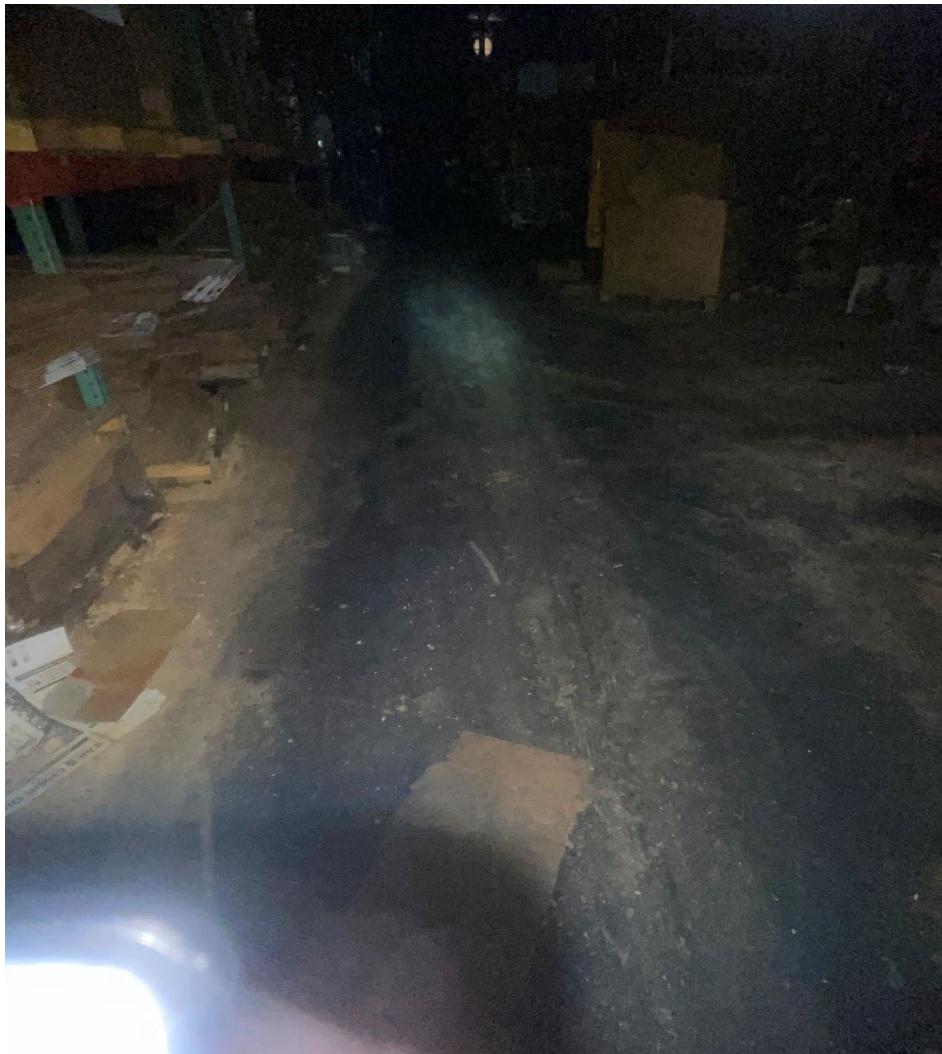
Description:	Warehouse 10 (Inside): Historic movement tracks and staining.		
Latitude:	N/A	Longitude:	N/A

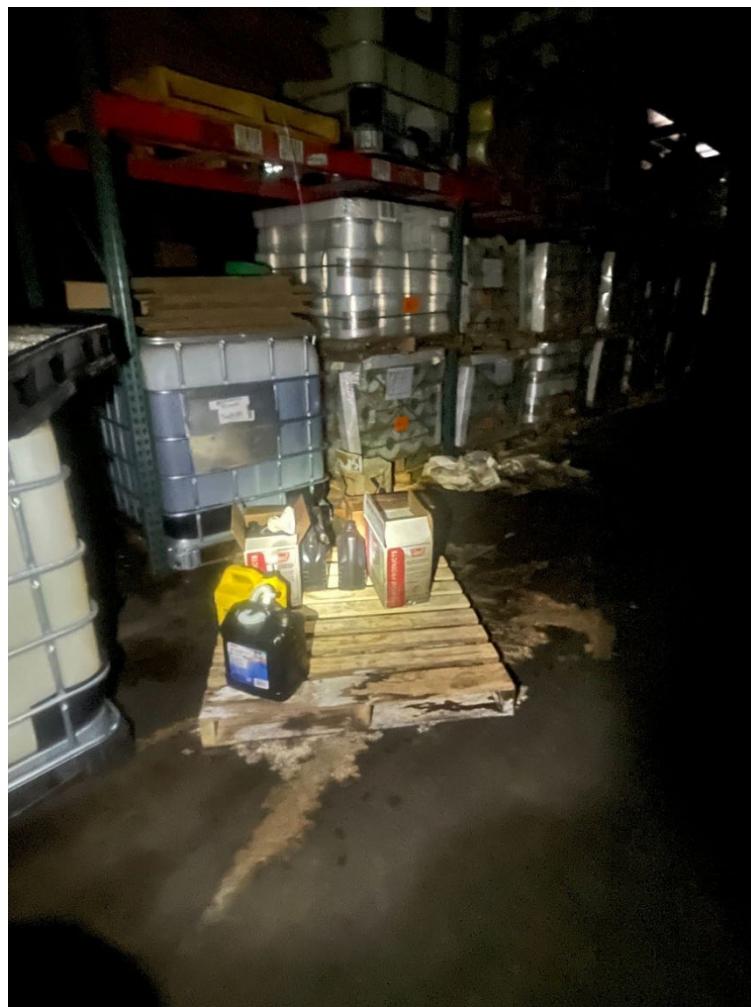
Description:	Warehouse 10 (Inside): Small containers of a petroleum product stored on a wooden pallet that's saturated with a liquid from an unknown spill. The floor stains show the occurrence of a spill with unknown source.		
Latitude:	N/A	Longitude:	N/A

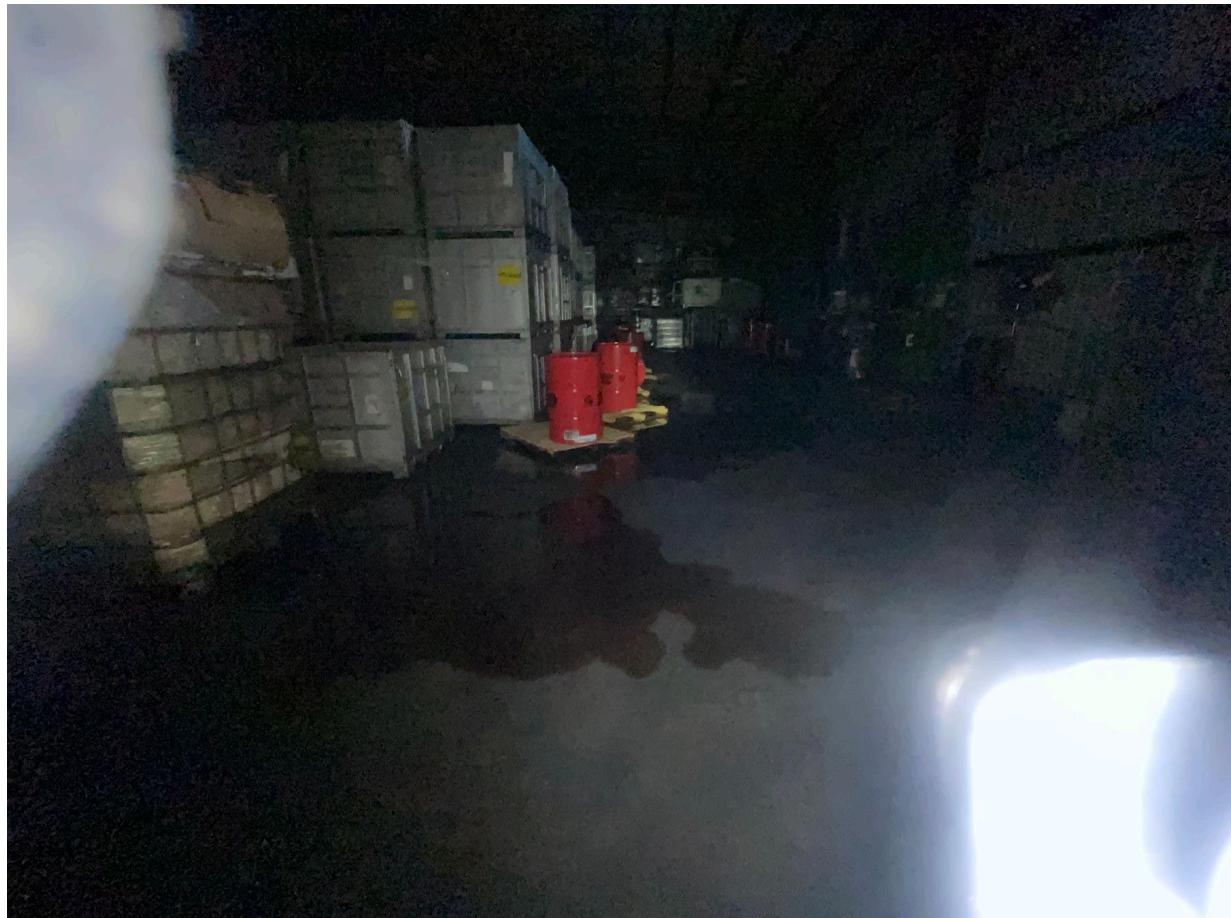
Description:	Warehouse 10 (Inside): View of filter crushing and draining area in background. Photo is of same area as photo 59. At least one metal box is leaking.		
Latitude:	N/A	Longitude:	N/A

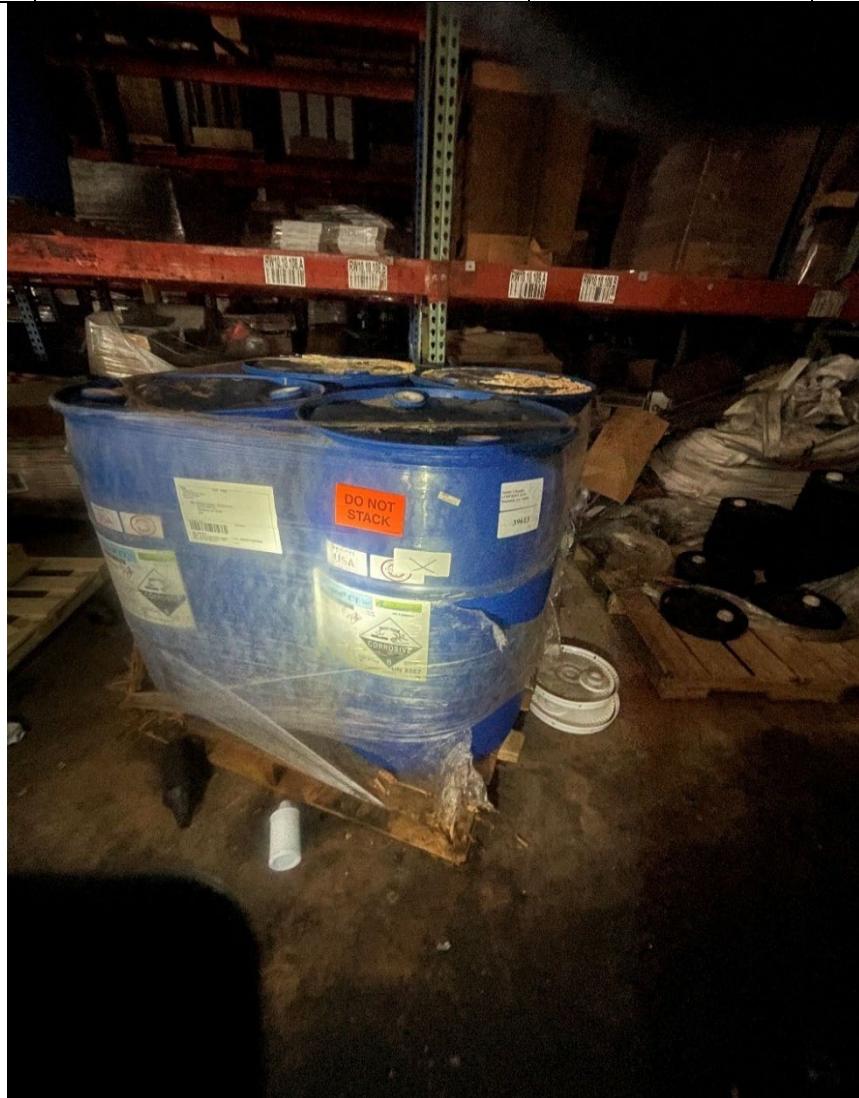
Description:	Warehouse 10 (Inside): A wooden pallet of four blue 55-gal drums of corrosive material identified. Drums have a liquid on top with sawdust. Pallet is damaged. It is unclear what was leaking on the drums.		
Latitude:	N/A	Longitude:	N/A

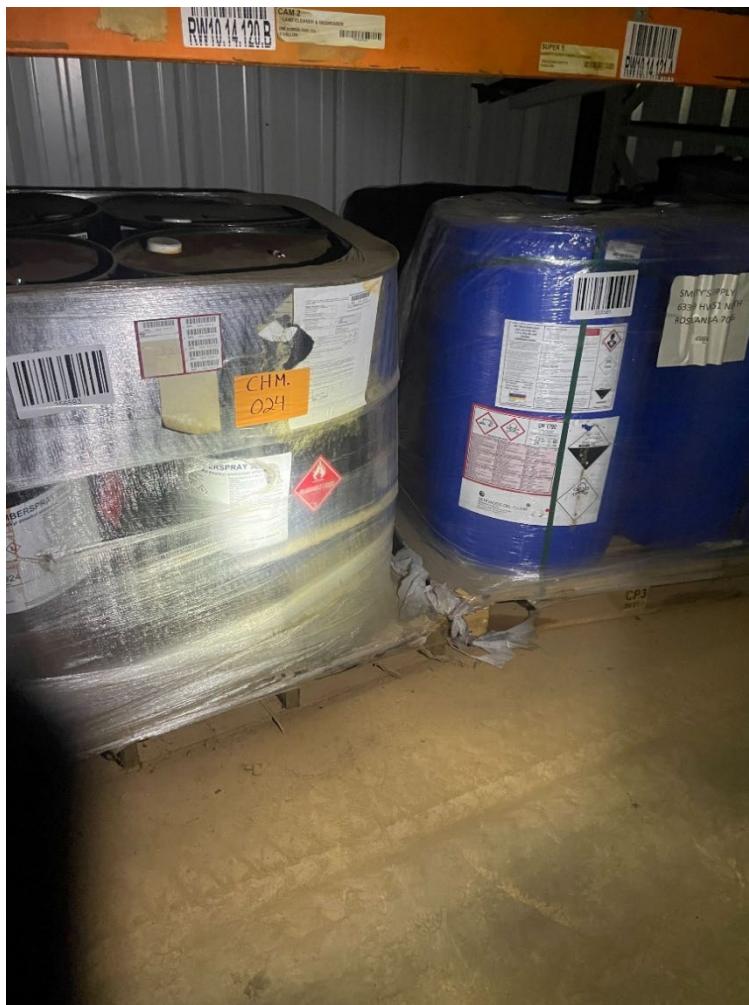
Description:	Warehouse 10 (Inside): Storage of incompatible material next to each other. One pallet of corrosive material and one pallet of flammable material.		
Latitude:	N/A	Longitude:	N/A

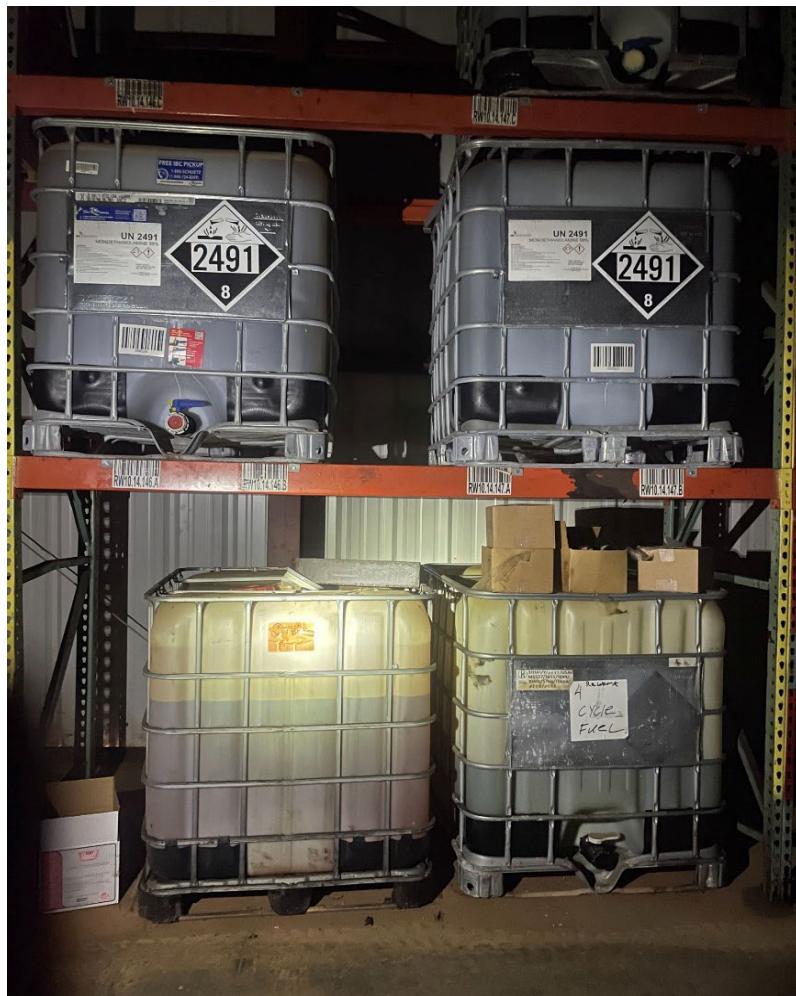
Description:	Warehouse 10 (Inside): Two totes of corrosive monoethanolamine stored above one tote labeled "rework / Dot 4 Brake" and one tote labeled "rework" cycle fuel, raising concerns over incompatible storage. Lack of "flammable" labeling on the 4-cycle tote and brake tote is open.		
Latitude:	N/A	Longitude:	N/A

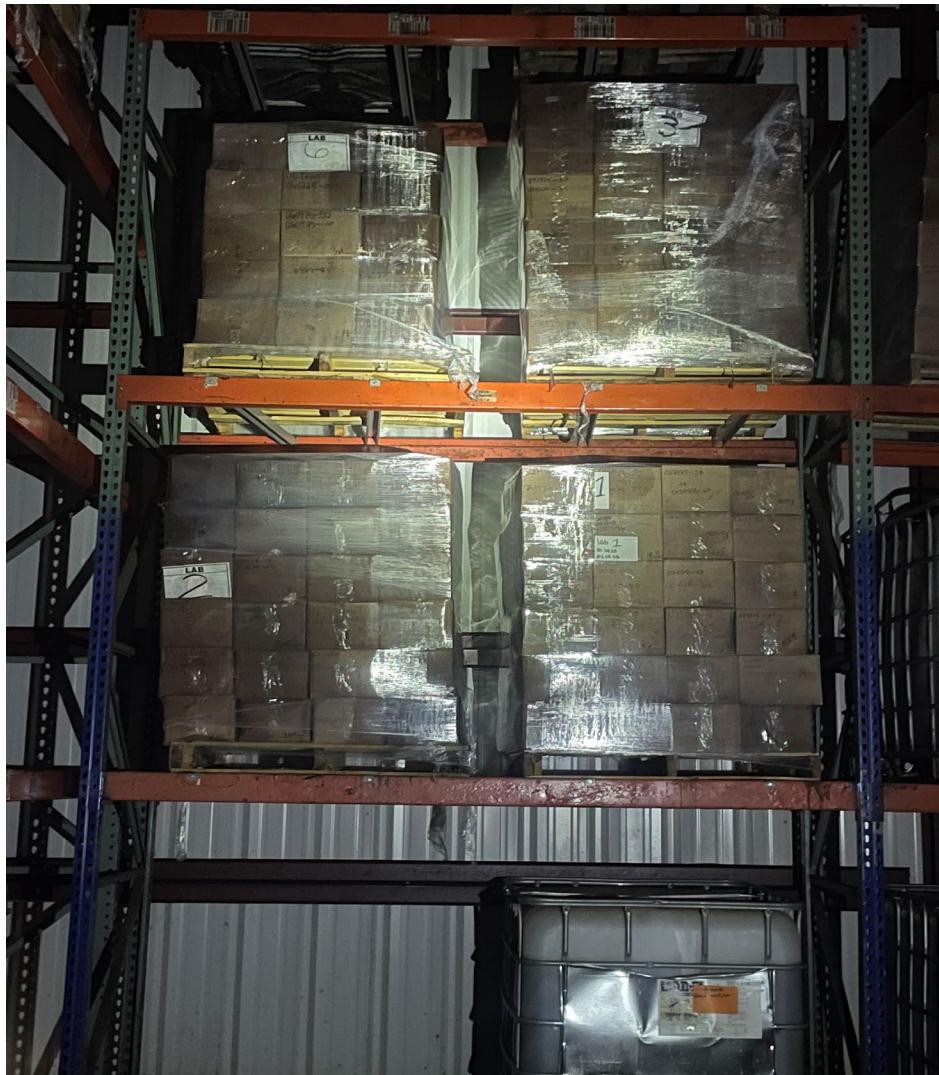
Description:	Warehouse 10 (Inside): Lab retain samples leaking through packaging.		
Latitude:	N/A	Longitude:	N/A

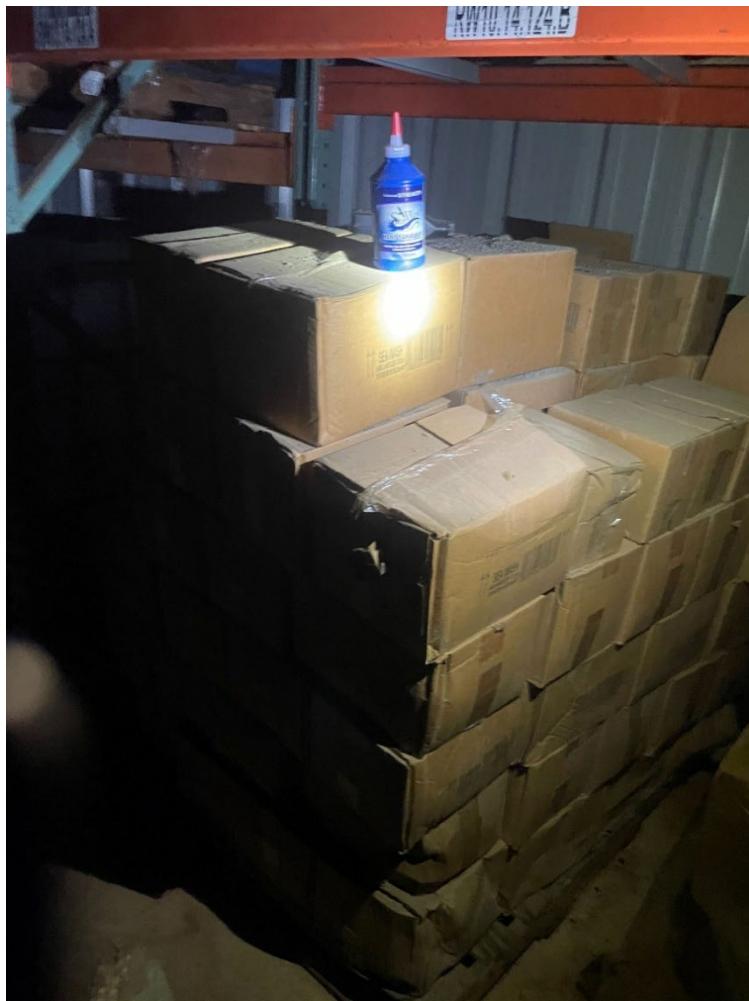
Photo No. 66

Description:	Warehouse 10 (Inside): Pallet of expired hand sanitizer (expiration date 2023). The bottle of hand sanitizer is representative of the contents of the boxes on the pallet.		
Latitude:	N/A	Longitude:	N/A

Inspectors also observed labels on at least 20 containers that suggested the stored materials were waste-like in nature. Many containers were marked as “off-grade” or “rework” or “bad” (Appendix 2: Photos 59, 60, 64, 67). Inspectors also found two pallets of hand sanitizer that expired in 2023 (Appendix 2: Photo 66).

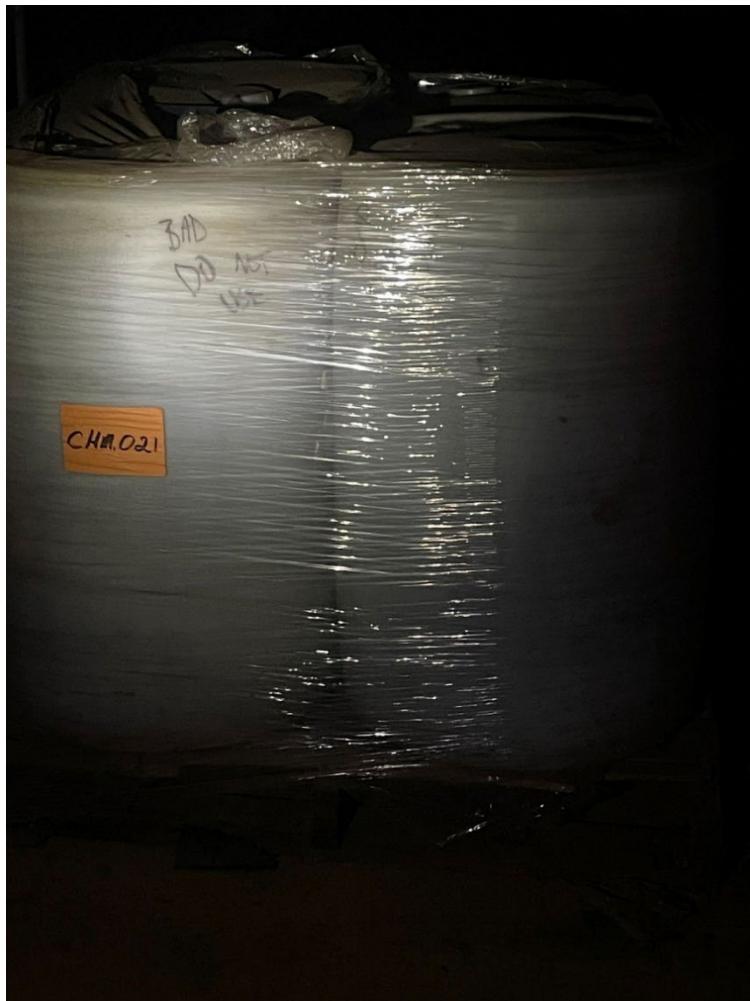
Photo No. 67

Description:	Warehouse 10 (Inside): A pallet of white 55-gal drums of unknown material labeled "Bad Do Not Use." Drums are not labeled identifying the contents of the containers.		
Latitude:	N/A	Longitude:	N/A

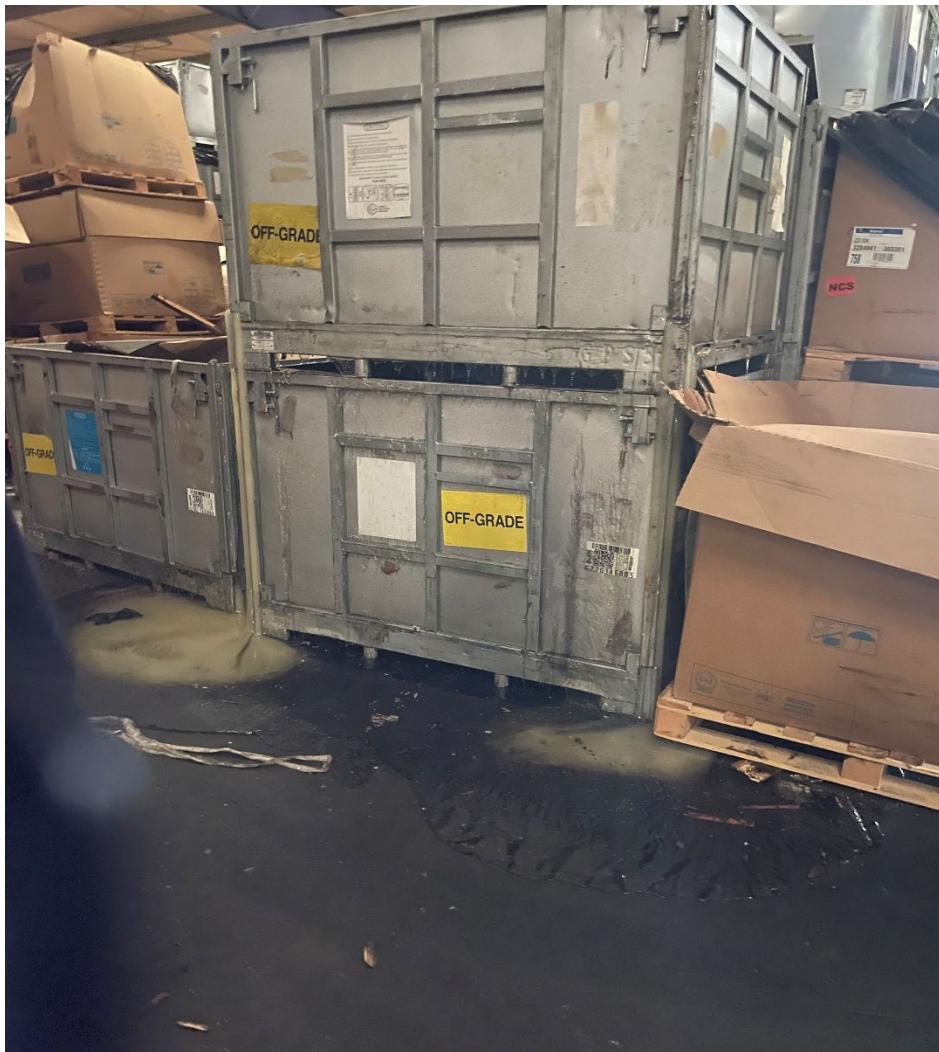
Description:	Warehouse 10 (Inside): Three metal boxes of a leaking plastic type material with "off grade" labeling.		
Latitude:	N/A	Longitude:	N/A

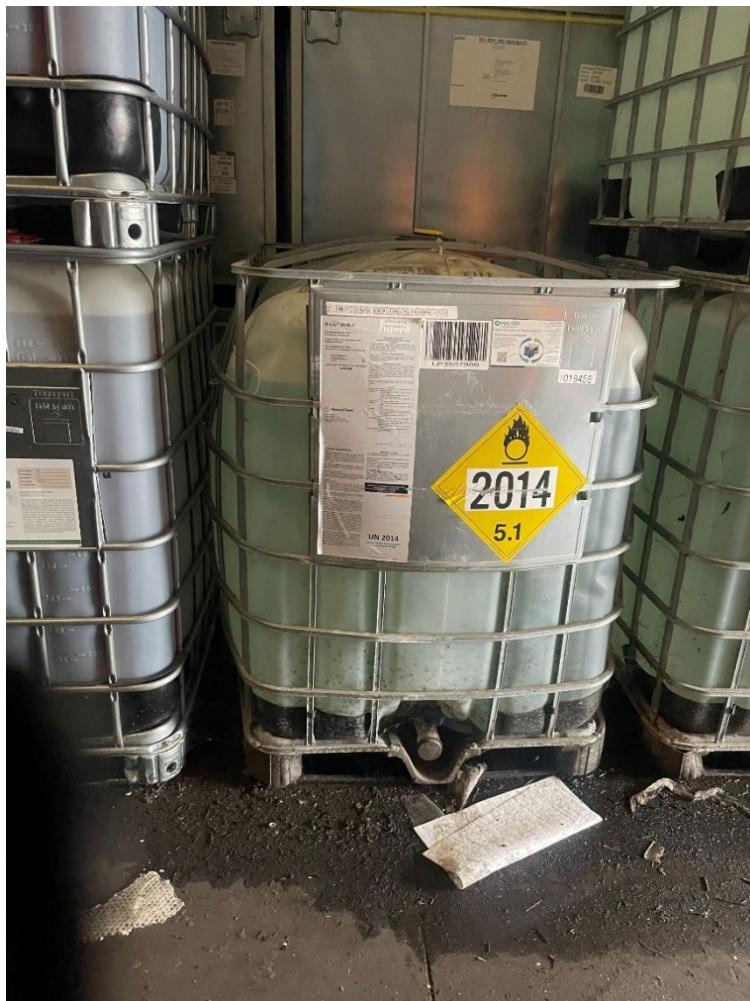
Description:	Warehouse 6 (Inside): Bulging tote containing peroxide. Staining and residue from past spills on the ground.		
Latitude:	N/A	Longitude:	N/A

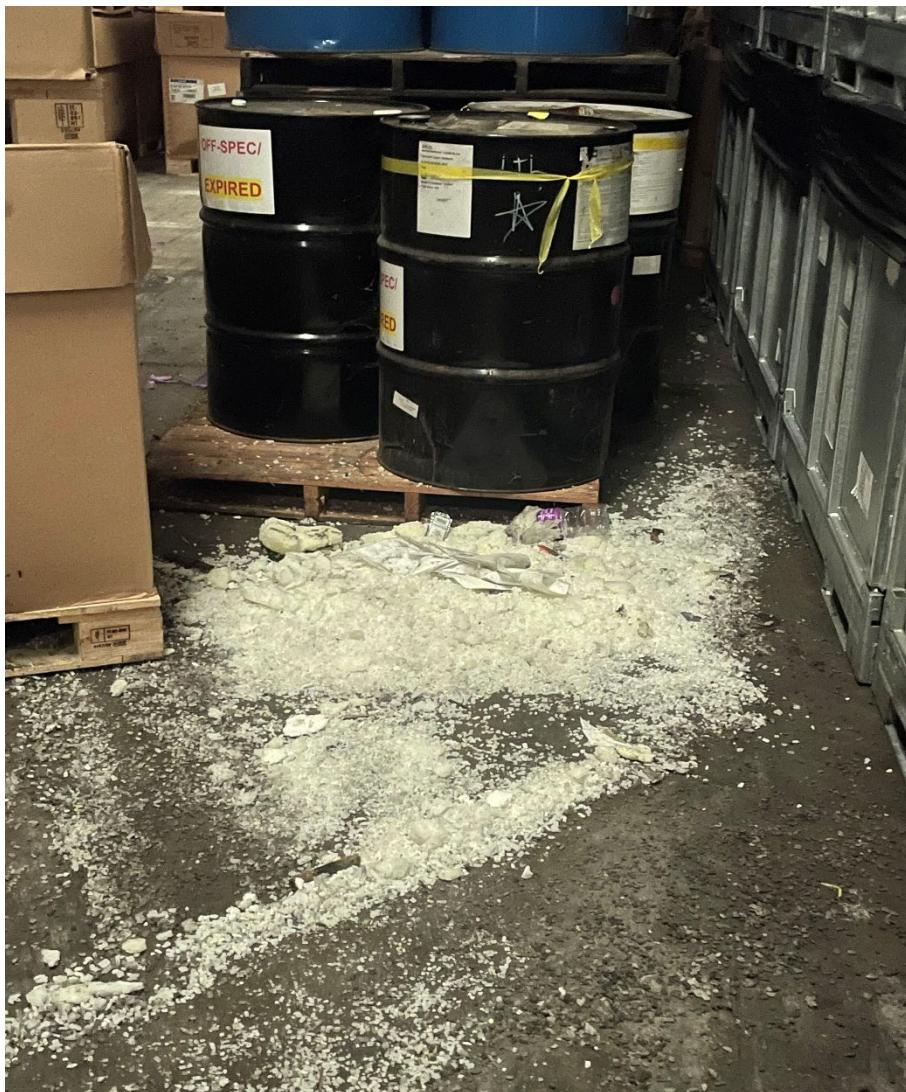
Photo No. 71

Description:	Warehouse 6 (Inside): Off spec/expired materials. Spill of white substance from unknown source.		
Latitude:	N/A	Longitude:	N/A

At the southwest entrance, spills of opaque hardened material formed thick deposits around some of the containers in this area. Much of the now-hard spills appeared to originate from metal boxes that were not suitable for holding liquids (Appendix 2: Photo 68). The metal boxes were labeled as “off grade.” Additional spilled liquids were on the floor under the totes, but inspectors were unable to identify a source (Appendix 2: Photo 69). Inspectors also identified a bulging tote of hydrogen peroxide (Appendix 2: Photo 70). Inspectors also found three black drums labeled “OFF-SPEC/EXPIRED” with an unknown white, powdery material spilled on the ground (Appendix 2: Photo 71).

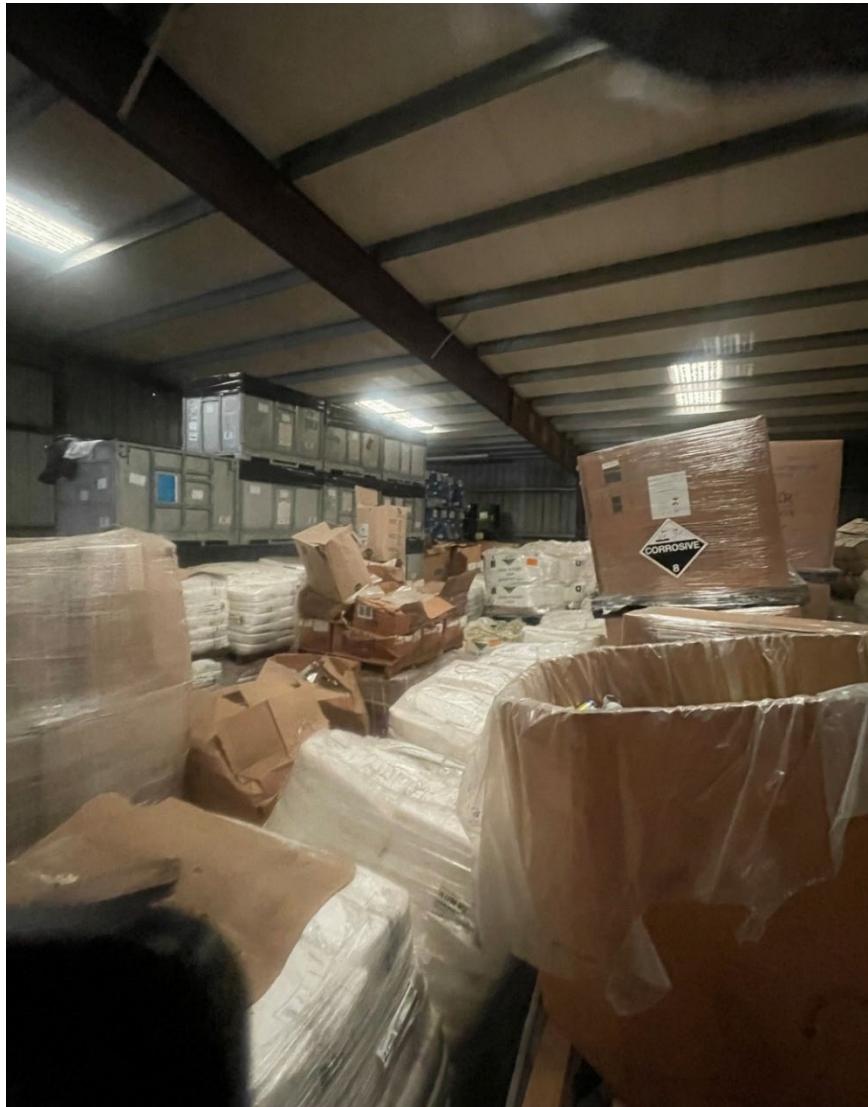
Photo No. 72

Description:	Warehouse 6 (Inside): Materials stored haphazardly and without aisle space.		
Latitude:	N/A	Longitude:	N/A

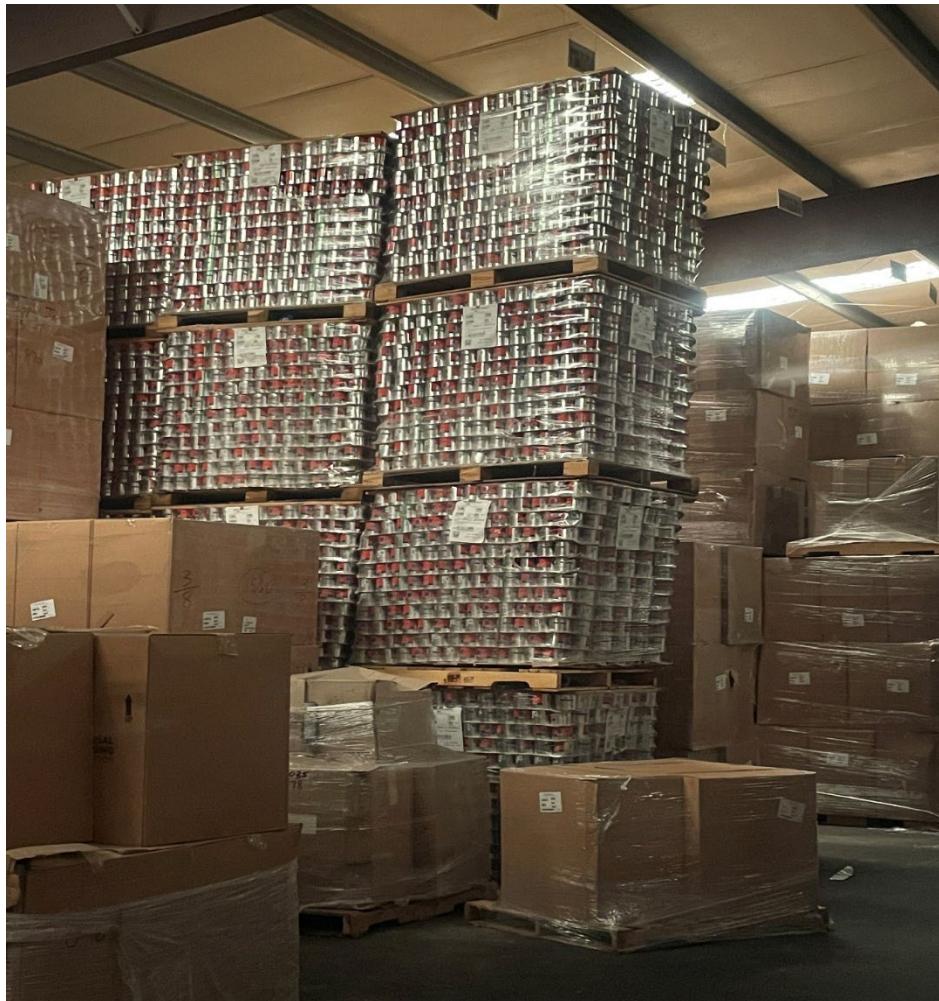
Photo No. 73

Description:	Warehouse 6 (Inside): Materials stored with no aisle space. Packaging is placed haphazardly. Stack of product is leaning precariously.		
Latitude:	N/A	Longitude:	N/A

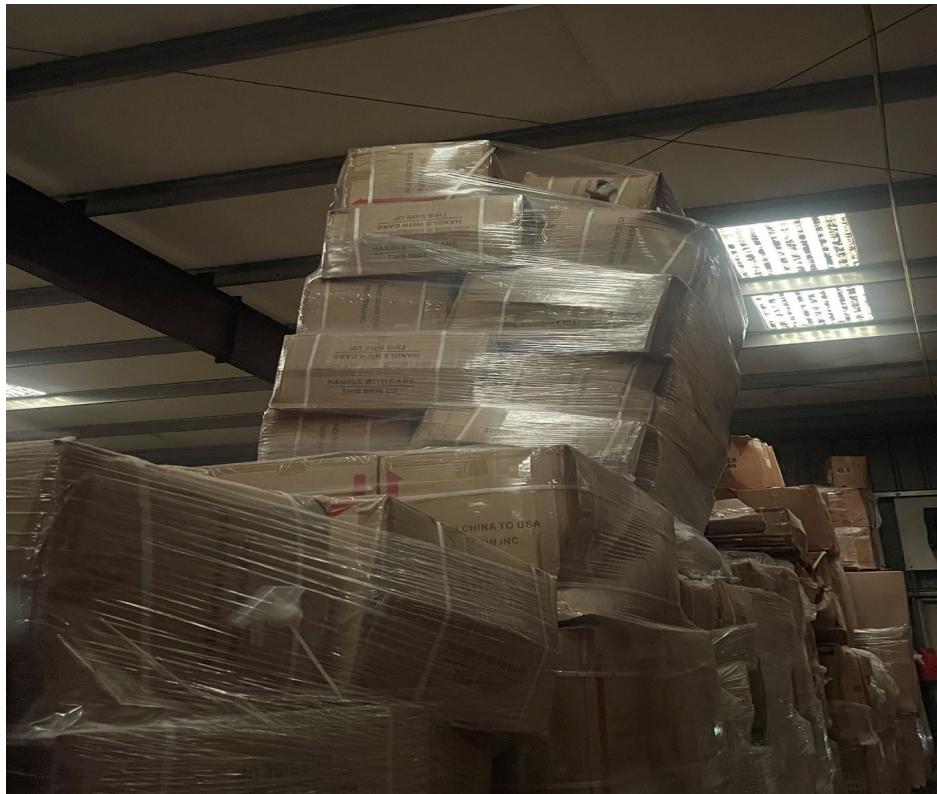
Photo No. 74

Description:	Warehouse 6 (Inside): Stacks of packaged product tipping precariously.		
Latitude:	N/A	Longitude:	N/A

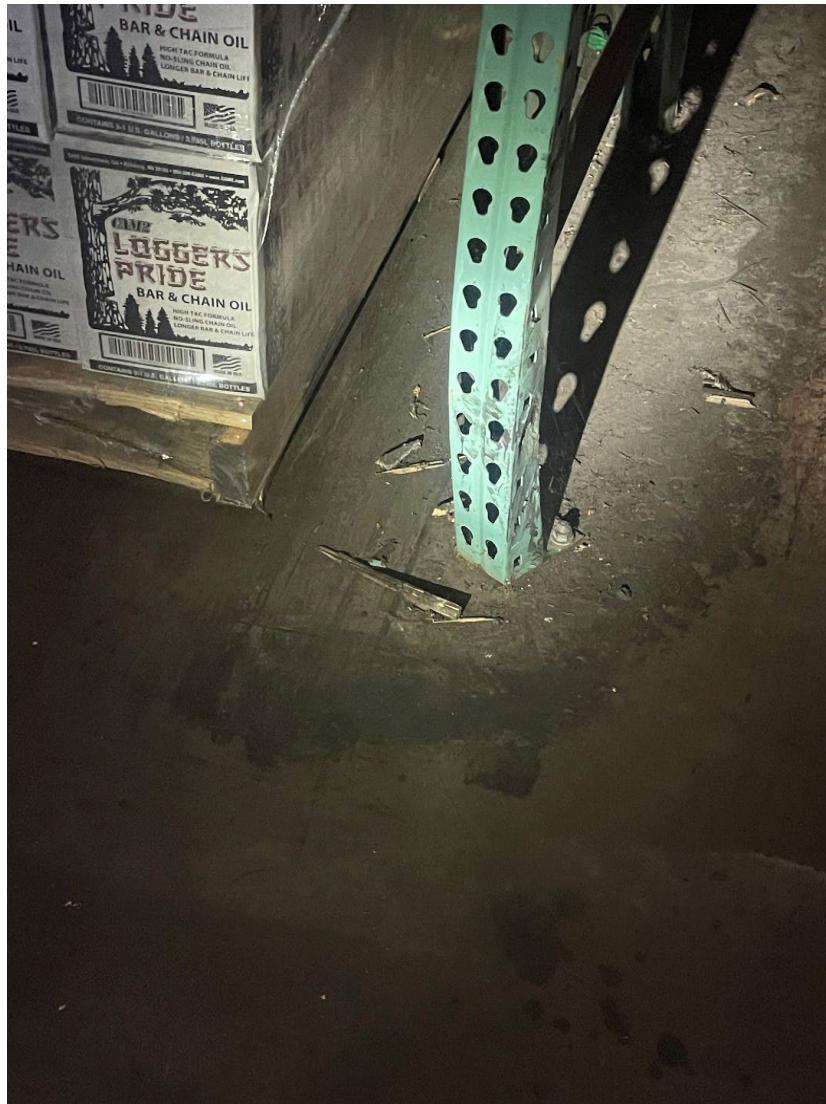
Photo No. 75

Description:	Warehouse 6 (Inside): Bent shelving support foot.		
Latitude:	N/A	Longitude:	N/A

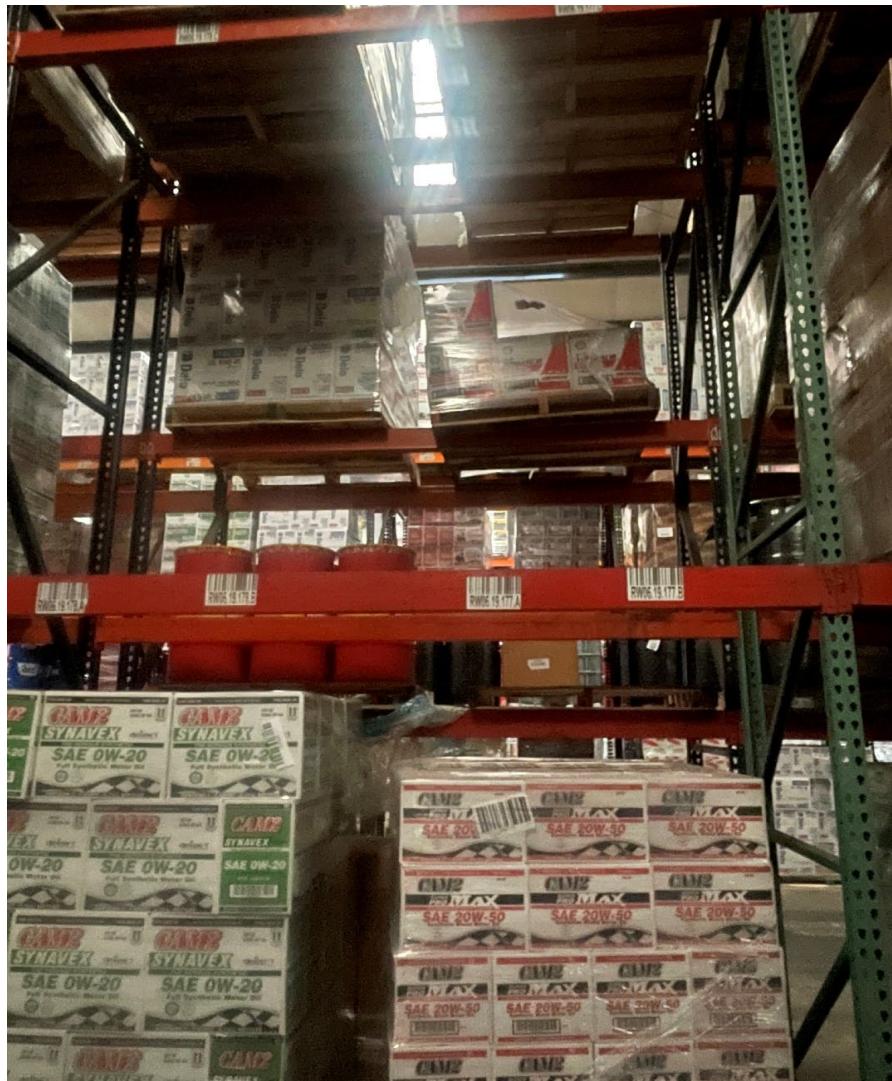
Photo No. 76

Description:	Warehouse 6 (Inside): Unstable loads on shelving due to unbalanced pallet placement.		
Latitude:	N/A	Longitude:	N/A

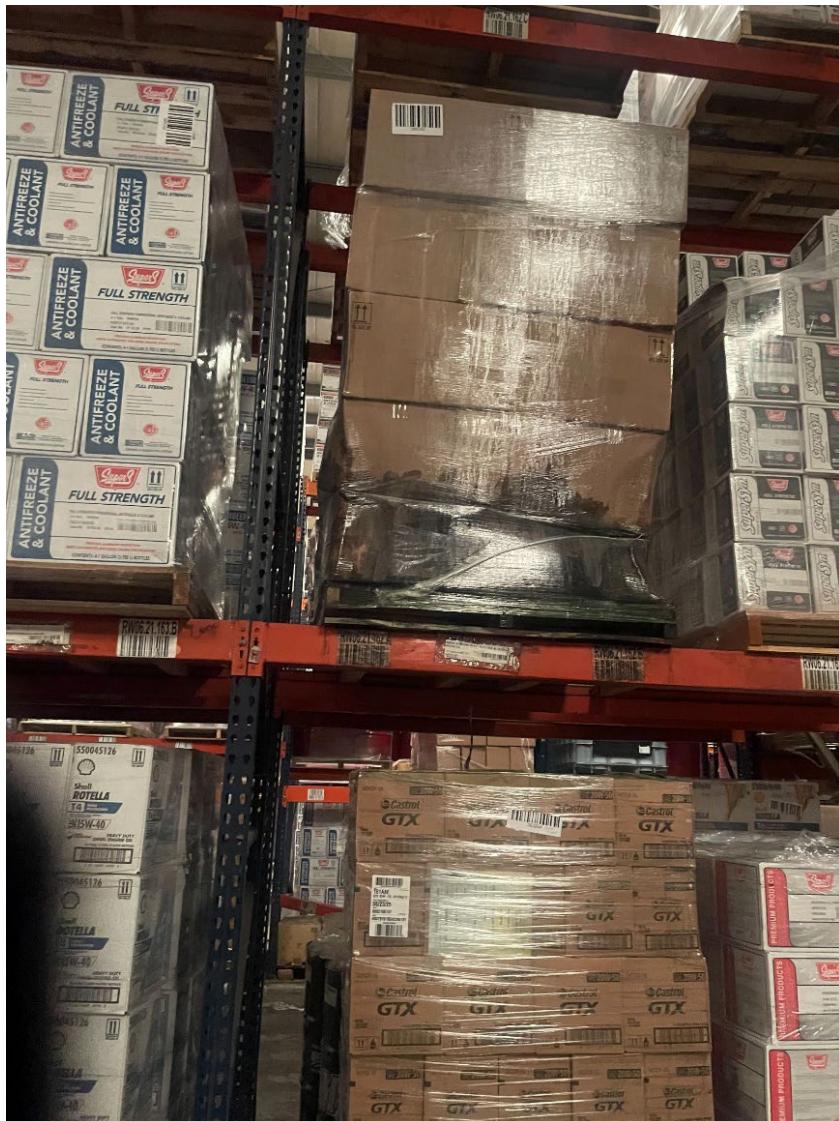
Description:	Warehouse 6 (Inside): A pallet of damaged leaking product. Packages sustained structural damage due to absorbed leaks and is in danger of tipping.		
Latitude:	N/A	Longitude:	N/A
