Region 6 - Enforcement & Compliance Assurance Division
INSPECTION REPORT

Inspection Date(s):	10/07/2025 – 10/09/2025	
Media Program:	RCRA	
Regulatory Program(s)	Hazardous Waste, Used Oil	
Company Name:	Smitty's Supply, Inc.	
Facility Name:	Smitty's Supply Roseland	
Facility Physical Location:	63399 Highway 51 N	
(city, state, zip code)	Roseland LA 70456	
Mailing address:	PO Box 530	
(city, state, zip code)	Roseland LA 70456	
County/Parish:	Tangipahoa	
Facility Phone Number	1-800-256-7575	
Facility Contact:	Craig Ellison craigellison@smittysinc.net	
FRS Number:	110016753075	
EPA ID Number:	LAR000078691	
NAICS:	324191 - PETROLEUM LUBRICATING OIL AND GREASE MANUFACTURING	
SIC:	2992 – LUBRICATING OILS AND GREASES 4952 – SEWERAGE SYSTEMS	
Personnel participating in inspection:		
Angela Hays	U.S. EPA – Region 6	Inspector
Erin Young-Dahl	U.S. EPA – Region 6	Inspector
AD Talton	U.S. EPA – Region 6	Inspector
Jimbo Earles	LDEQ	Senior Environmental Scientist
Craig Easley	LDEQ	Senior Environmental Scientist

Section I – INTRODUCTION

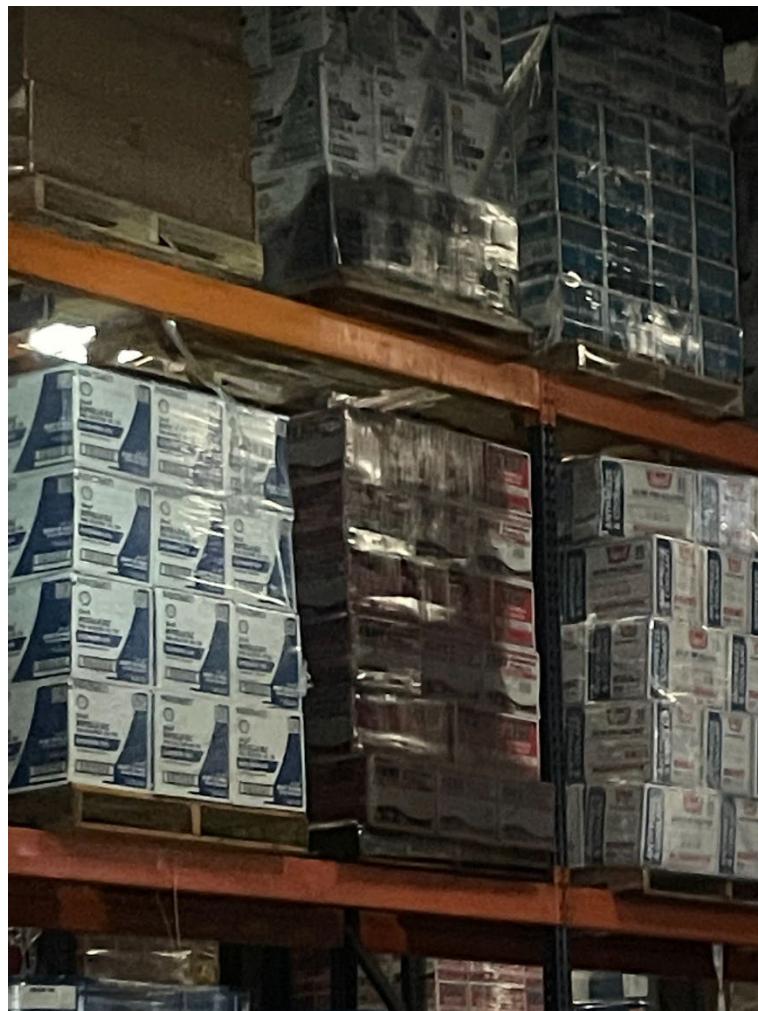
Photo No. 78

Description:	Warehouse 6 (Inside): A pallet of several saturated boxes of oil product on the second row. Evidence of a release.		
Latitude:	N/A	Longitude:	N/A

Dozens of containers showed signs of damage, including large dents, punctures/tears, bulging, corrosion, and/or leakage (Appendix 2: Photos 77 – 82). Numerous spills, as well as evidence of past spills, were spread over the entire warehouse. Some appeared to be the direct result of unstable storage practices. Precariously stored boxes of green wiper fluid had toppled to the floor from the top rack and spilled ignitable wiper fluid on the ground (Appendix 2: Photos 83, 84). Others were still actively dripping. Of the spilled materials, inspectors identified multiple spills of oil/lube product, antifreeze, wiper fluid (with a flash point of 95°F), broken bulbs from ceiling light fixtures, and lighter fluid, along with myriad unidentifiable spills (Appendix 2: Photos 85 - 91). One palletized group of containers placed on a shelving unit above a walkthrough was actively dripping onto the thoroughfare and into the path of forklifts and workers. Still more spills had been covered by an absorbent material like sawdust, kitty litter, cardboard or absorbent pads/booms, then left behind or swept under a pallet (Appendix 2: Photos 86, 90, 91). In all, inspectors counted at least 80 individually identifiable spills and at least 40 damaged containers in warehouse 6.

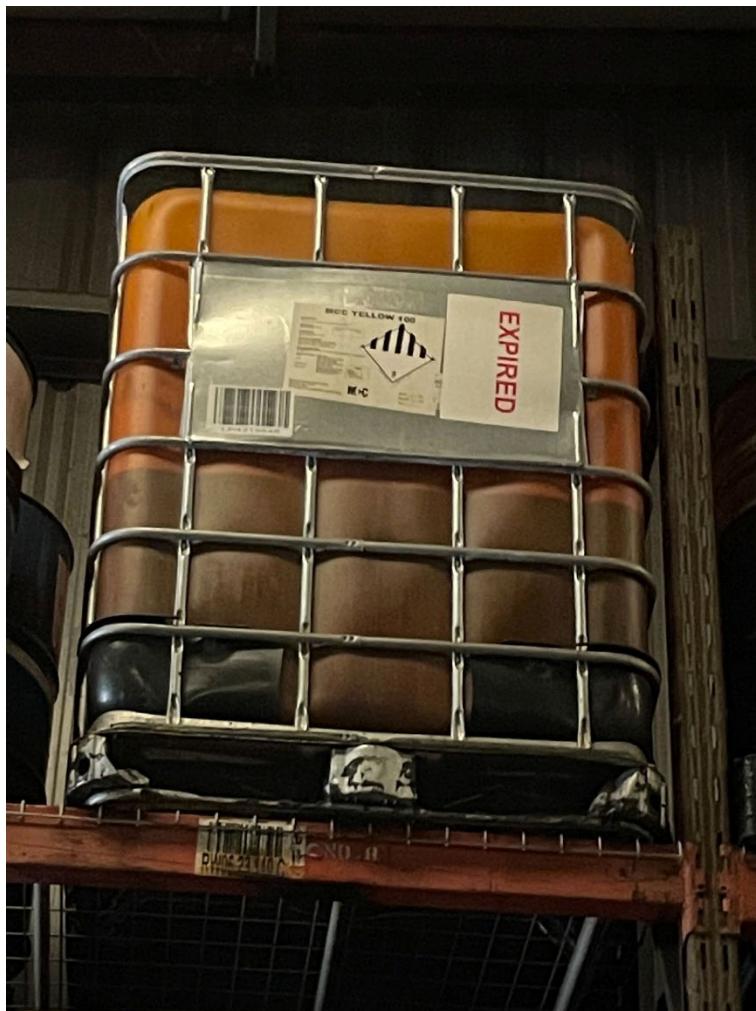
Photo No. 79

Description:	Warehouse 6 (Inside): Tote of expired dye.		
Latitude:	N/A	Longitude:	N/A

Inspectors also observed at least 25 containers without labeling or with ambiguous labeling. Of note include drums with “expired” labels, “do not use” labels, “rework” labels, “waste” labels, “danger” tape, and “flush” labels (Appendix 2: Photos 79, 92 – 94). To inspectors’ knowledge, no waste determinations had been made on any of these materials.

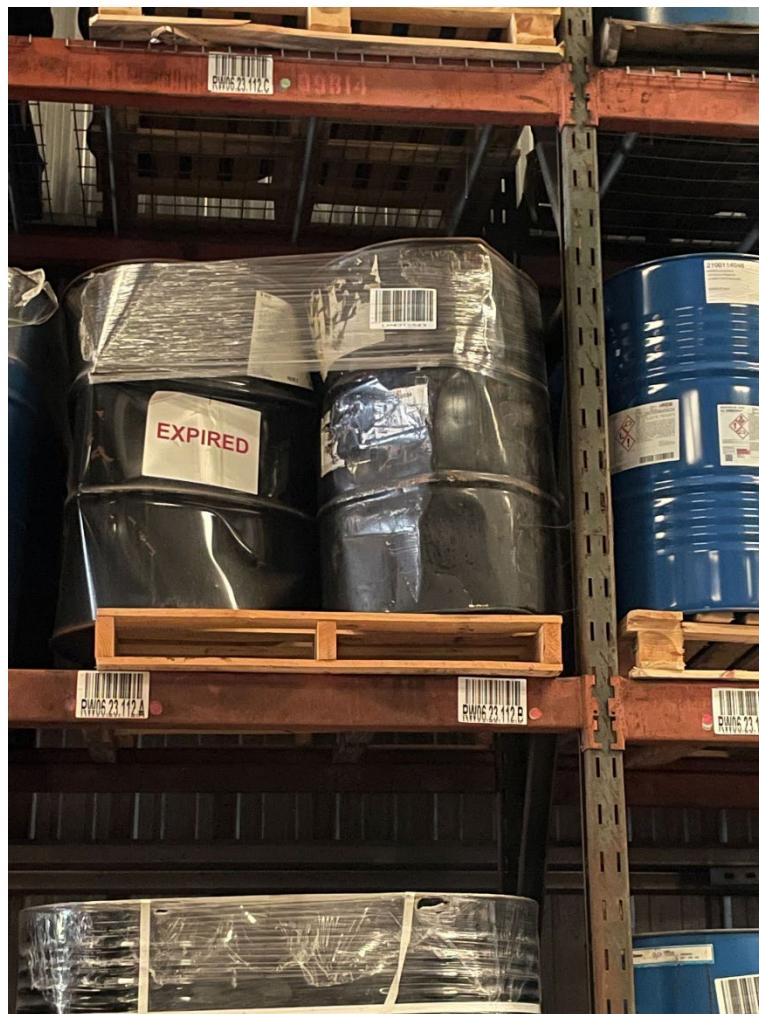
Description:	Warehouse 10 (Inside): A pallet of four 55-gal drums labeled as "expired." Drums are damaged with large dents.		
Latitude:	N/A	Longitude:	N/A

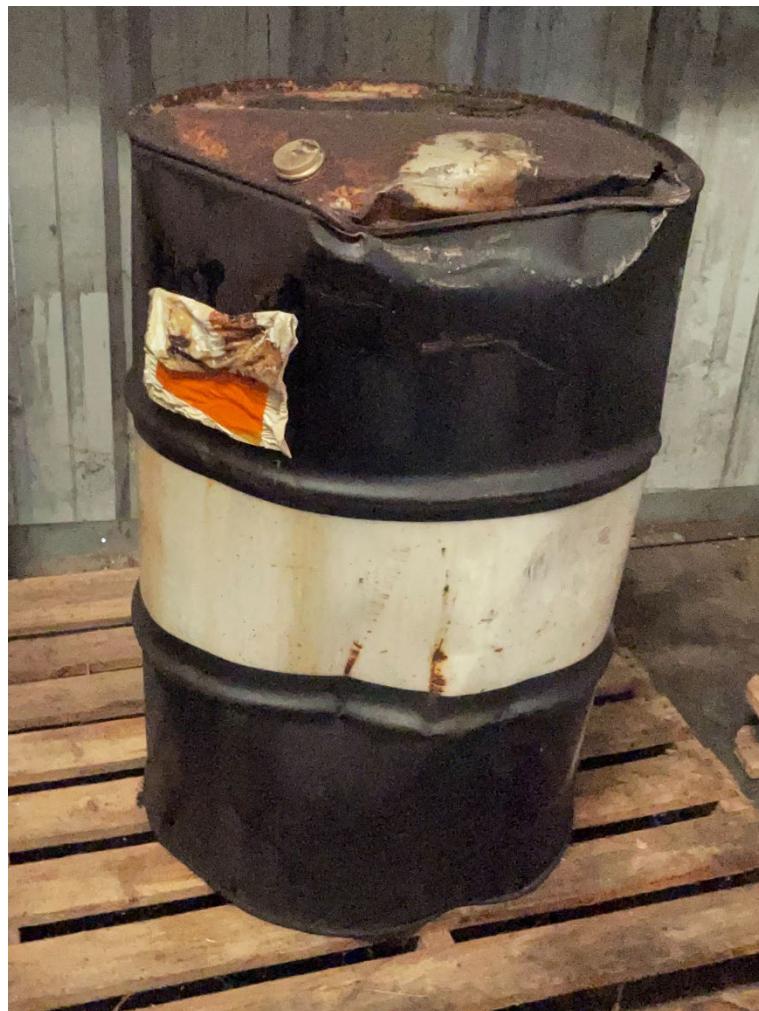
Description:	Warehouse 10 (Inside): An unlabeled 55-gal drum. Heavily damaged with severe denting and moderate corrosion. Open container due to holes in the top.		
Latitude:	N/A	Longitude:	N/A

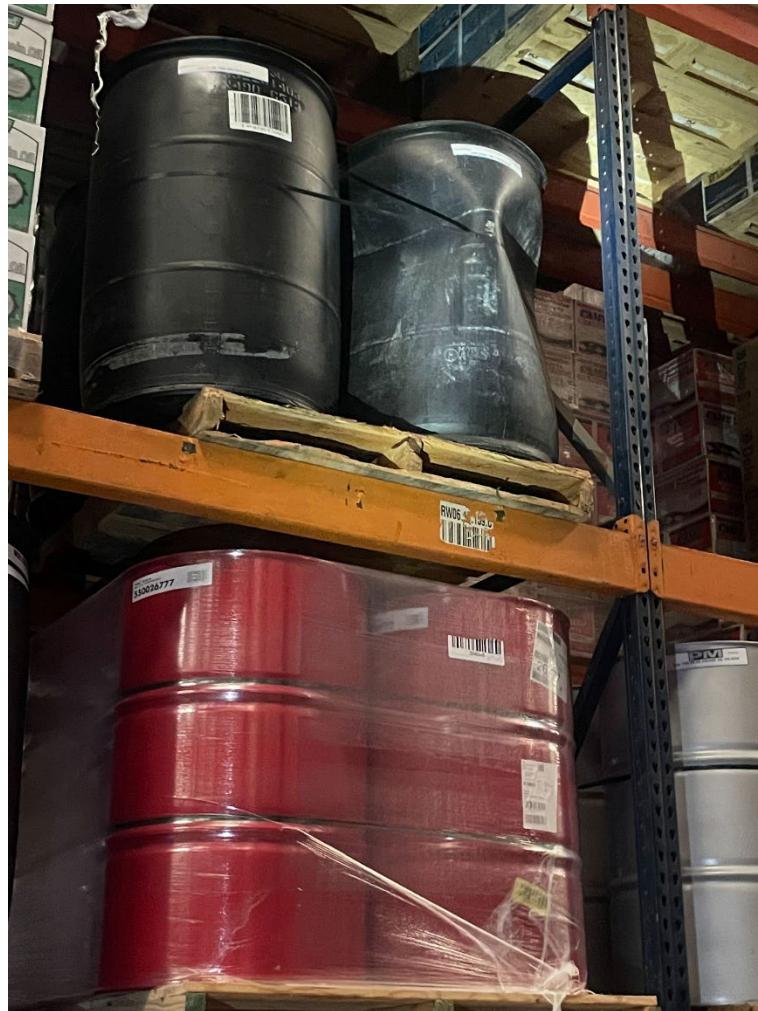
Photo No. 82

Description:	Warehouse 6 (Inside): Two black 55-gal drums of unknown material. The drum on the right is warped/dented. The drum on the left is not fully balanced on the pallet. The drums are barcoded but otherwise unlabeled.		
Latitude:	N/A	Longitude:	N/A

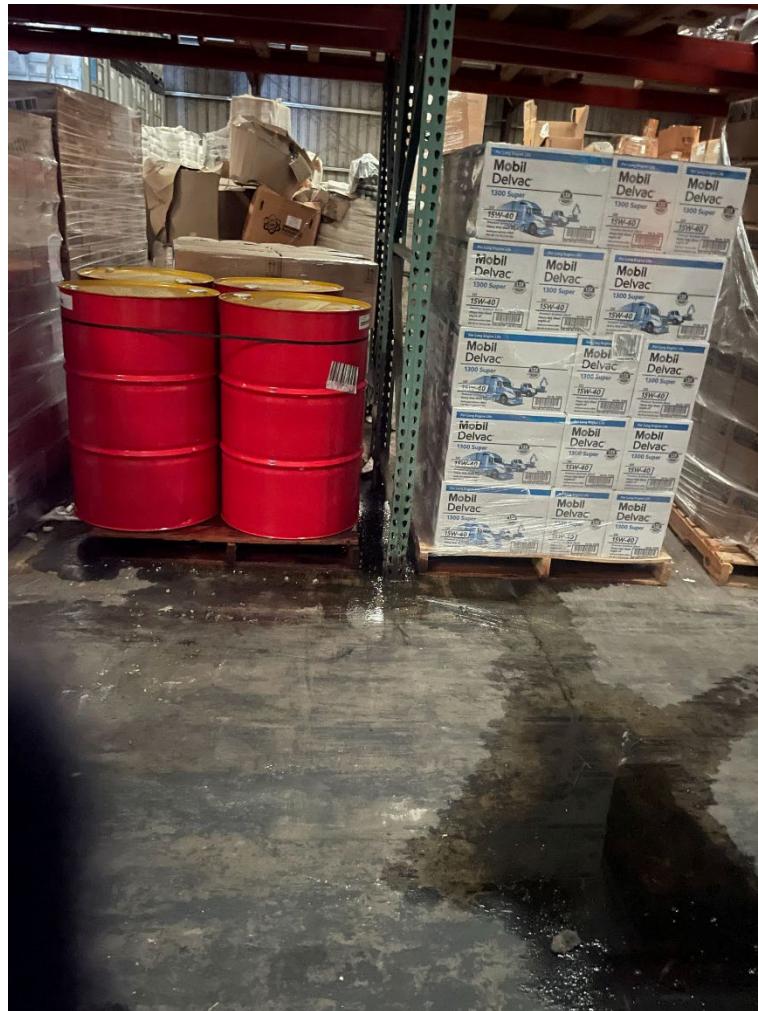
Photo No. 85

Description:	Warehouse 6 (Inside): Evidence of a spill. The source and contents of the spill is unknown.		
Latitude:	N/A	Longitude:	N/A

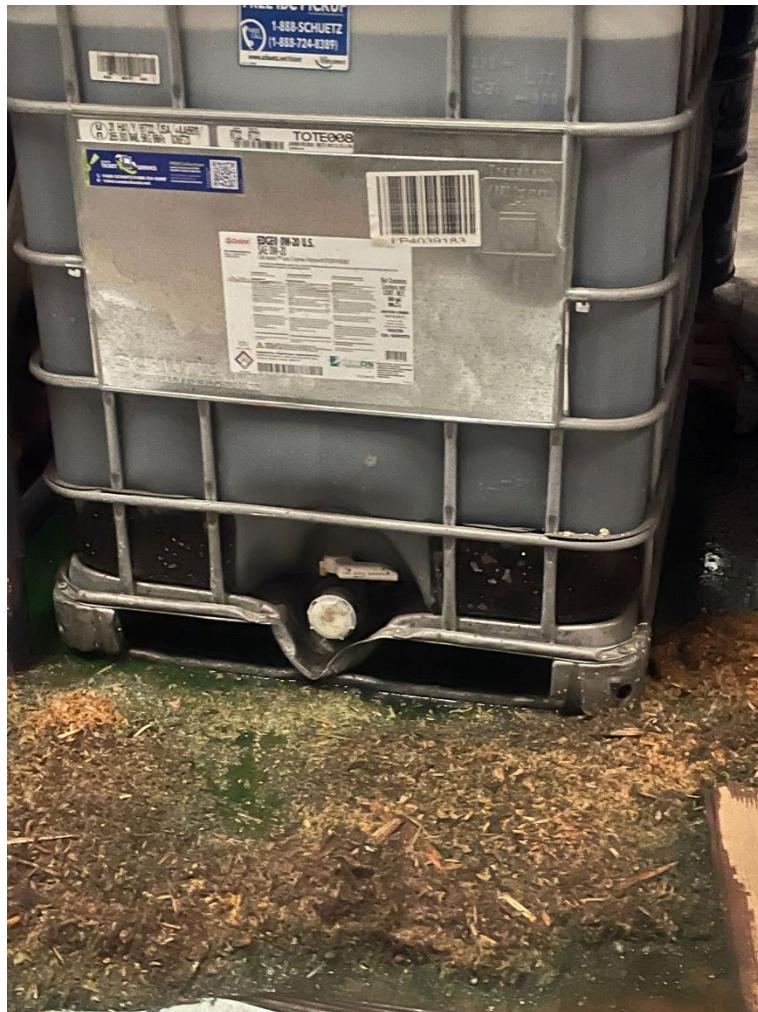
Photo No. 86

Description:	Warehouse 6 (Inside): Active release of unknown green liquid that's saturating the absorbent surrounding the tote.		
Latitude:	N/A	Longitude:	N/A

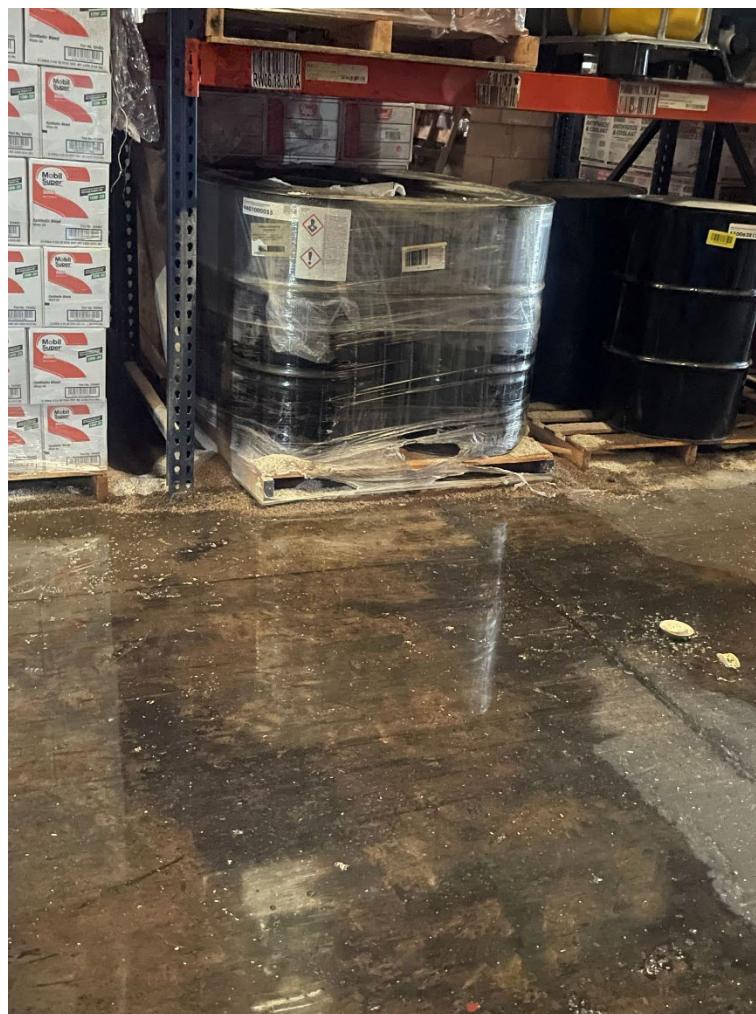
Photo No. 87

Description:	Warehouse 6 (Inside): Spill of an unknown liquid. Source of the release was not immediately apparent. Absorbent material placed around pallet of drums (center) holding antifreeze is now saturated.		
Latitude:	N/A	Longitude:	N/A

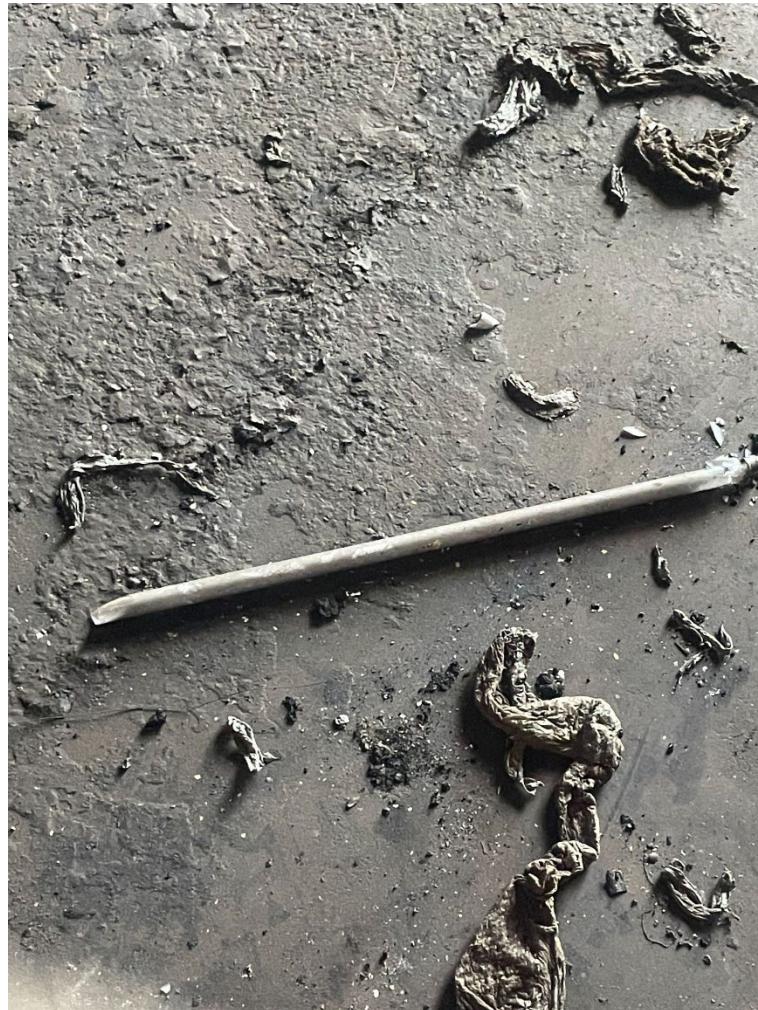
Description:	Warehouse 6 (Inside): Broken silver-tipped fluorescent lightbulb. May be managed as universal waste.		
Latitude:	N/A	Longitude:	N/A

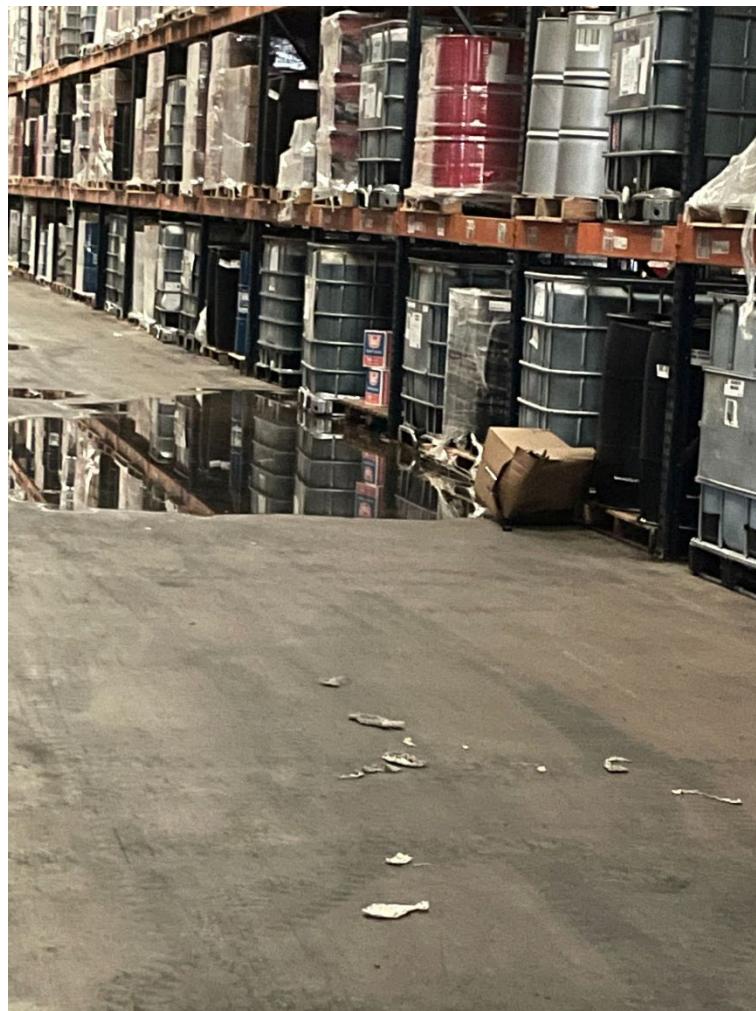
Photo No. 89

Description:	Warehouse 6 (Inside): Evidence of a release, source unknown. There is no evidence of containment or cleanup of the release.		
Latitude:	N/A	Longitude:	N/A

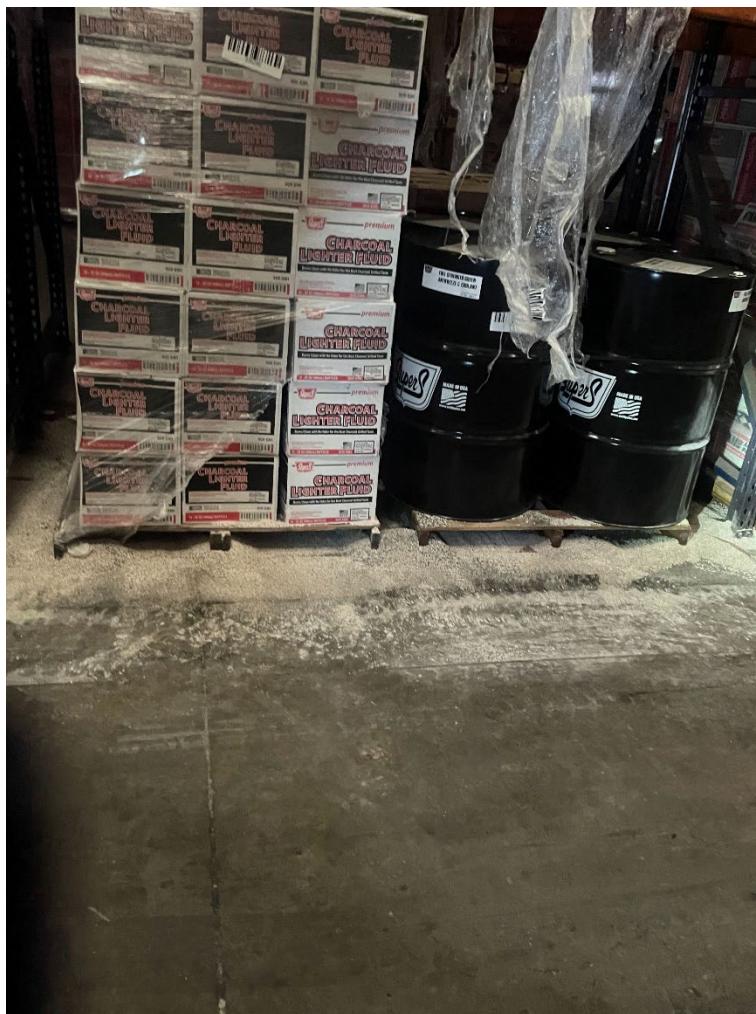
Photo No. 91

Description:	Warehouse 6 (Inside): Evidence of a release with saturated absorbant. The source of the release was not immediately apparent.		
Latitude:	N/A	Longitude:	N/A

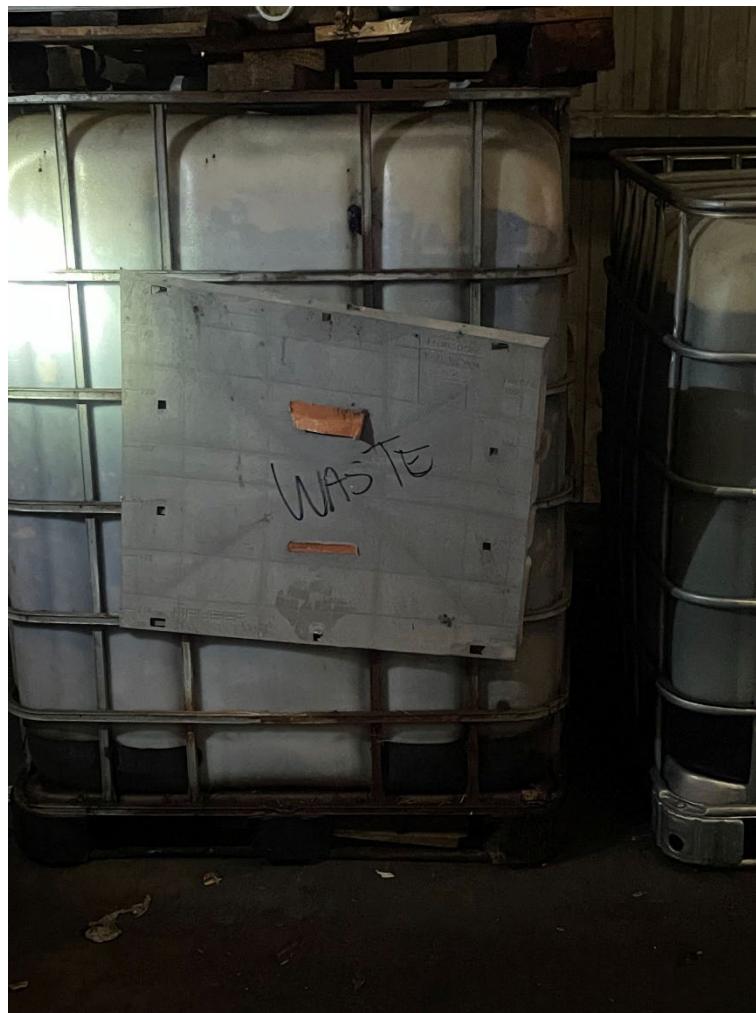
Photo No. 94

Description:	Warehouse 6 (Inside): Tote of unknown oily liquid labeled "waste." The tote is not labeled indicating its contents.		
Latitude:	N/A	Longitude:	N/A

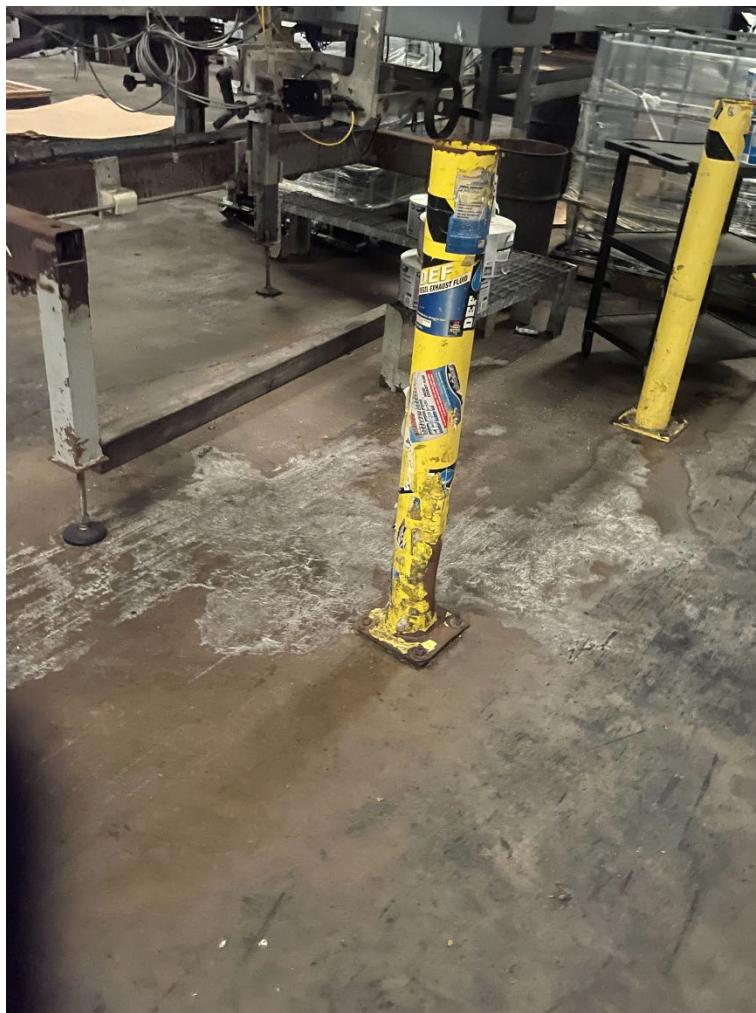
Photo No. 95

Description:	Warehouse 6 (Inside): Crystallized spill residue near yellow poles in packaging area. The source of the release was not immediately apparent. There is no evidence of attempts to control the spill.		
Latitude:	N/A	Longitude:	N/A

In the packaging area, inspectors noted several instances of overflowing secondary containment around pumps and other mechanical equipment. DEF crystals covered the floor around these units and showed evidence of escaping the confinement of the building (Appendix 2: Photos 95 – 98). The packing area also had spills of red oily substance. Cardboard had been placed over these spills (Appendix 2: Photo 99). Two holes in the roof, caused by projectile tank lids, make the warehouse 6 packaging area partially open to the elements. Inspectors also found evidence of animal activity through the spill areas (Appendix 2: Photo 100).

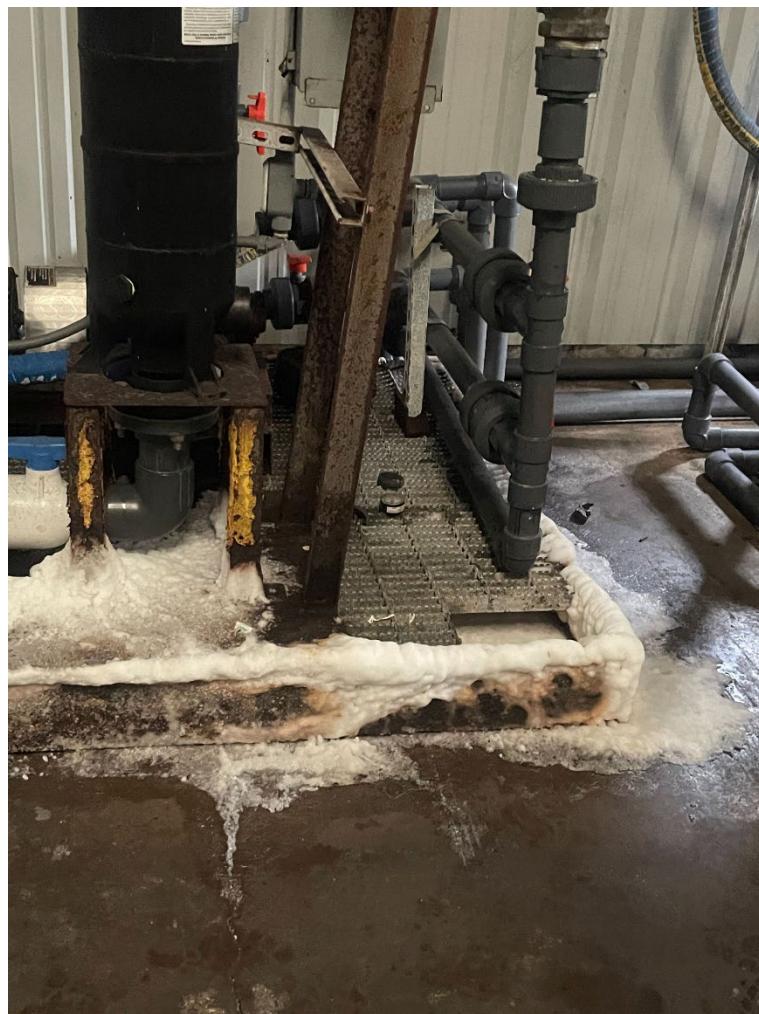
Photo No. 96

Description:	Warehouse 6 (Inside): A crystallized diesel exhaust fluid overflowing from the secondary containment onto the floor. There is no evidence of prevention of the release spreading.		
Latitude:	N/A	Longitude:	N/A

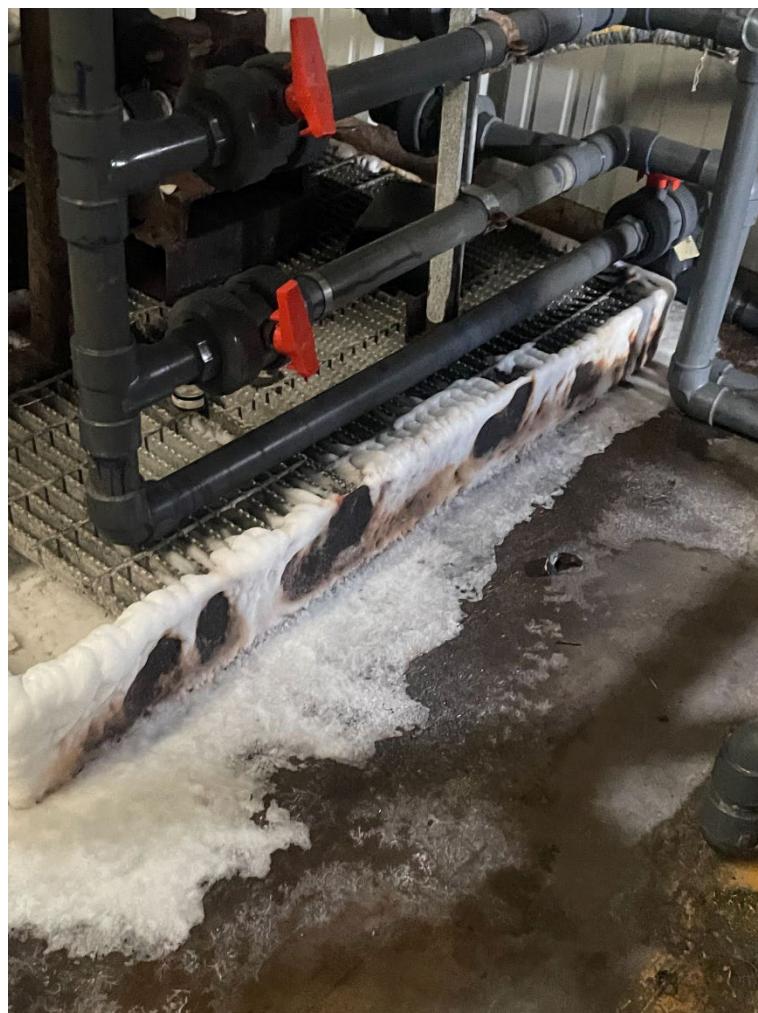
Photo No. 97

Description:	Warehouse 6 (Inside): Crystalline DEF overflowing from the secondary containment onto the floor. The white crystal material is unknown. There is no evidence of prevention of the release or containment.		
Latitude:	N/A	Longitude:	N/A

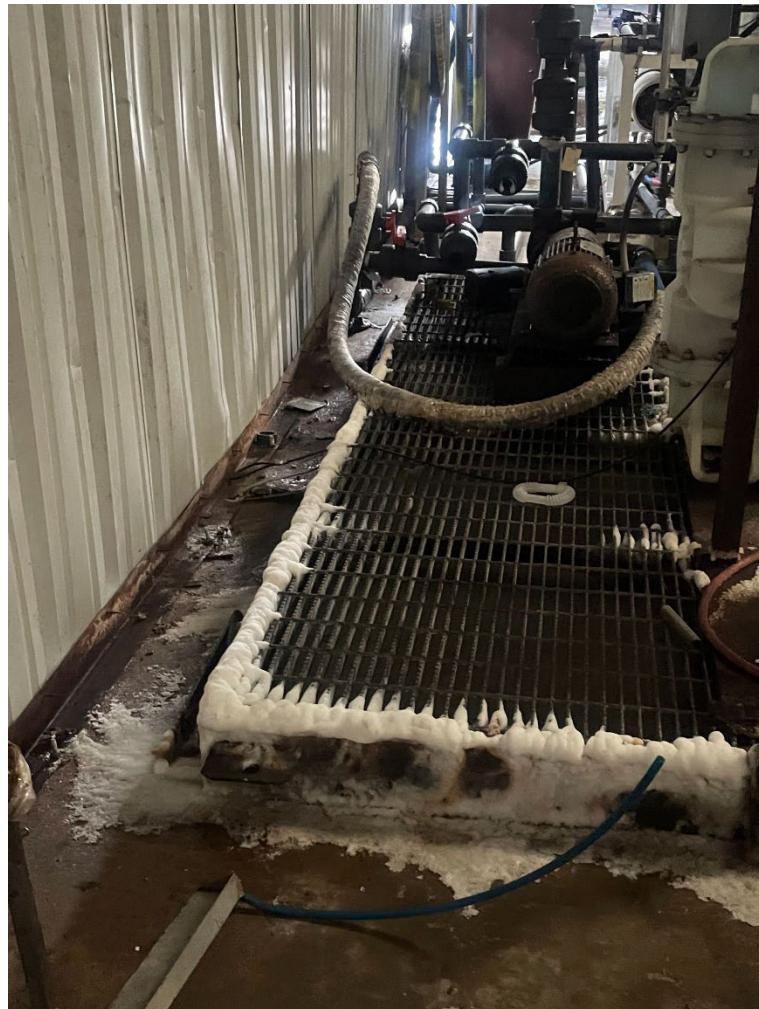
Photo No. 98

Description:	Warehouse 6 (Inside): Crystalline DEF overflowing from secondary containment within the packaging area. There is no evidence of containment attempts.		
Latitude:	N/A	Longitude:	N/A

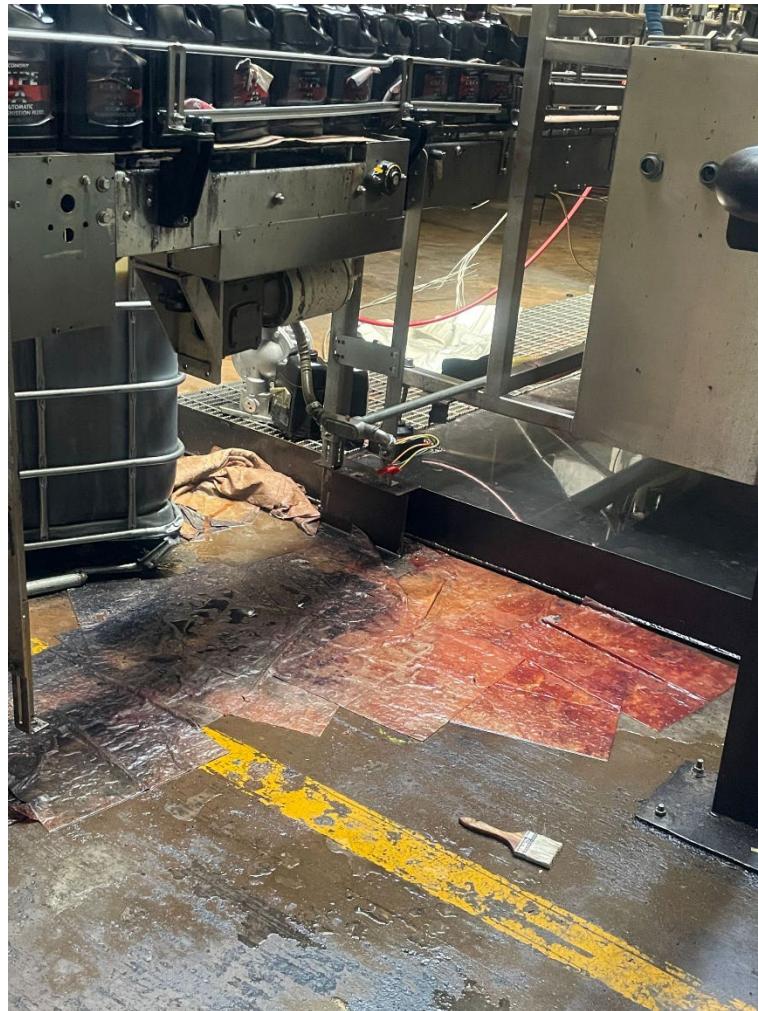
Photo No. 99

Description:	Warehouse 6 (Inside): Evidence of a release of a reddish, oily material in the packaging area. Saturated absorbent pads have not been removed and no further management of the spill appears to have taken place.		
Latitude:	N/A	Longitude:	N/A

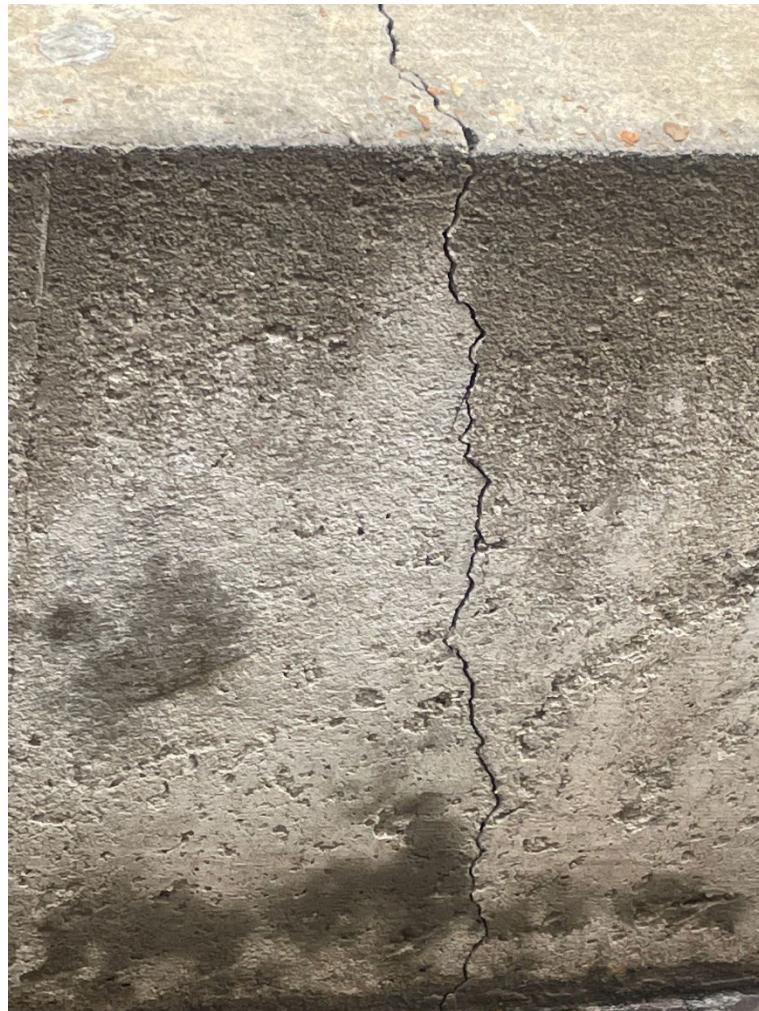
Description:	Tank Farm 17 (Outside of warehouse 6): A crack in the wall of the secondary containment.		
Latitude:	N/A	Longitude:	N/A

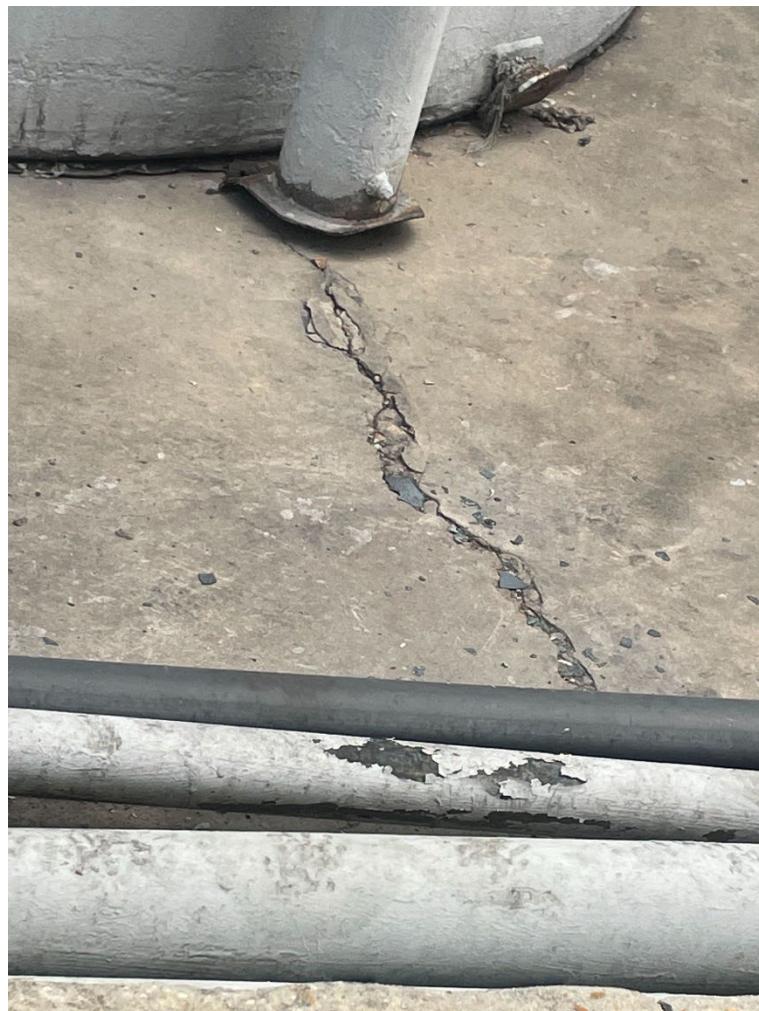
Description:	Tank Farm 17 (Outside of warehouse 6): A crack in the floor of the secondary containment.		
Latitude:	N/A	Longitude:	N/A

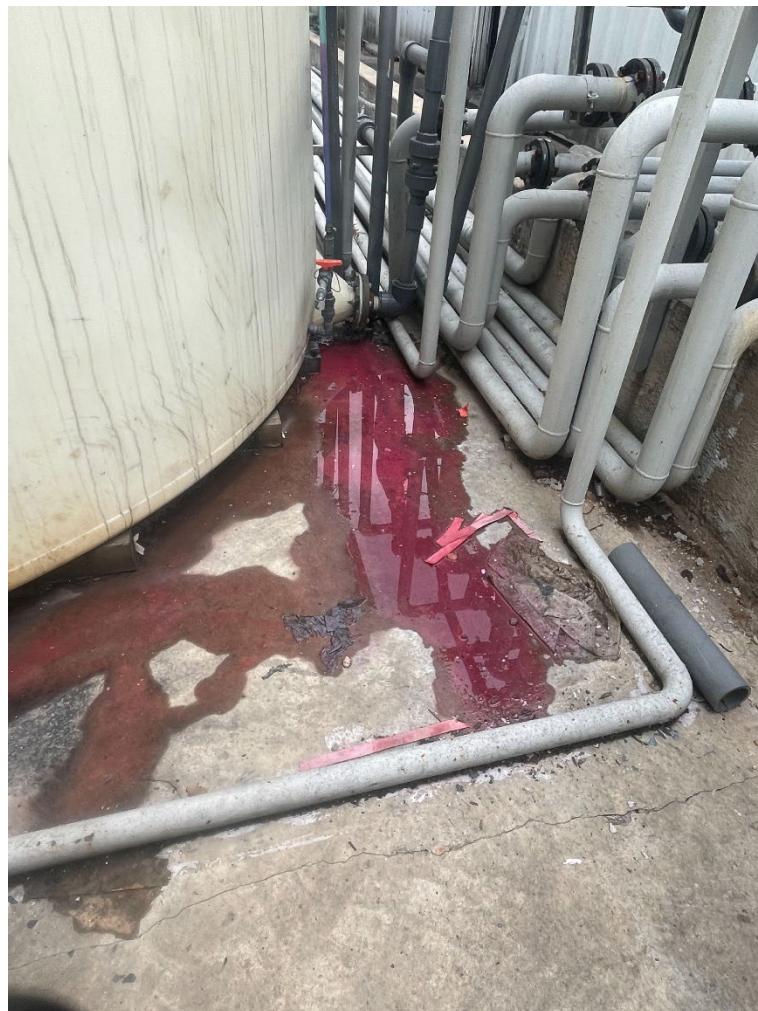
Description:	Tank Farm 17 (Outside of warehouse 6): Evidence of a leak within the secondary containment. The source of the release appears to be a piping connection or other ancillary piping within TF-17. There is no evidence of attempted cleanup.		
Latitude:	N/A	Longitude:	N/A

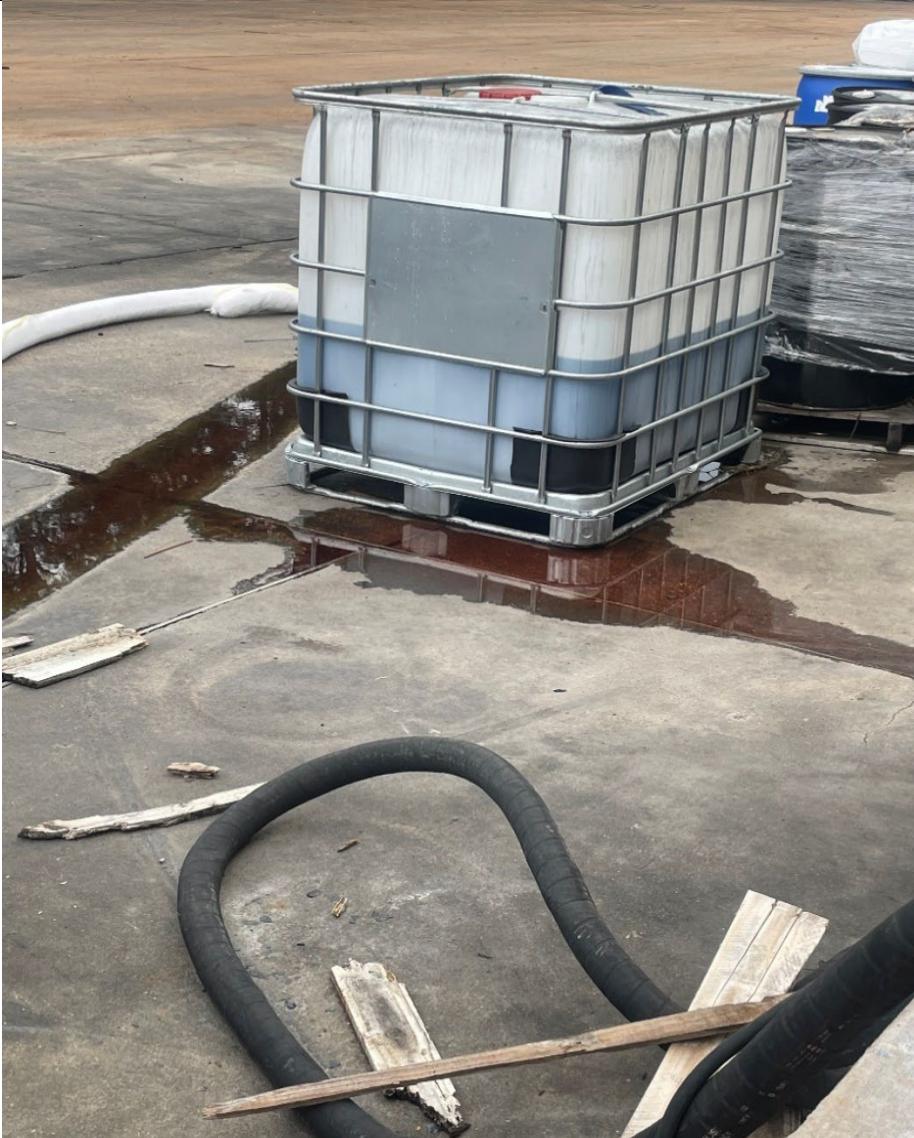
Description:	Outside of Tank Farm 17 (Outside of warehouse 6): Evidence of a leak that migrated outside the secondary containment of Tank Farm 17. No evidence of cleanup of the released red liquid.		
Latitude:	N/A	Longitude:	N/A

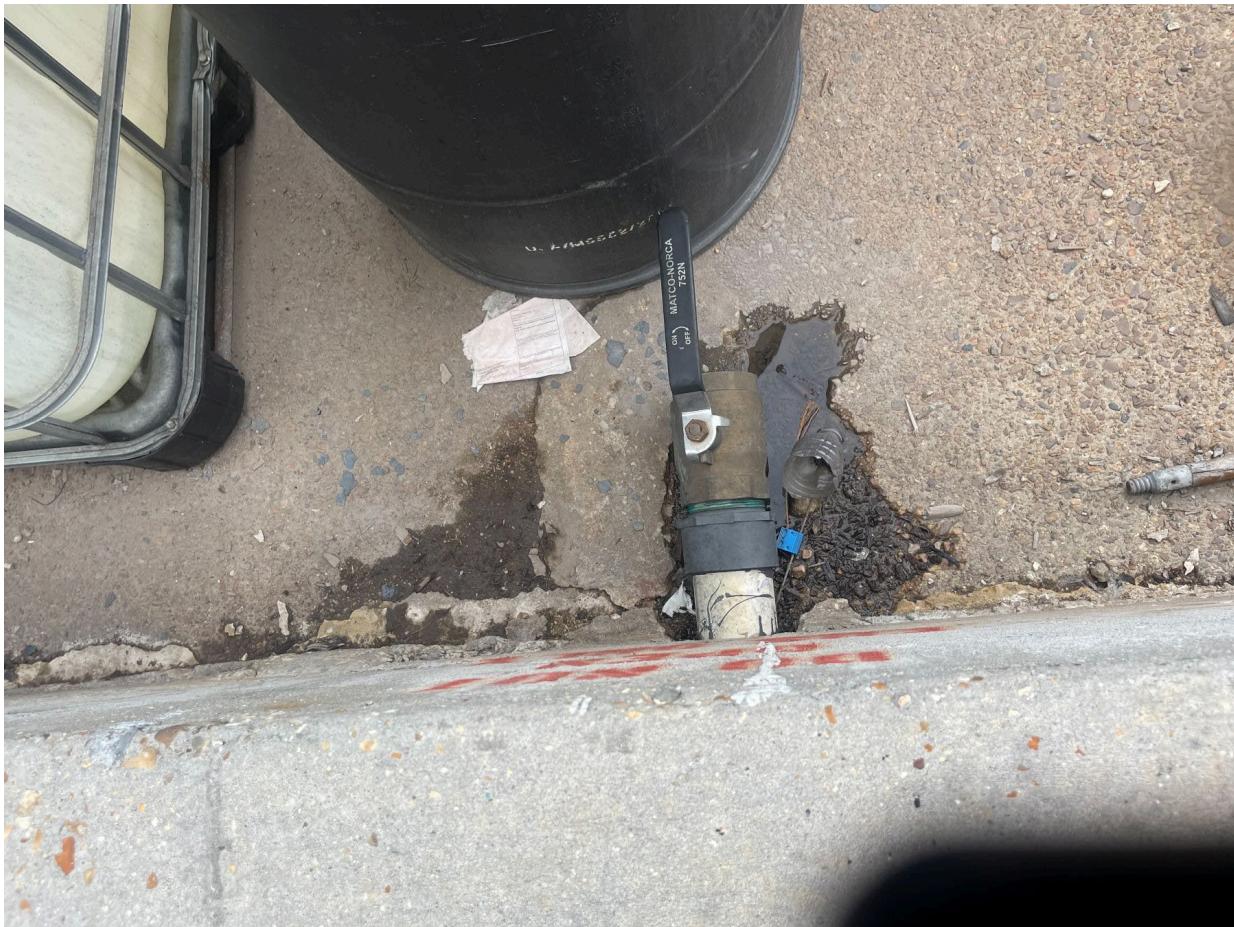
Description:	Tank Farm 17 (Outside of warehouse 6): Evidence of a leak and seepage from the secondary containment structure. Valve in the open position.		
Latitude:	N/A	Longitude:	N/A

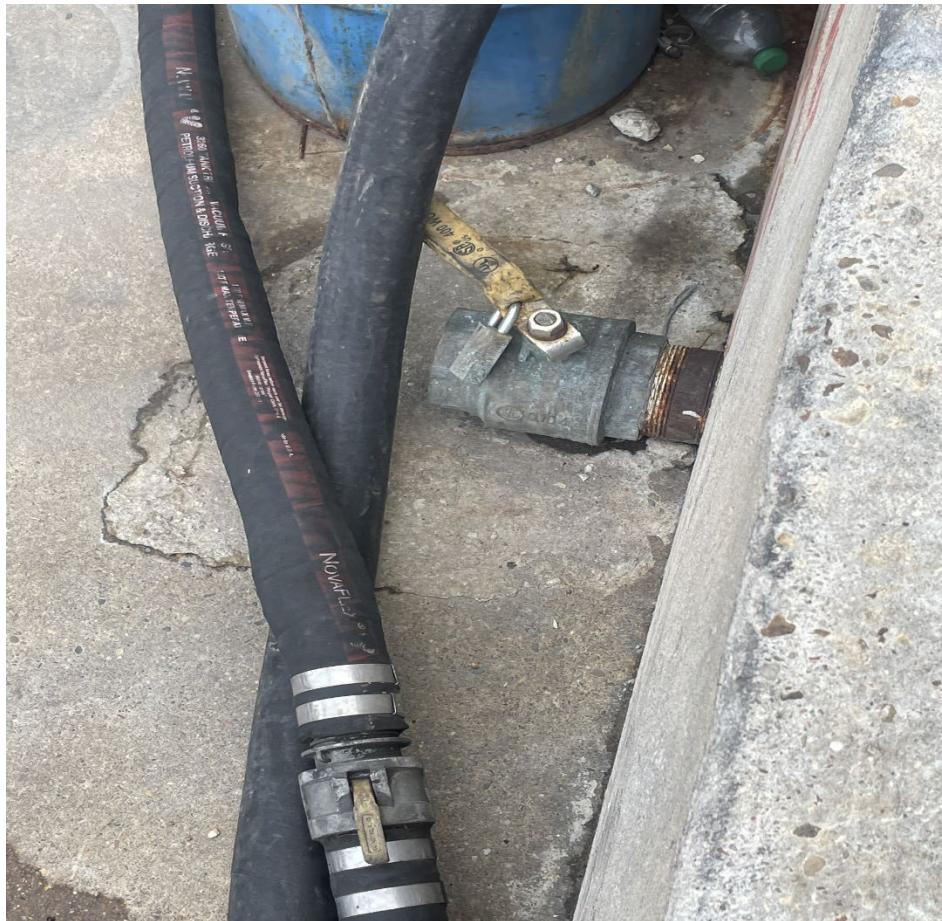
Photo No. 108

Description:	Tank Farm 17 (Outside of warehouse 6): Valve padlocked open		
Latitude:	N/A	Longitude:	N/A

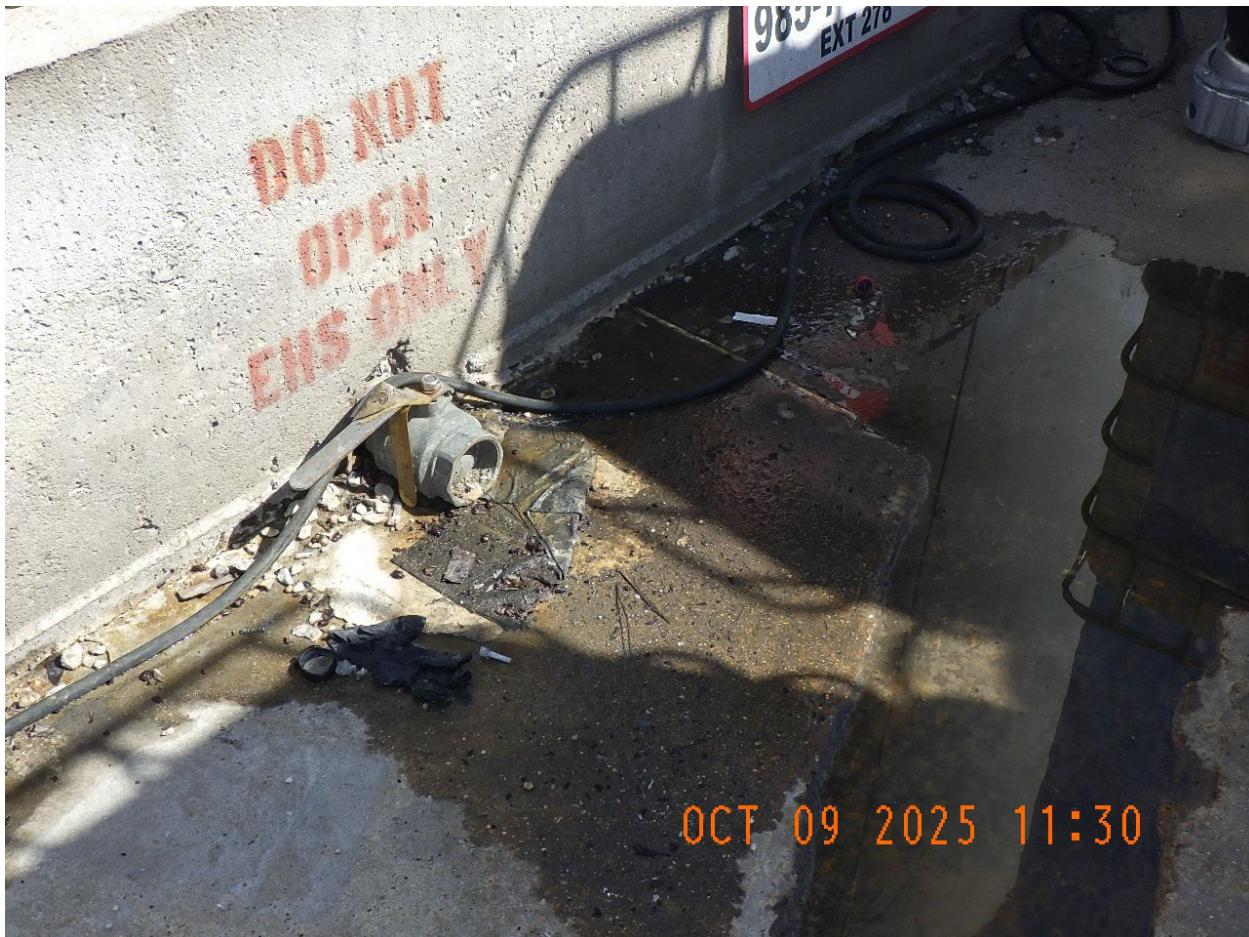
Photo No. 109

Description:	Tank Farm 17 (Outside of warehouse 6): Seeping release from TF-17.		
Latitude:	N/A	Longitude:	N/A

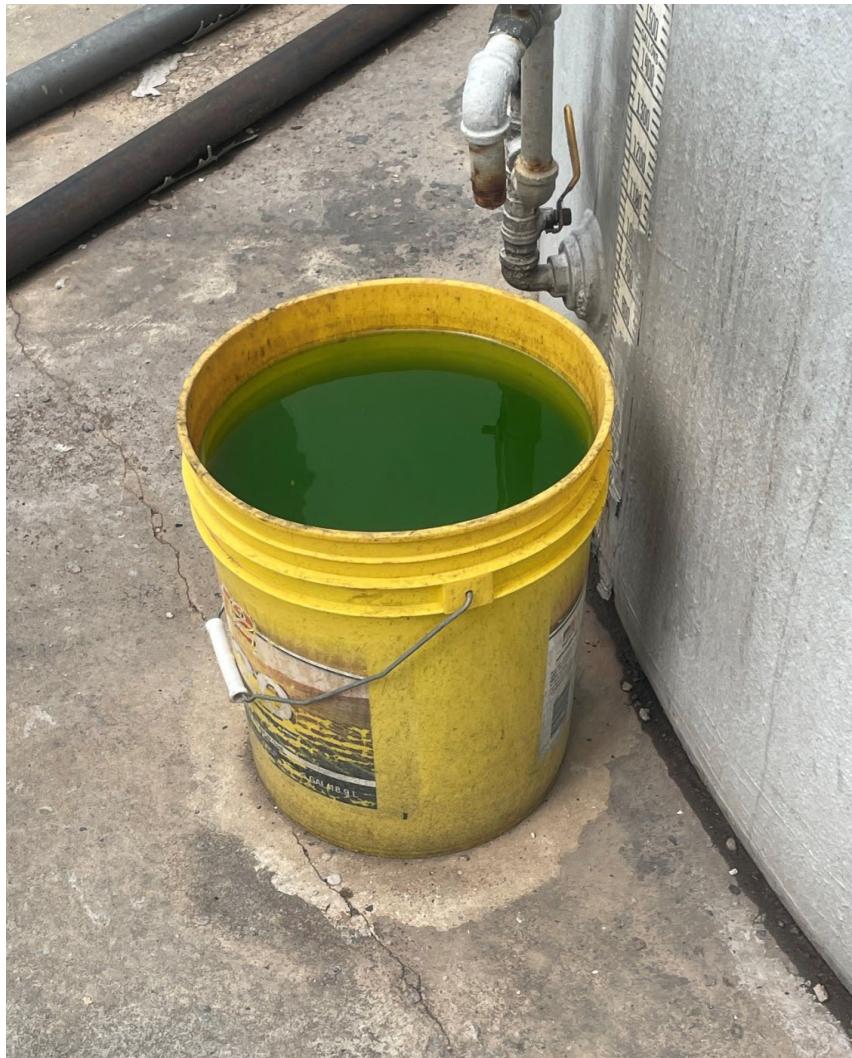
Photo No. 110

Description:	Tank Farm 17 (Outside of warehouse 6): Open and unlabeled green oily substance. Bucket appears to have been placed to catch drips from a sight gauge.		
Latitude:	N/A	Longitude:	N/A

Inside the secondary containment structure, at least three unlabeled and open, five-gallon buckets contained colorful liquid. One containing a green liquid was placed under the sight gauge at tank 430 (Appendix 2: Photo 110) , and two additional buckets had been placed at tank 429. One of the buckets at 429 contained a blue liquid and sorbent rags (Appendix 2: Photo 111). Some free liquid was present in the eastern side of the containment structure. One HDPE tank had been damaged by a projectile during the fire.
