Region 6 - Enforcement & Compliance Assurance Division
INSPECTION REPORT

Inspection Date(s):	10/07/2025 – 10/09/2025	
Media Program:	RCRA	
Regulatory Program(s)	Hazardous Waste, Used Oil	
Company Name:	Smitty's Supply, Inc.	
Facility Name:	Smitty's Supply Roseland	
Facility Physical Location:	63399 Highway 51 N	
(city, state, zip code)	Roseland LA 70456	
Mailing address:	PO Box 530	
(city, state, zip code)	Roseland LA 70456	
County/Parish:	Tangipahoa	
Facility Phone Number	1-800-256-7575	
Facility Contact:	Craig Ellison craigellison@smittysinc.net	
FRS Number:	110016753075	
EPA ID Number:	LAR000078691	
NAICS:	324191 - PETROLEUM LUBRICATING OIL AND GREASE MANUFACTURING	
SIC:	2992 – LUBRICATING OILS AND GREASES 4952 – SEWERAGE SYSTEMS	
Personnel participating in inspection:		
Angela Hays	U.S. EPA – Region 6	Inspector
Erin Young-Dahl	U.S. EPA – Region 6	Inspector
AD Talton	U.S. EPA – Region 6	Inspector
Jimbo Earles	LDEQ	Senior Environmental Scientist
Craig Easley	LDEQ	Senior Environmental Scientist

Section I – INTRODUCTION

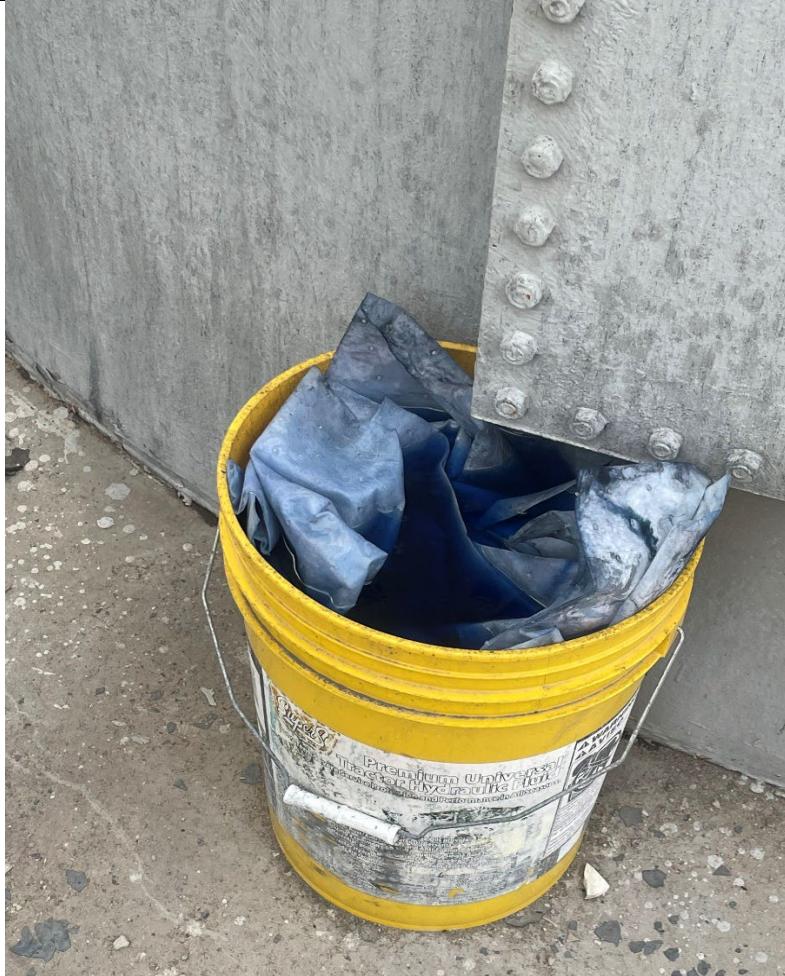
Photo No. 111

Description:	Tank Farm 17 (Outside of warehouse 6): Open and unlabeled bucket containing a blue oily substance and absorbent pads. Bucket appears to have been placed intentionally to catch drips.		
Latitude:	N/A	Longitude:	N/A

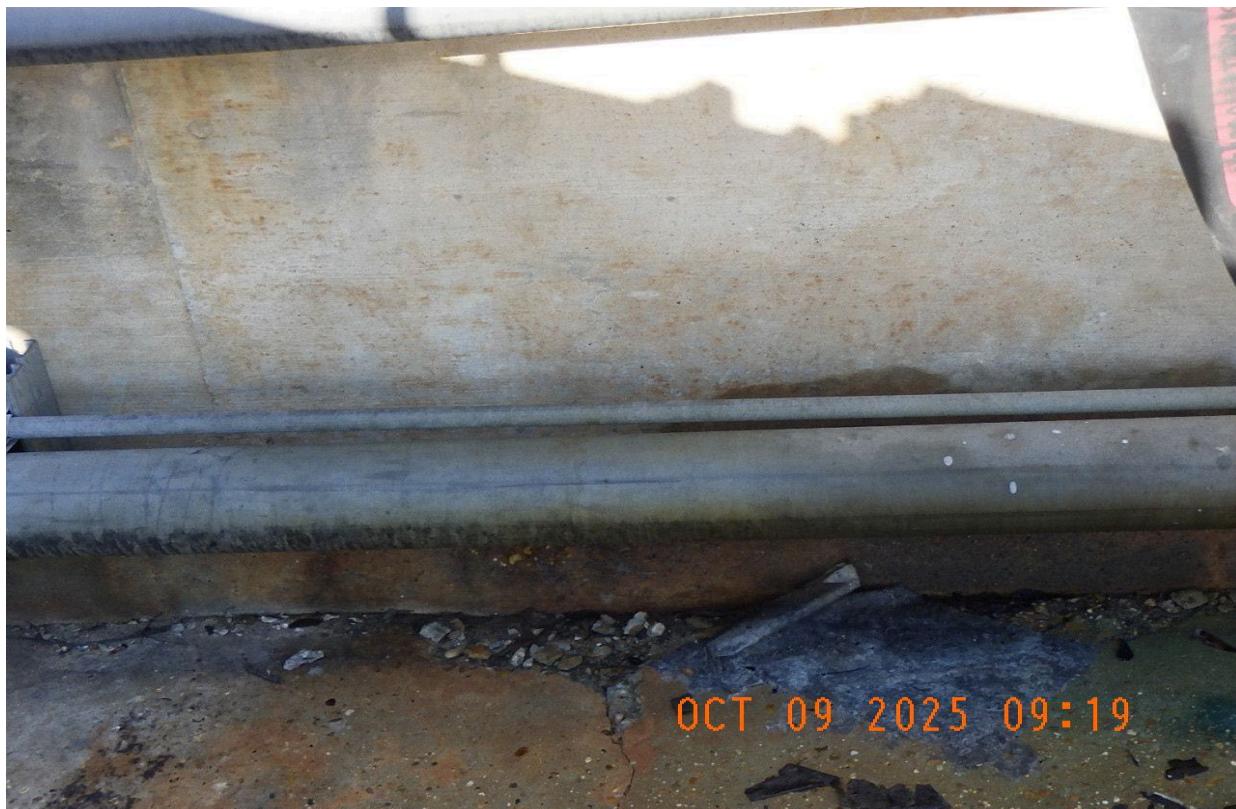
Description:	Tank Farm 16 (Outside Warehouse 10): Outside crack in the bottom of the secondary containment showing seep release of an oily liquid. There is no evidence of repair attempts.		
Latitude:	N/A	Longitude:	N/A

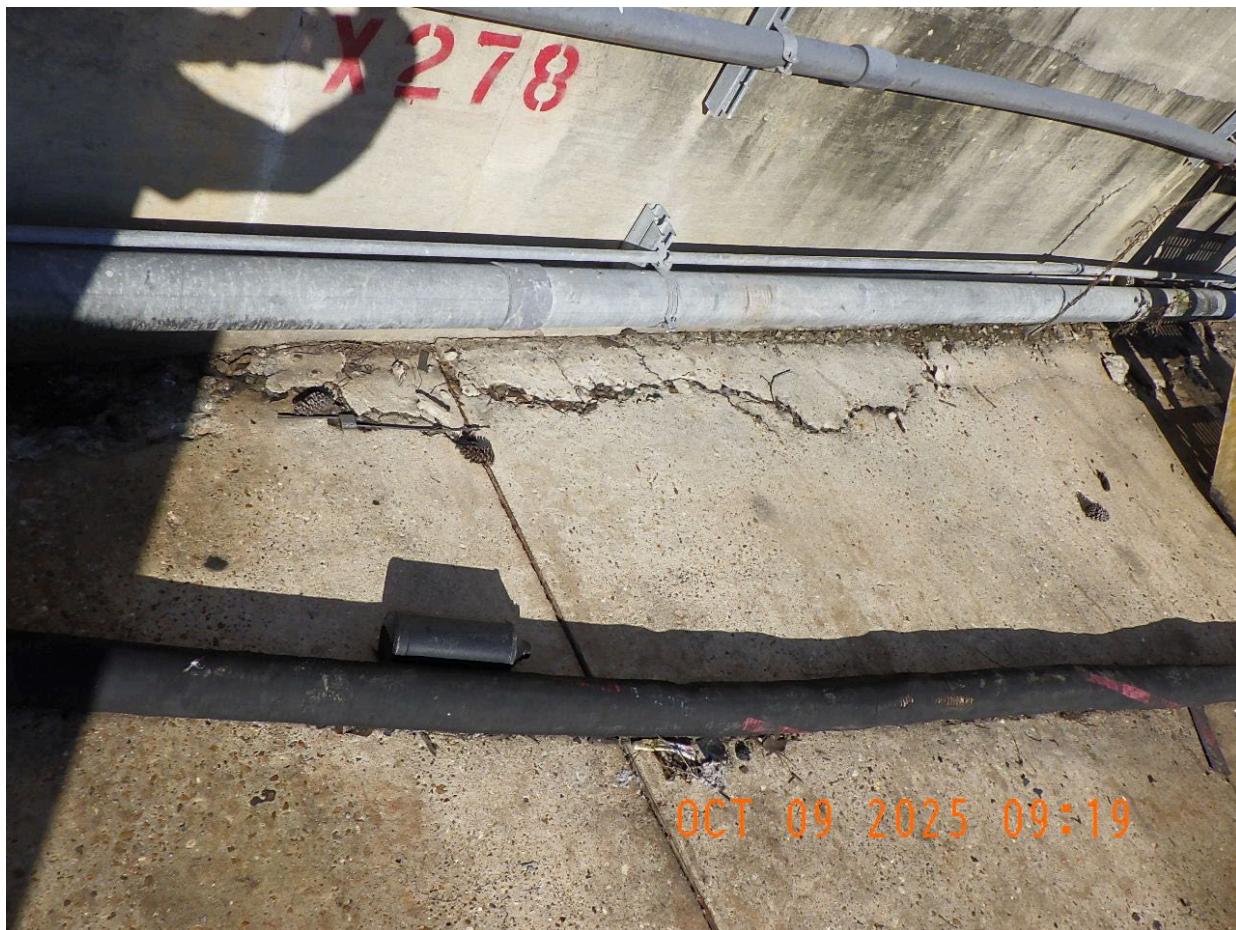
Description:	Tank Farm 16 (Outside Warehouse 10): Outside crack in the bottom of the secondary containment showing seep release of an oily liquid. There is no evidence of repair attempts.		
Latitude:	N/A	Longitude:	N/A

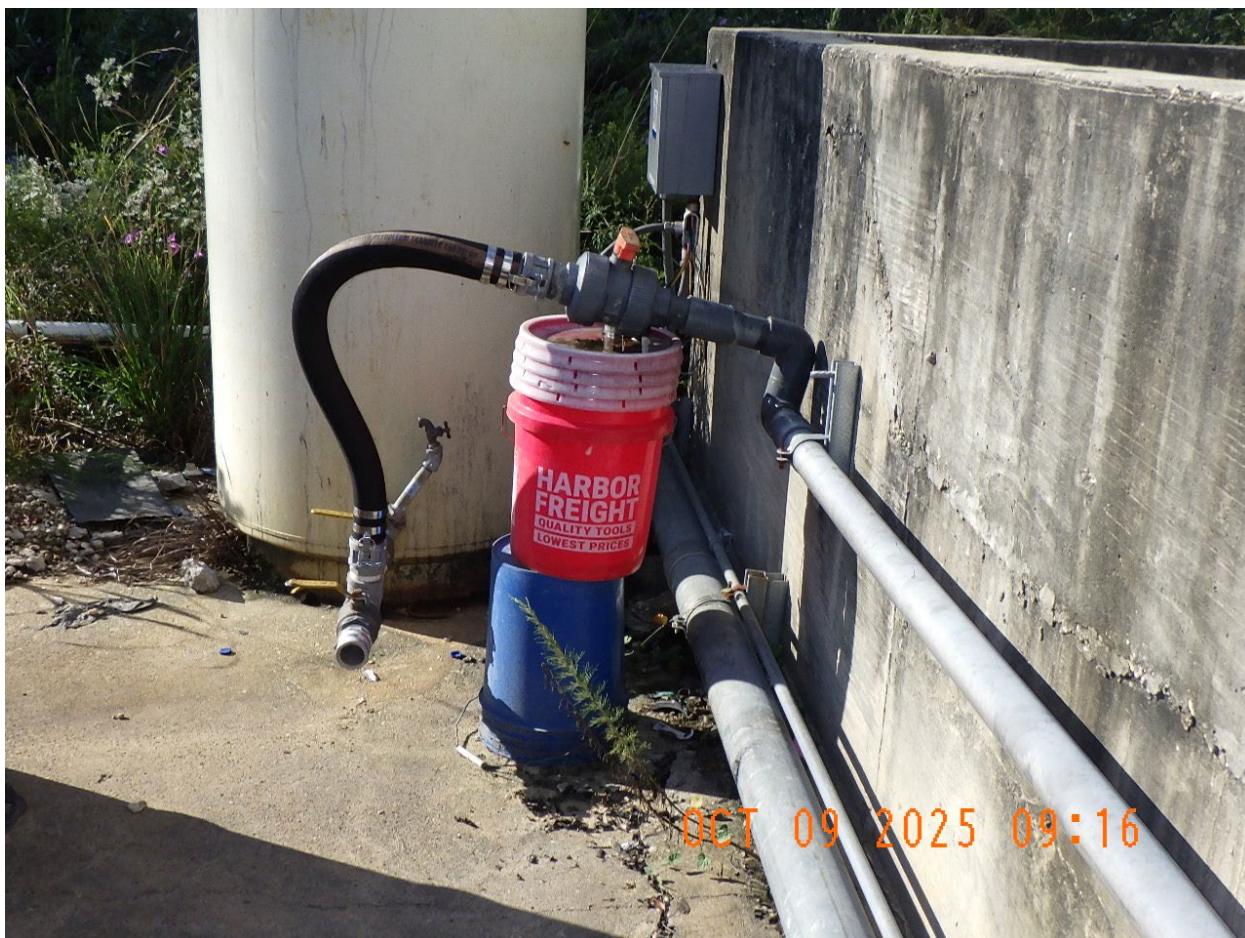
Description:	Tank Farm 16 (Outside Warehouse 10): Leak in ancillary equipment. Oily liquid substance on top of bucket lid propping up hose connection. There is a visible crack in the cement pad running along secondary containment.		
Latitude:	N/A	Longitude:	N/A

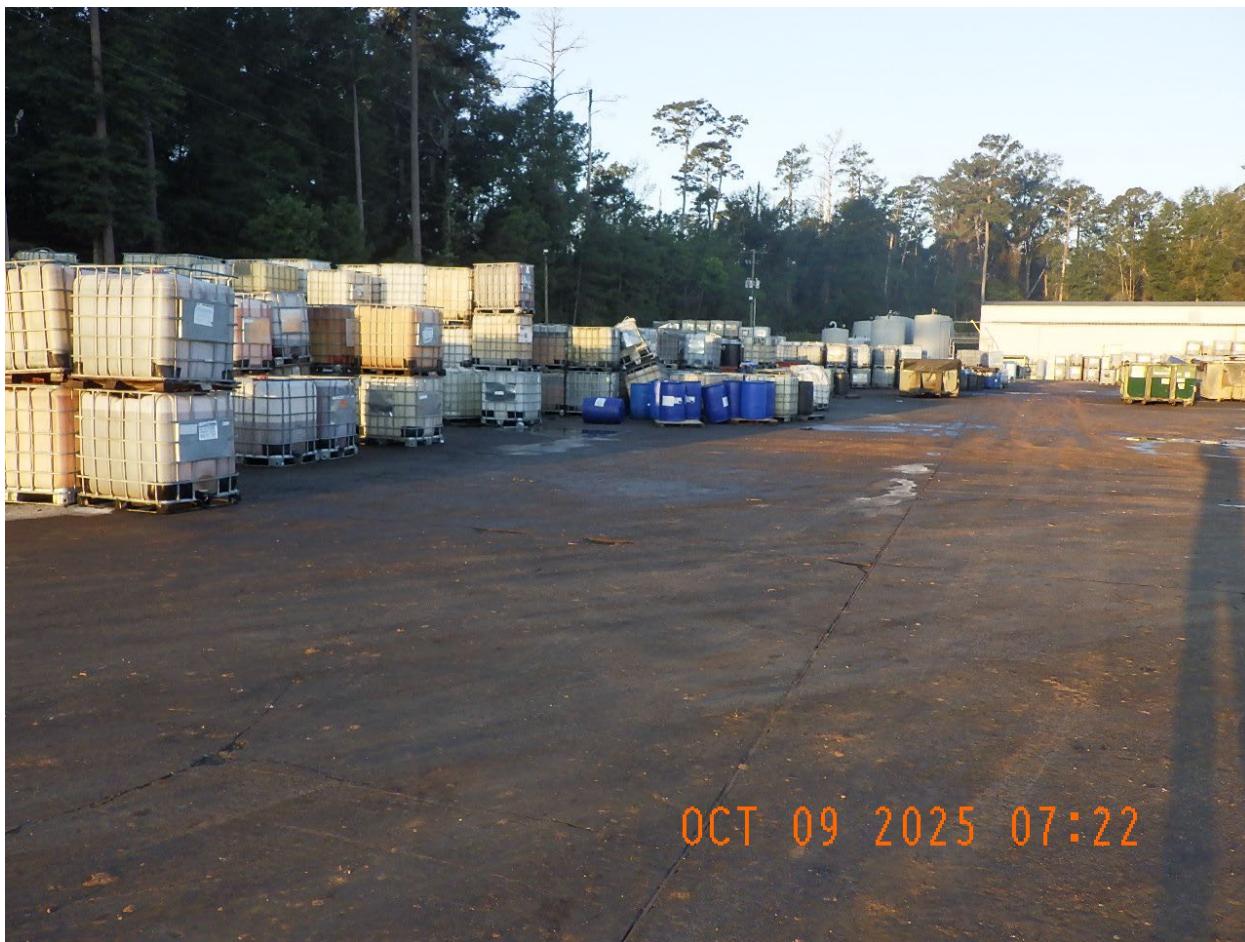
Photo No. 115

Description:	Outdoor container area: Overview of southwest corner of storage area.		
Latitude:	N/A	Longitude:	N/A

Inspectors started at the southern fence line, walking west, then moved on to the east side of warehouse 10, then the south side of warehouse 6, traveling east. The inspection of this area concluded just beyond the eastern boundary of the TF-17 secondary containment (Appendix 3: Photos 115, 116).

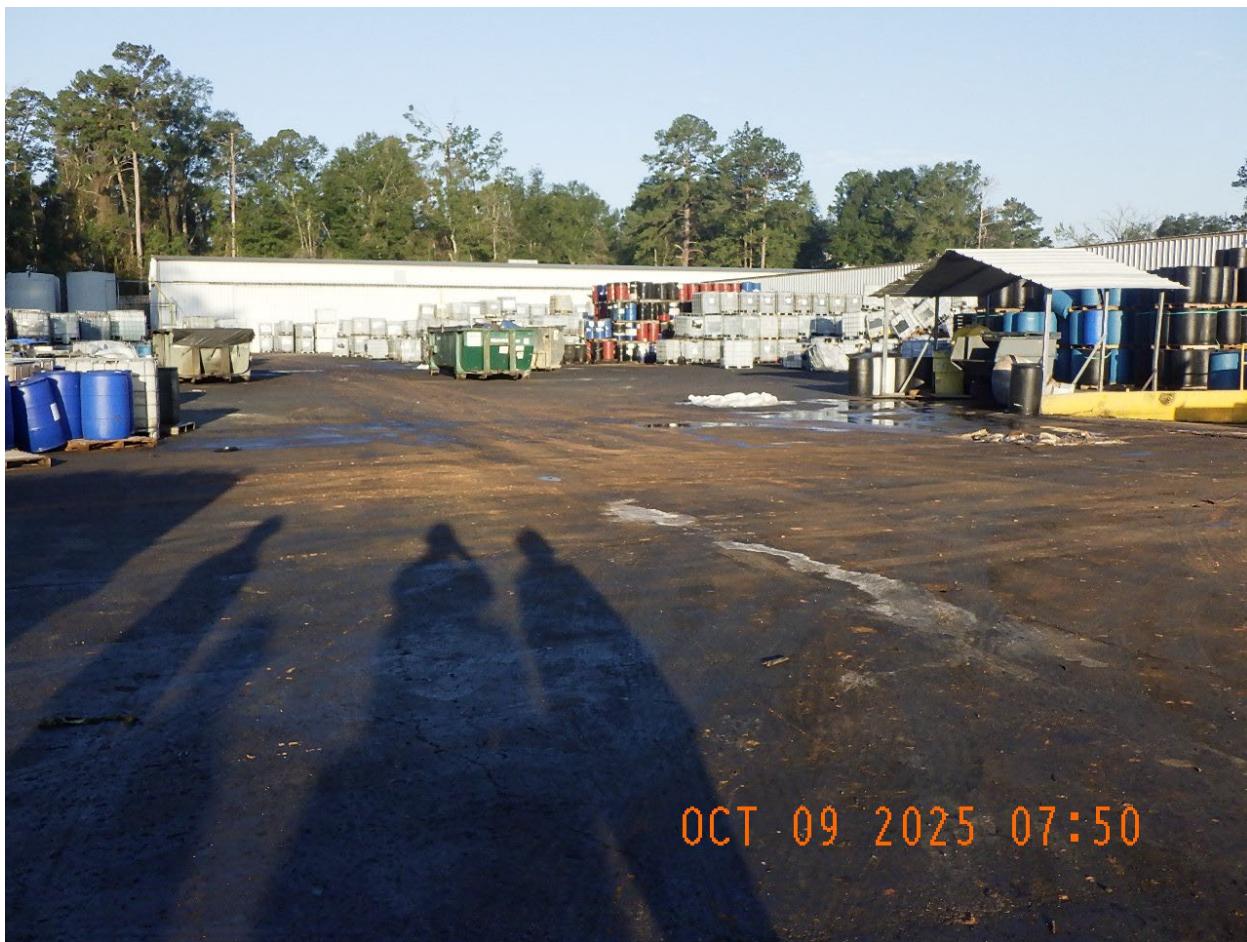
Photo No. 116

Description:	Outdoor container area: Overview of northwest corner of storage area.		
Latitude:	N/A	Longitude:	N/A

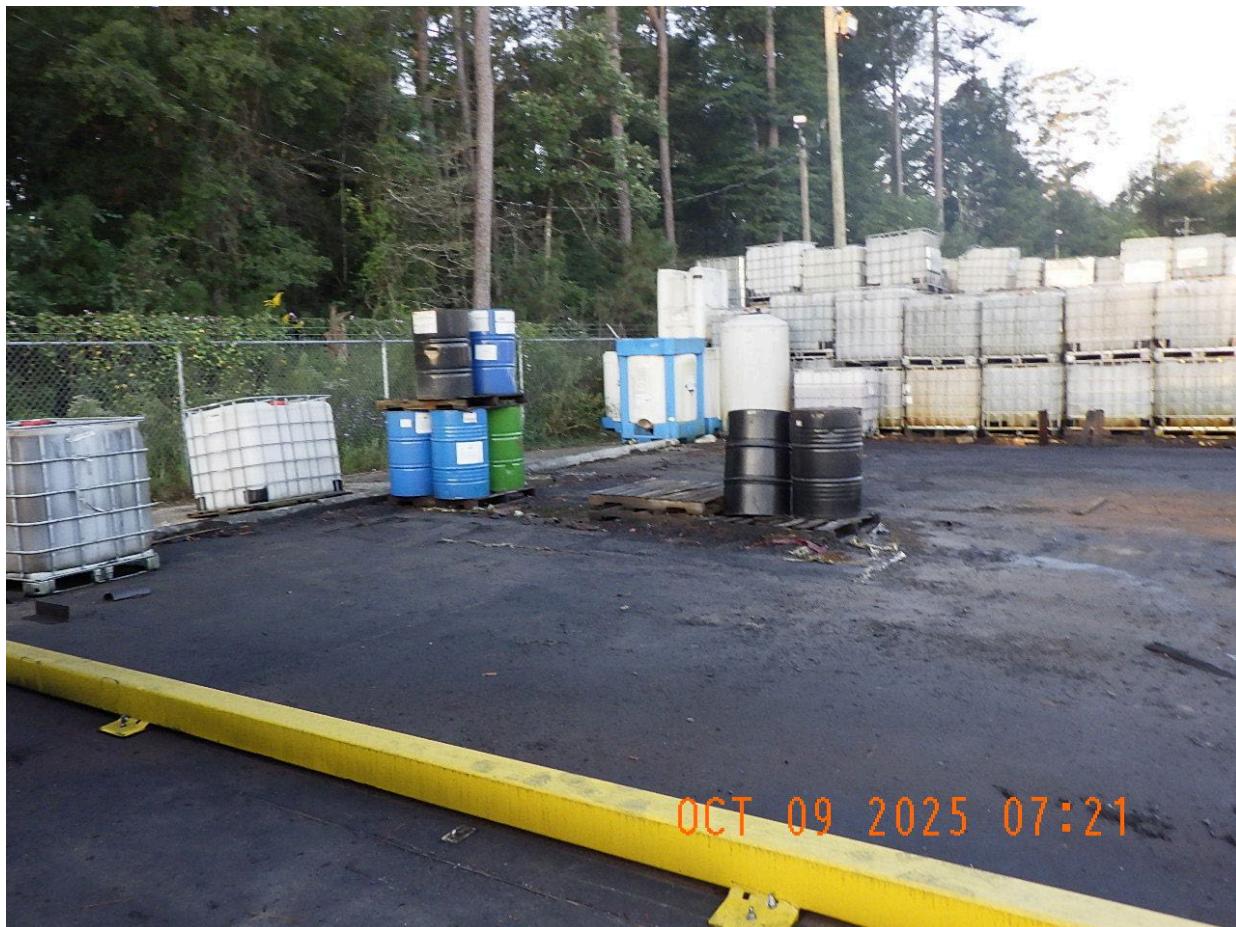
Description:	Outdoor container area: Heavy staining and spills on concrete pad. Overview of SE portion of the area.		
Latitude:	N/A	Longitude:	N/A

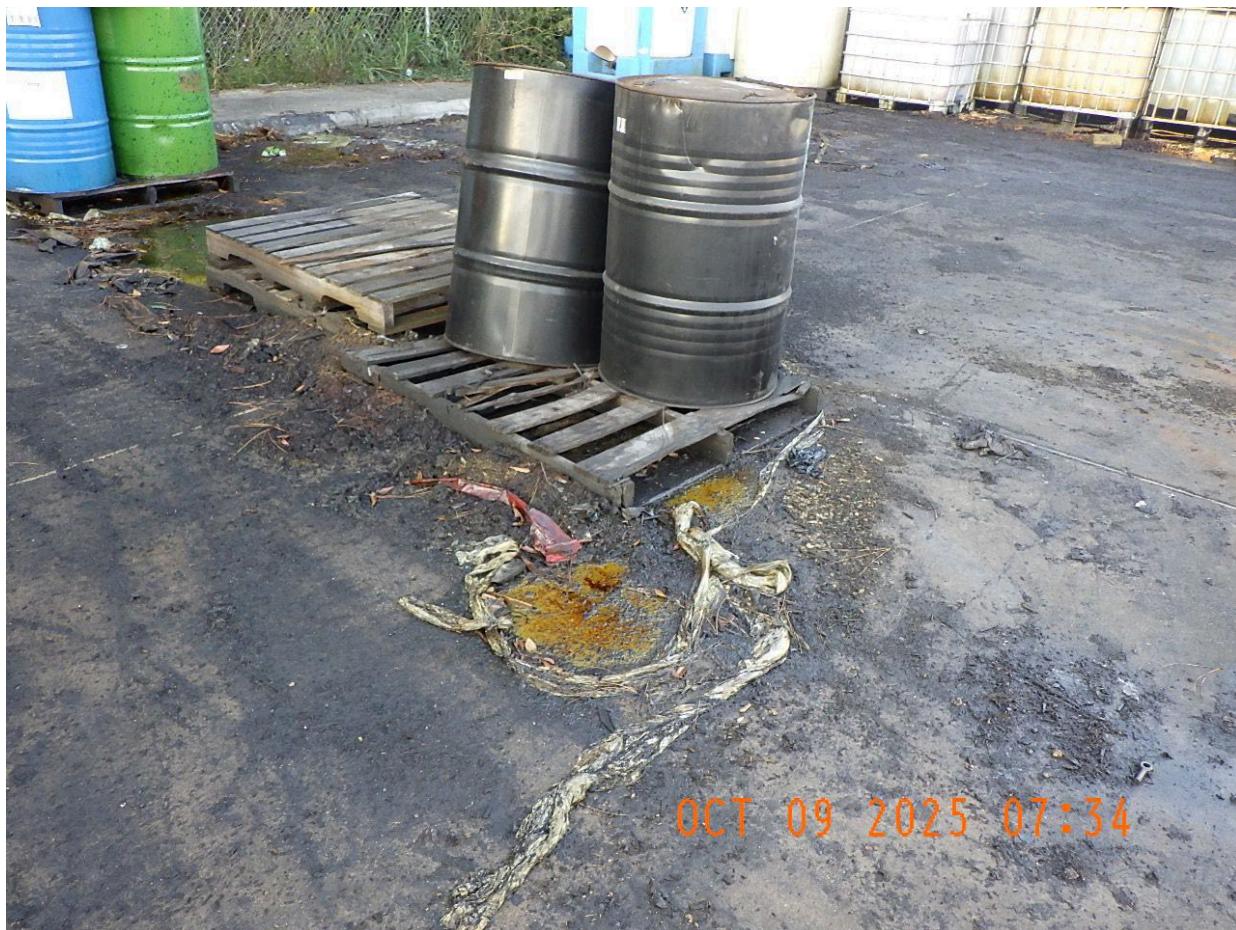
Description:	Outdoor container area: Unlabeled damaged drums on damaged pallet. Debris from spills collected around pallets.		
Latitude:	N/A	Longitude:	N/A

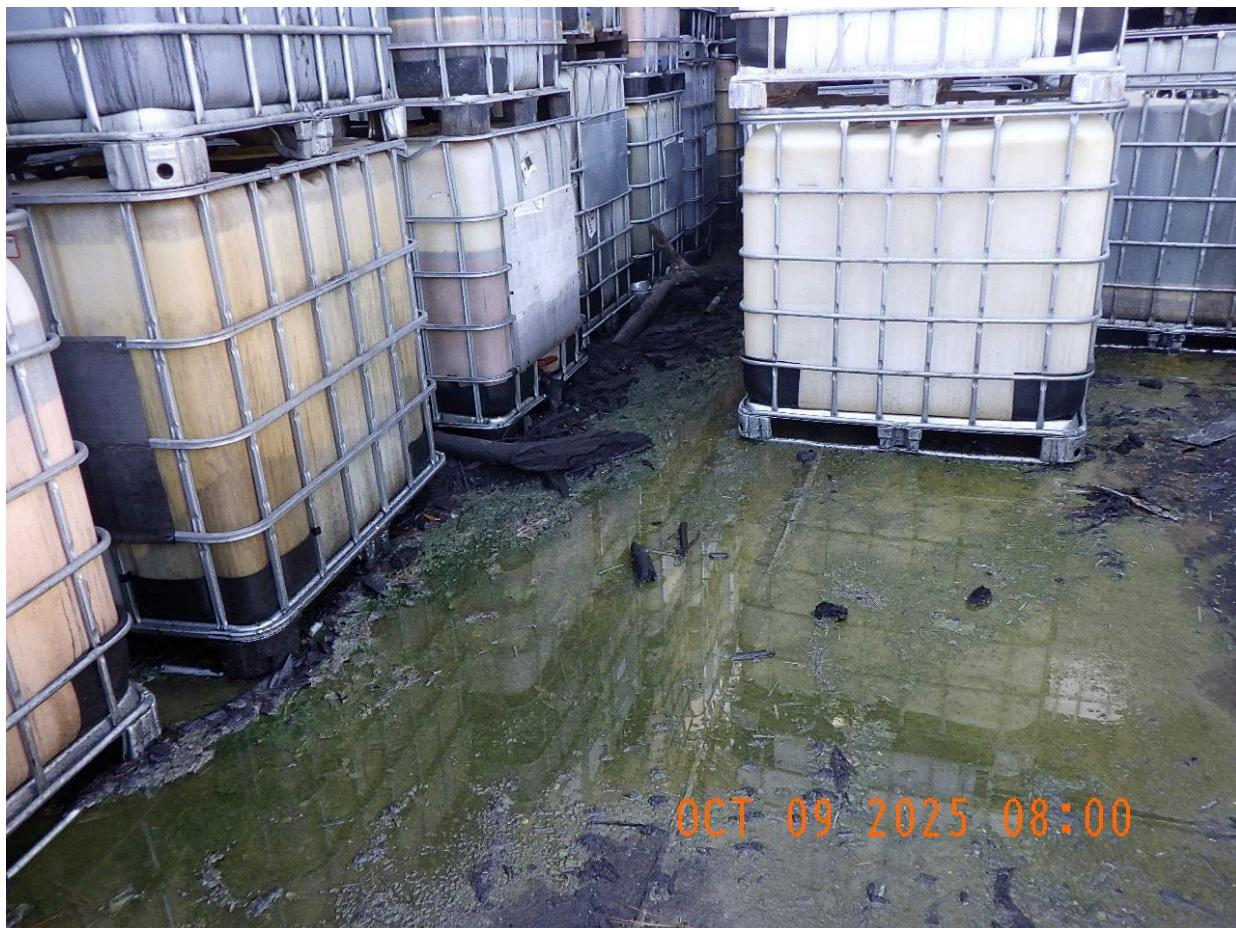
Photo No. 119

Description:	Outdoor container area: Heavy releases of green oily liquids. Oils have emulsified.		
Latitude:	N/A	Longitude:	N/A

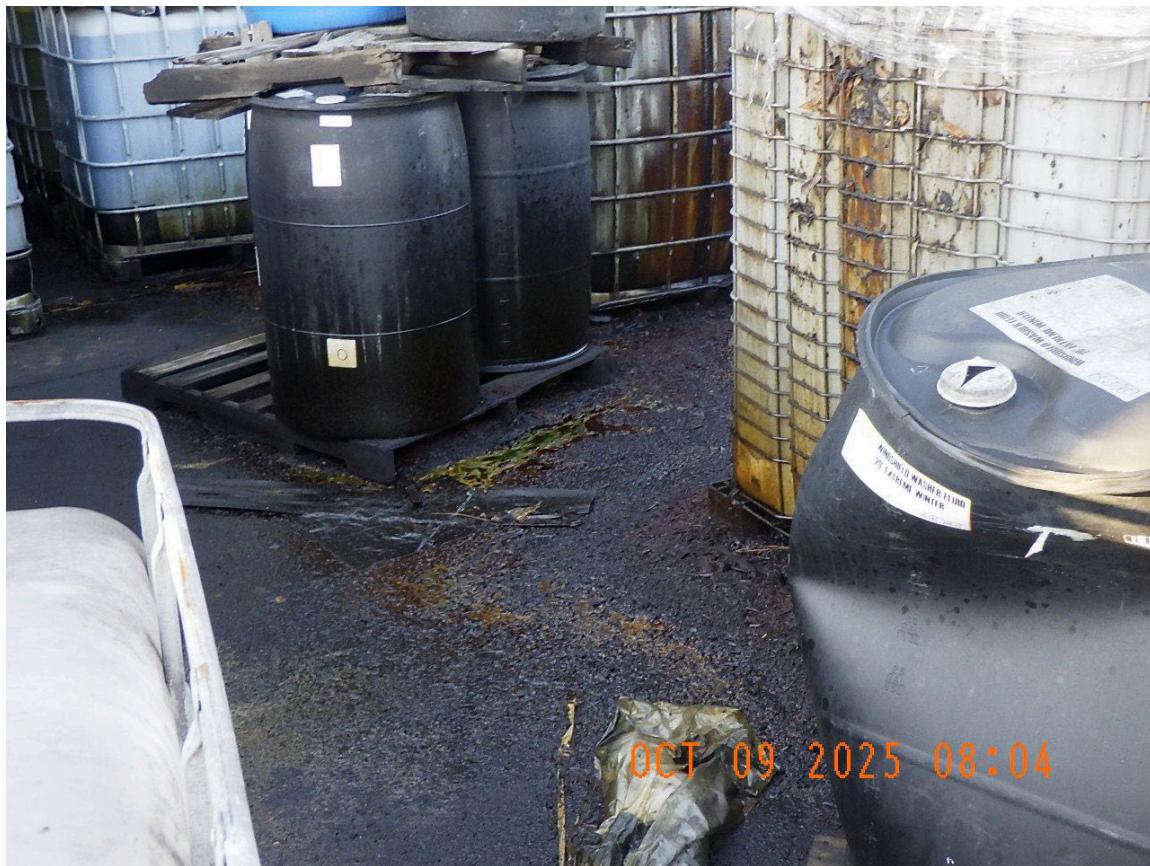
Description:	Outdoor Container Storage Area (Parking lot): Several totes of unknown oily liquids with releases/spills on the ground. The sources of the releases/spills are unknown. Totes are unlabeled, contents unknown to inspectors. There is a damaged 55-gal drum (foreground) that is damaged with dents and/or warping. One black and one blue poly drums of unknown material are unsteadily balanced on a broken wooden pallet placed on top of three drum of unknown material. Bottom pallet is saturated with spilled material.		
Latitude:	N/A	Longitude:	N/A

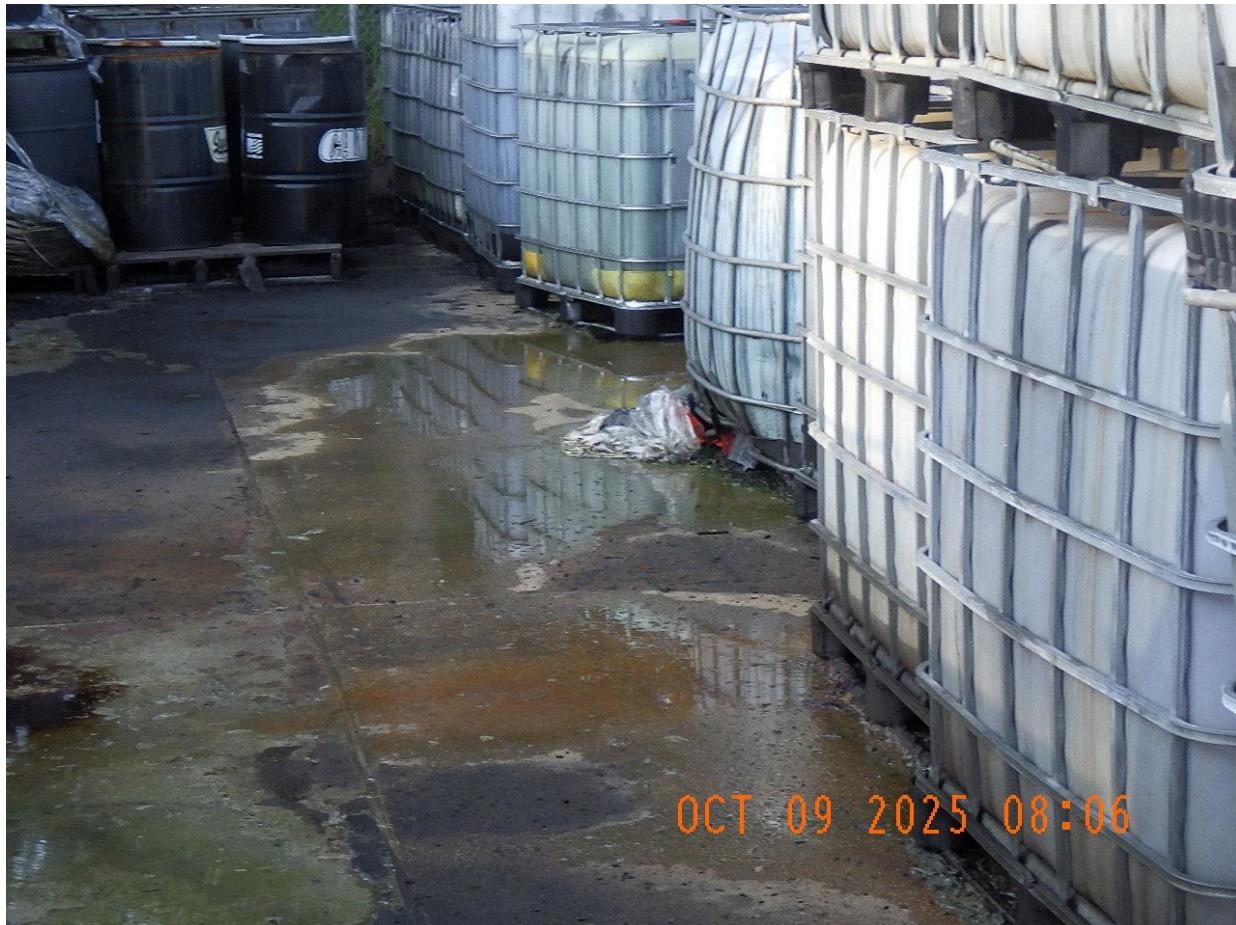
Description:	Outdoor Container Storage Area (Parking lot): Evidence of releases and emulsified oils. Bulging tote of unknown contents. No evidence of a cleanup.		
Latitude:	N/A	Longitude:	N/A

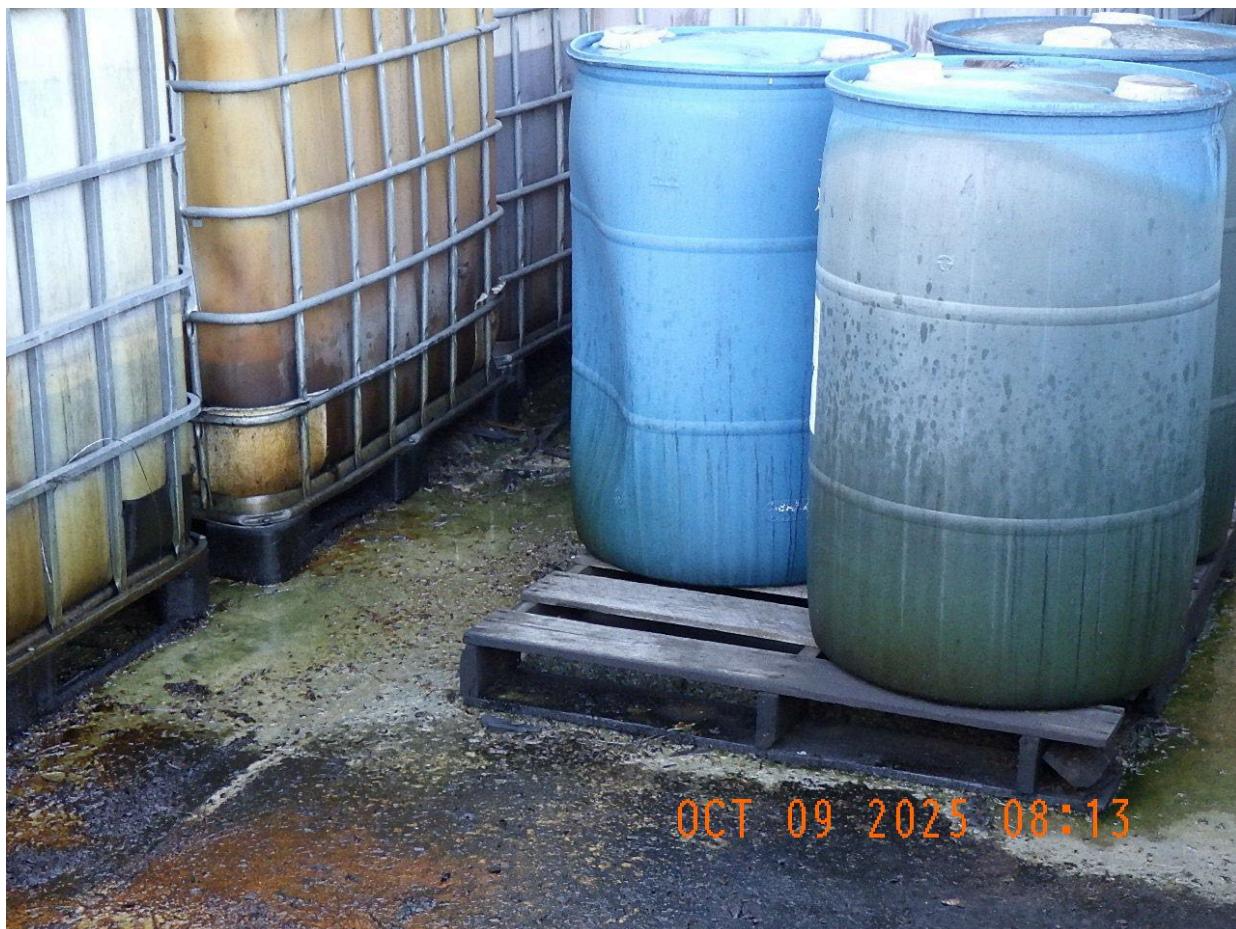
Description:	Outdoor Container Storage Area (Parking lot): Evidence of a release. The source of the release is unknown. The drums and totes are not labeled identifying the contents and some of the drums and totes are damaged with dents. No aisle space.		
Latitude:	N/A	Longitude:	N/A

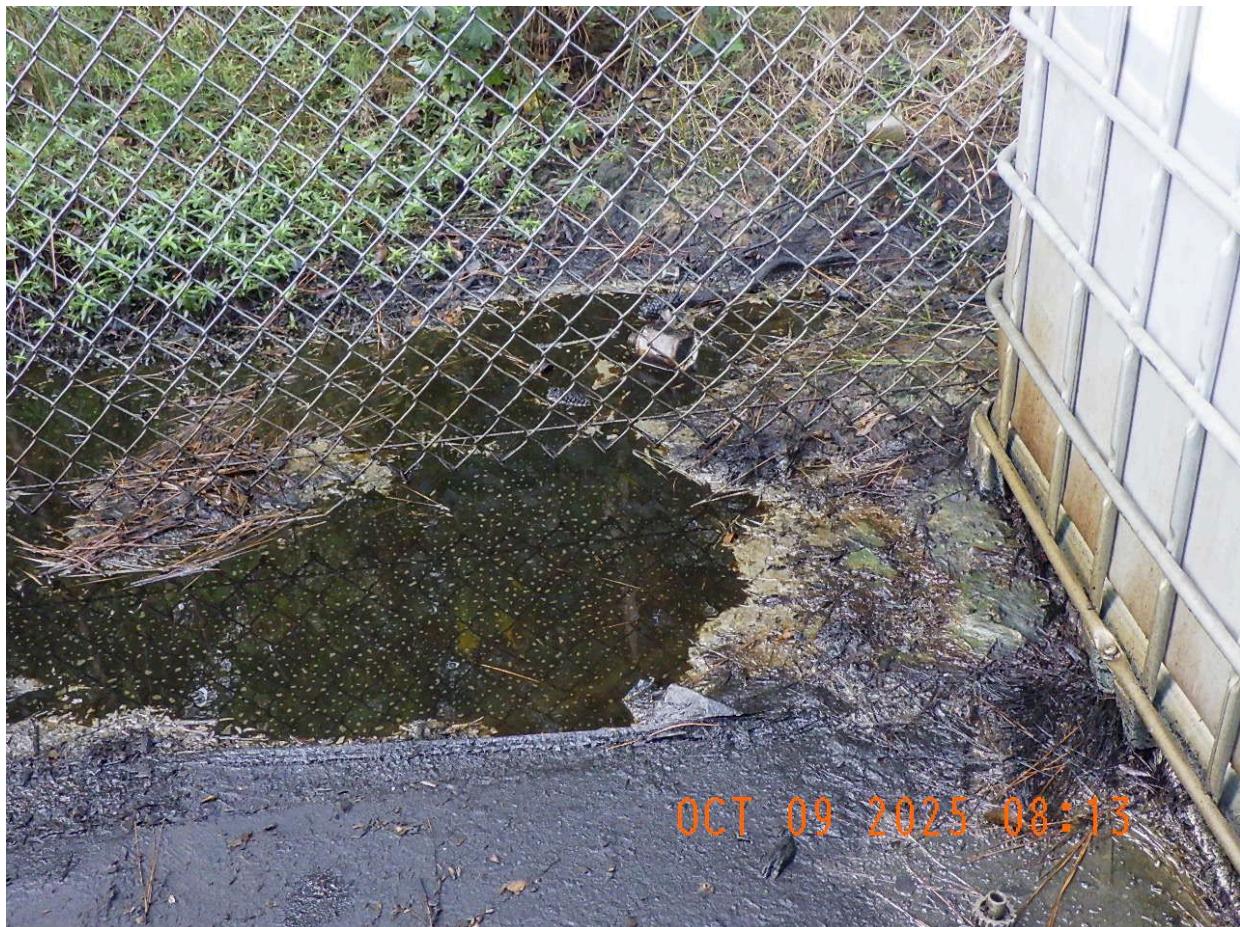
Photo No. 124

Description:	Outdoor Container Storage Area (Parking lot): Evidence of a release. The pool of unknown liquid is beyond the facility's property and fence line.		
Latitude:	N/A	Longitude:	N/A

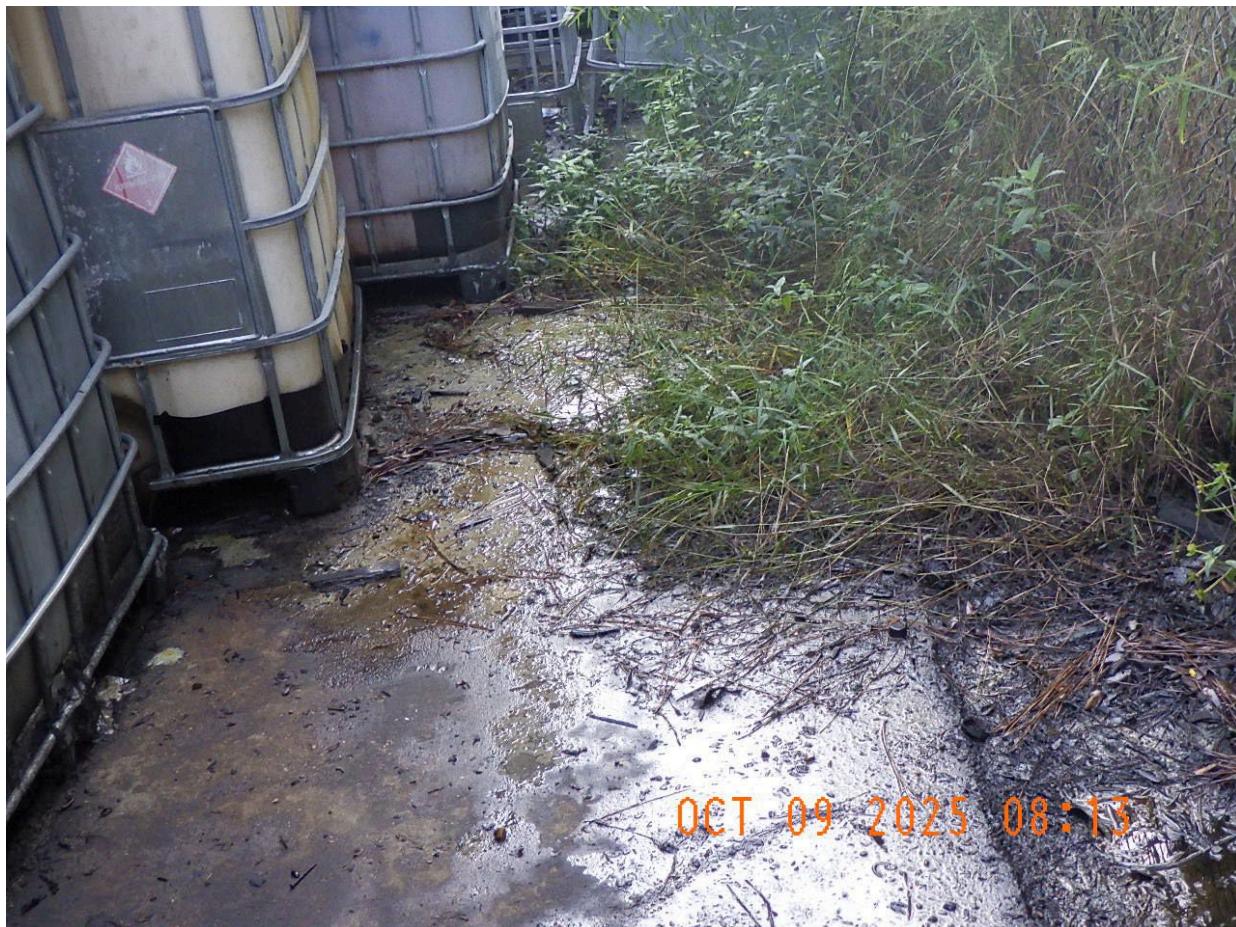
Photo No. 125

Description:	Outdoor Container Storage Area (Parking lot): Evidence of a release. The oily liquid is emulsified and flows beyond the facility's property and fence line. Faded "flammable" placard visible on one tote, but no other labeling was apparent.		
Latitude:	N/A	Longitude:	N/A

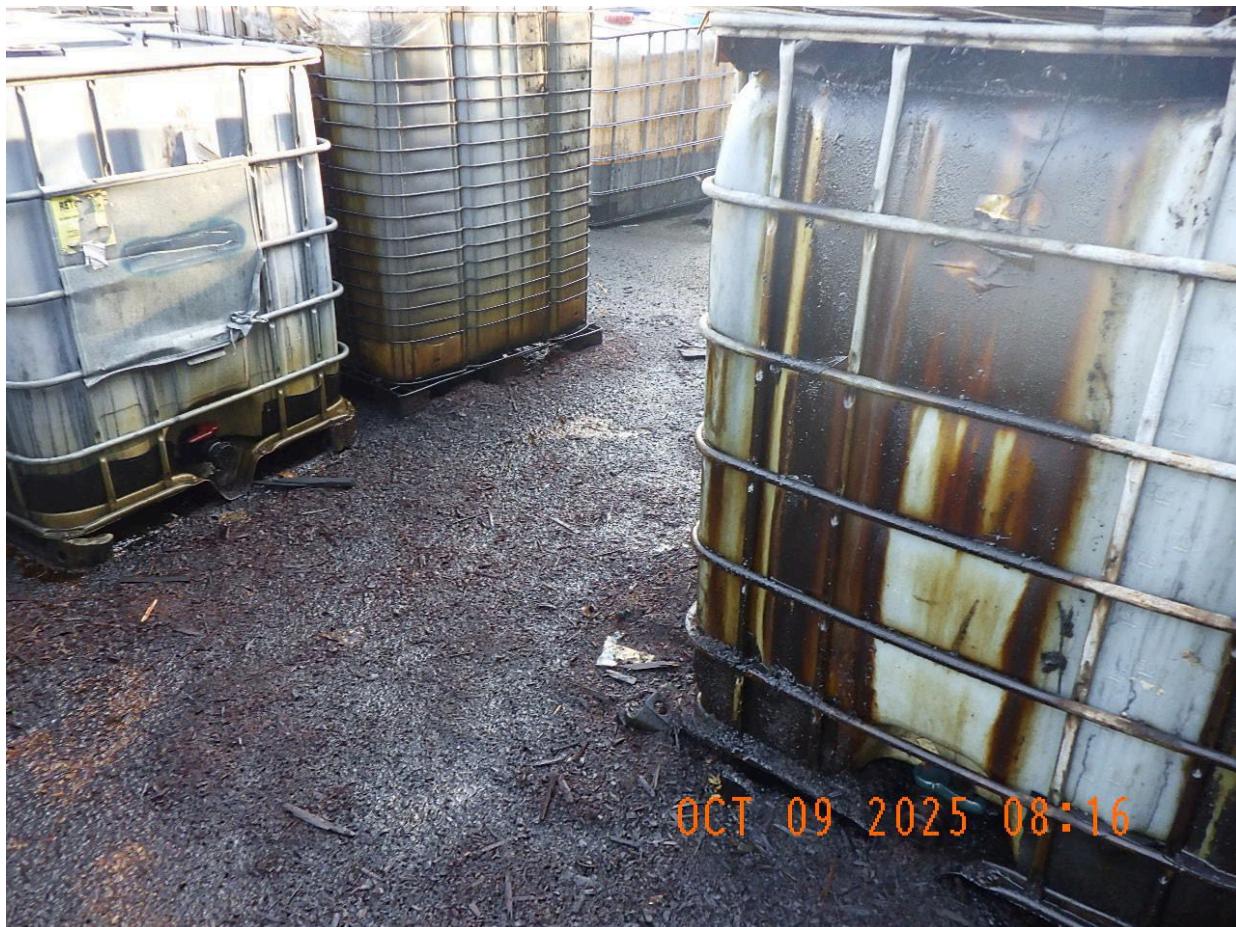
Photo No. 126

Description:	Outdoor Container Storage Area (Parking lot): Evidence of release on the ground and overflowing tote. Unlabeled totes, contents unknown.		
Latitude:	N/A	Longitude:	N/A

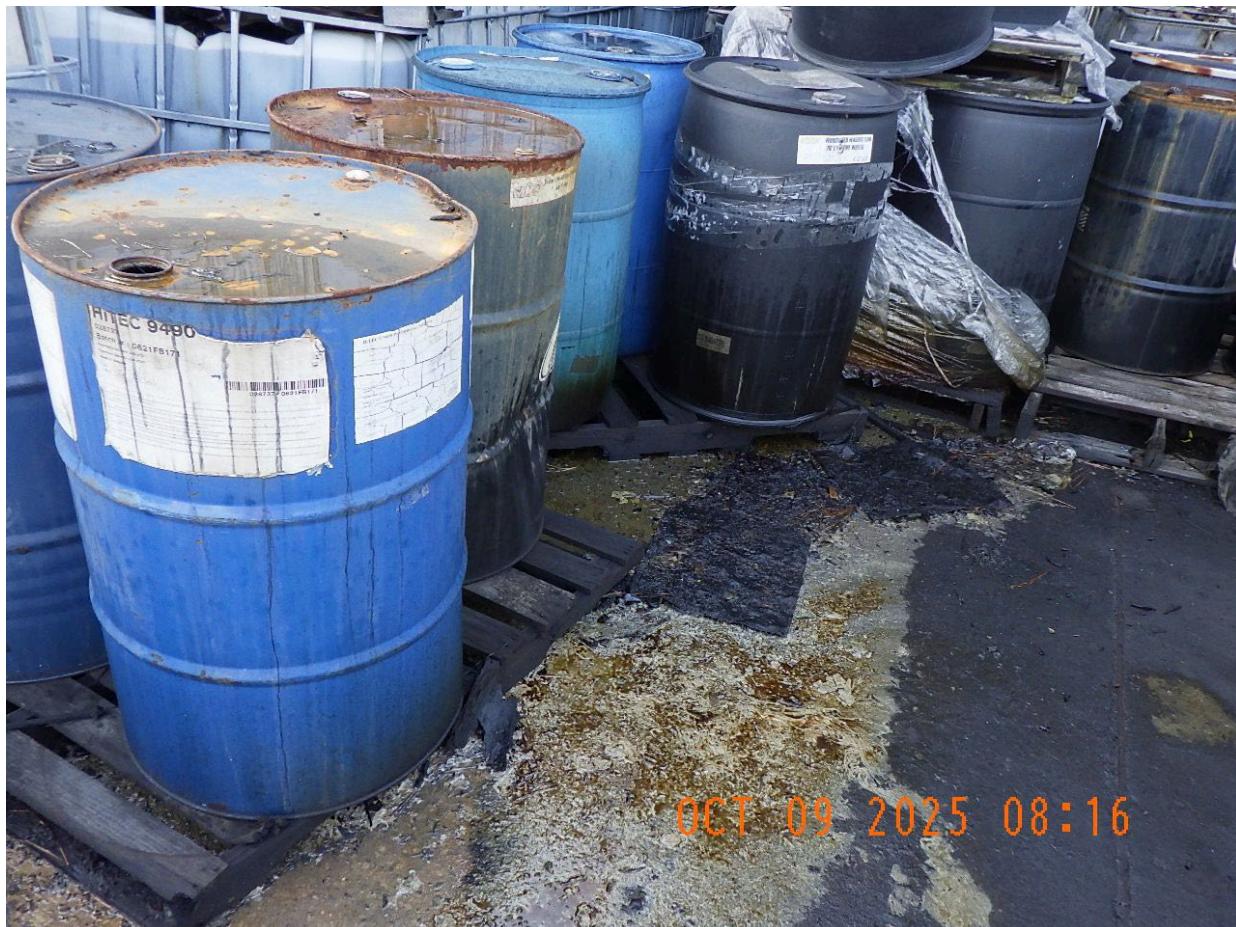
Description:	Outdoor Container Storage Area (Parking lot): Evidence of release on the ground, old absorbent pads have not been replaced, oil has emulsified, damaged drums, open container.		
Latitude:	N/A	Longitude:	N/A

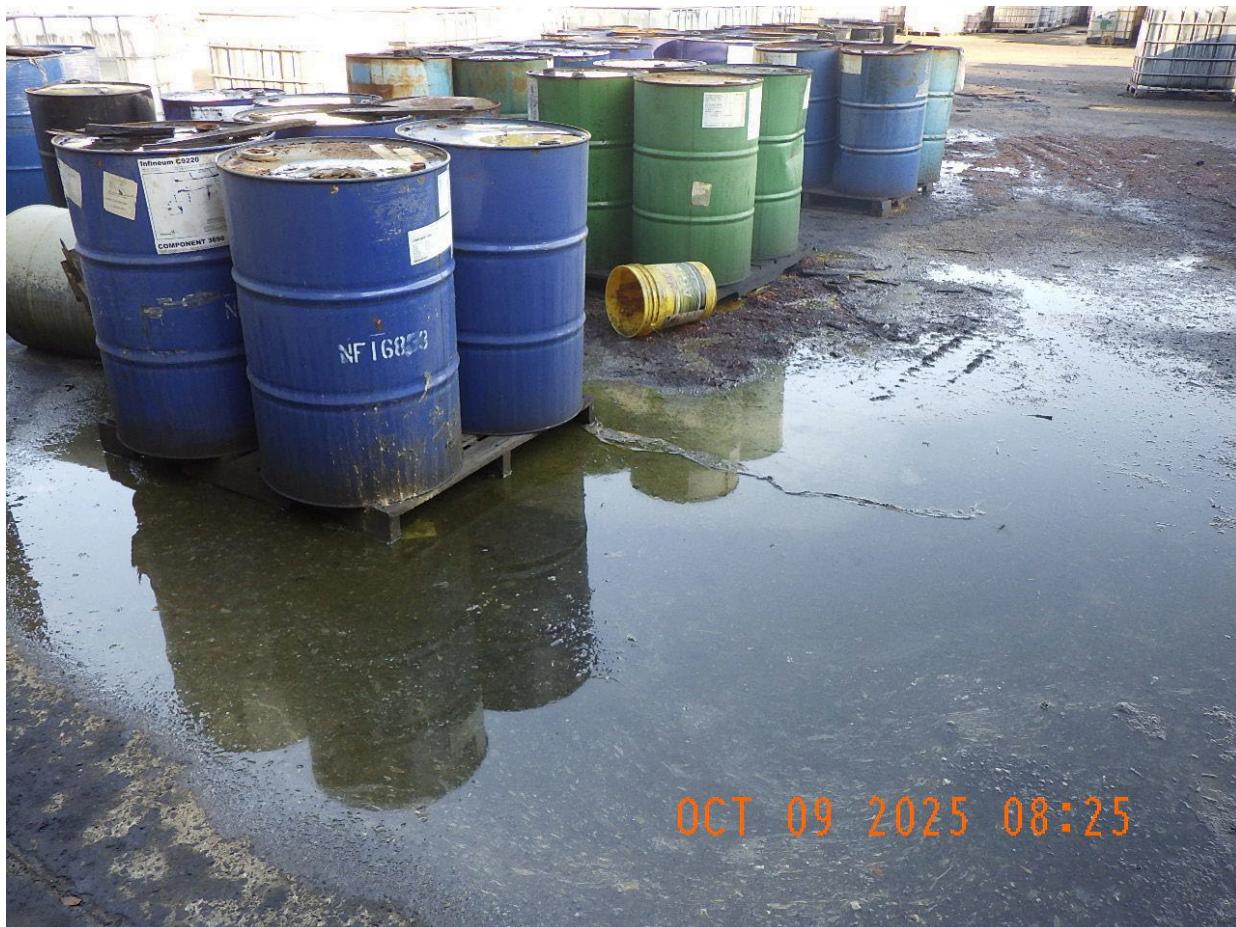
Photo No. 128

Description:	Outdoor Container Storage Area (Parking lot): Evidence of a spill/release. The oily liquid is unknown. Drums are not labeled and some of the wooden pallets are saturated with the liquid released/spilled on the ground of the area.		
Latitude:	N/A	Longitude:	N/A

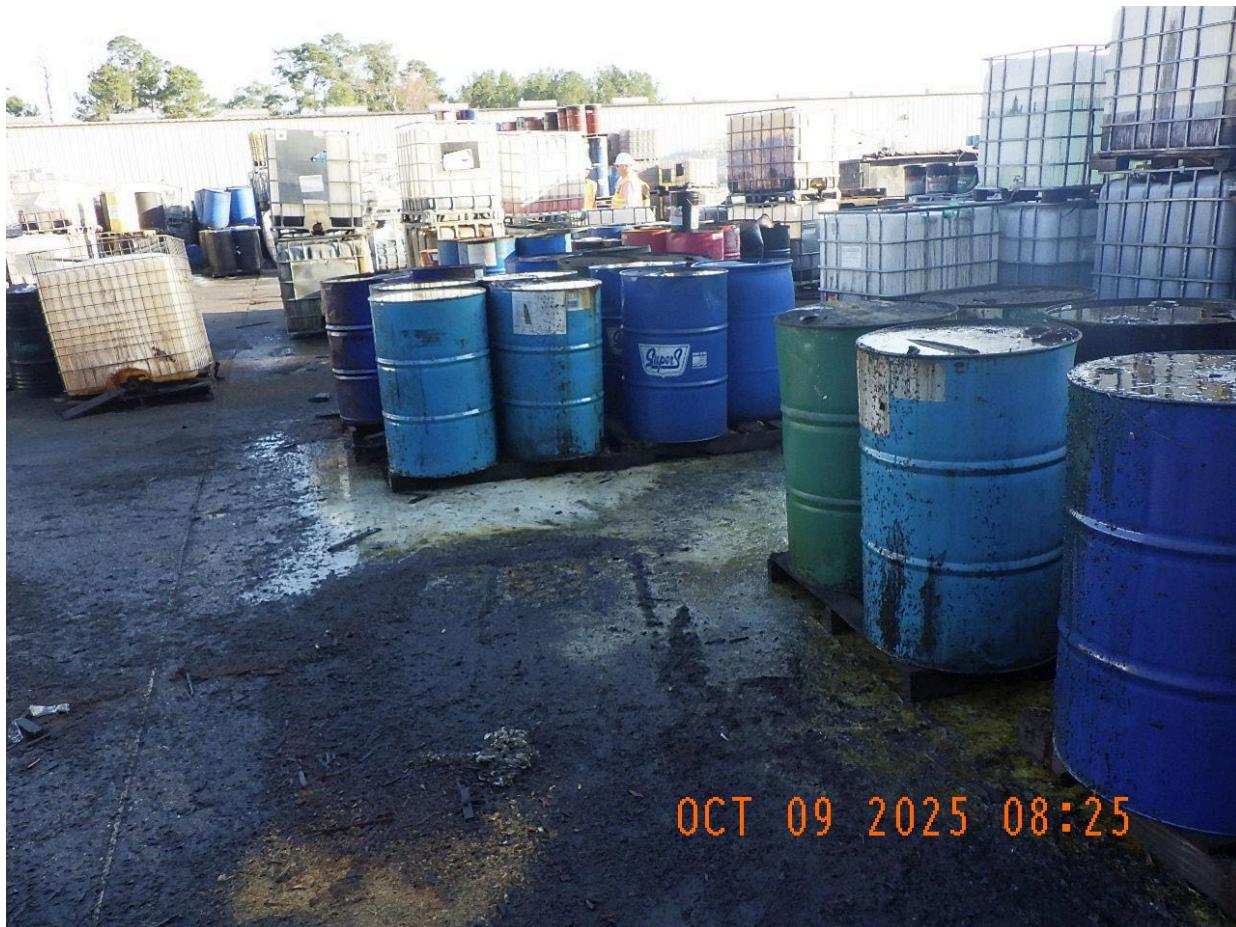
Description:	Outdoor Container Storage Area (Parking lot): Evidence of a spill/releases. Oils have emulsified. Drums have oily liquids on tops. Green drum is open. Labels are unreadable or missing. Contents unknown.		
Latitude:	N/A	Longitude:	N/A

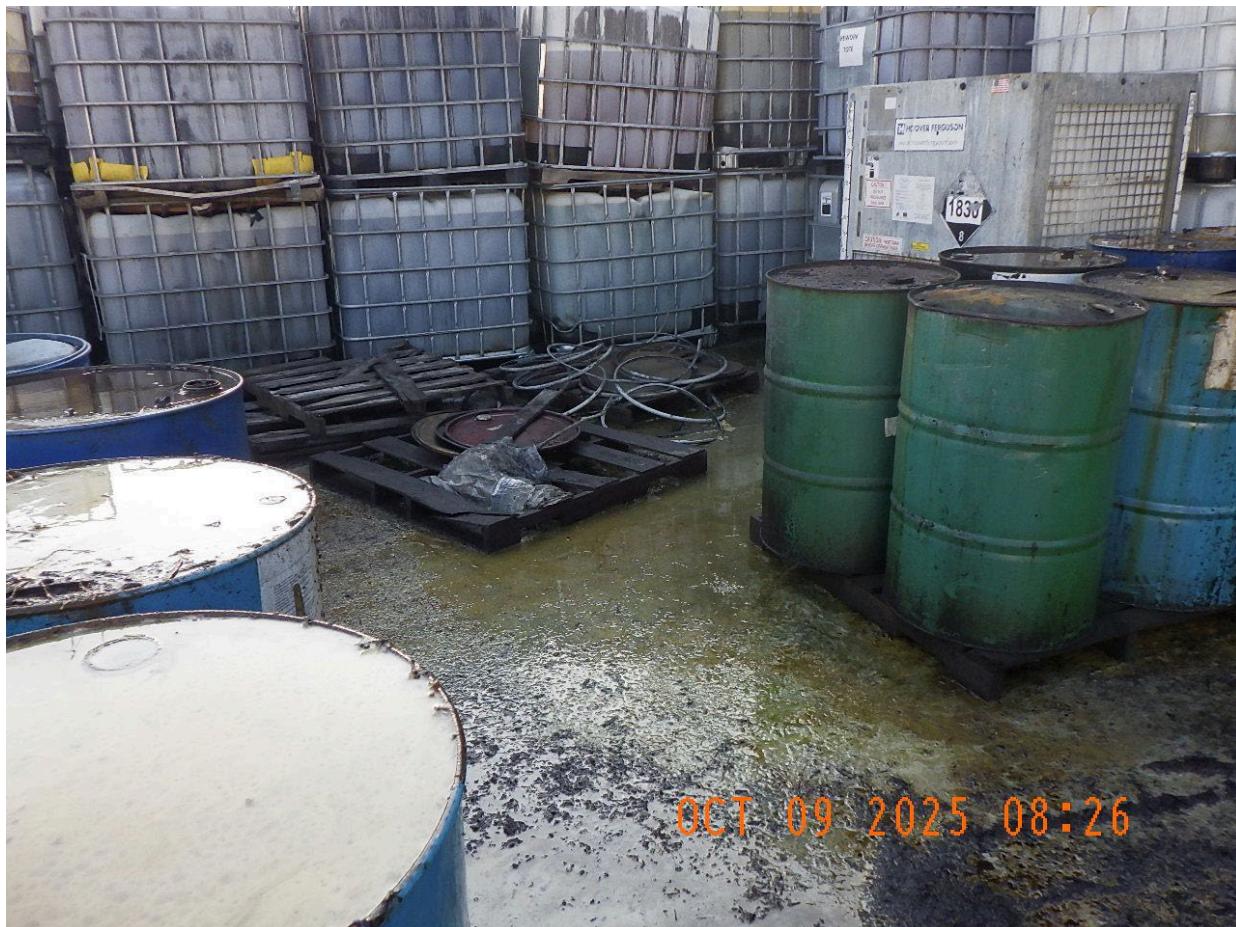
Description:	Outdoor Container Storage Area (Parking lot): Evidence of spill/releases. Oils have emulsified. Drums have oily liquids on top. Labels are unreadable or missing. Contents of containers is unknown. Green drum to the right has an open bung hole and is bulging on the top. Totes in background are damaged.		
Latitude:	N/A	Longitude:	N/A
