Region 6 - Enforcement & Compliance Assurance Division
INSPECTION REPORT

Inspection Date(s):	10/07/2025 – 10/09/2025	
Media Program:	RCRA	
Regulatory Program(s)	Hazardous Waste, Used Oil	
Company Name:	Smitty's Supply, Inc.	
Facility Name:	Smitty's Supply Roseland	
Facility Physical Location:	63399 Highway 51 N	
(city, state, zip code)	Roseland LA 70456	
Mailing address:	PO Box 530	
(city, state, zip code)	Roseland LA 70456	
County/Parish:	Tangipahoa	
Facility Phone Number	1-800-256-7575	
Facility Contact:	Craig Ellison craigellison@smittysinc.net	
FRS Number:	110016753075	
EPA ID Number:	LAR000078691	
NAICS:	324191 - PETROLEUM LUBRICATING OIL AND GREASE MANUFACTURING	
SIC:	2992 – LUBRICATING OILS AND GREASES 4952 – SEWERAGE SYSTEMS	
Personnel participating in inspection:		
Angela Hays	U.S. EPA – Region 6	Inspector
Erin Young-Dahl	U.S. EPA – Region 6	Inspector
AD Talton	U.S. EPA – Region 6	Inspector
Jimbo Earles	LDEQ	Senior Environmental Scientist
Craig Easley	LDEQ	Senior Environmental Scientist

Section I – INTRODUCTION

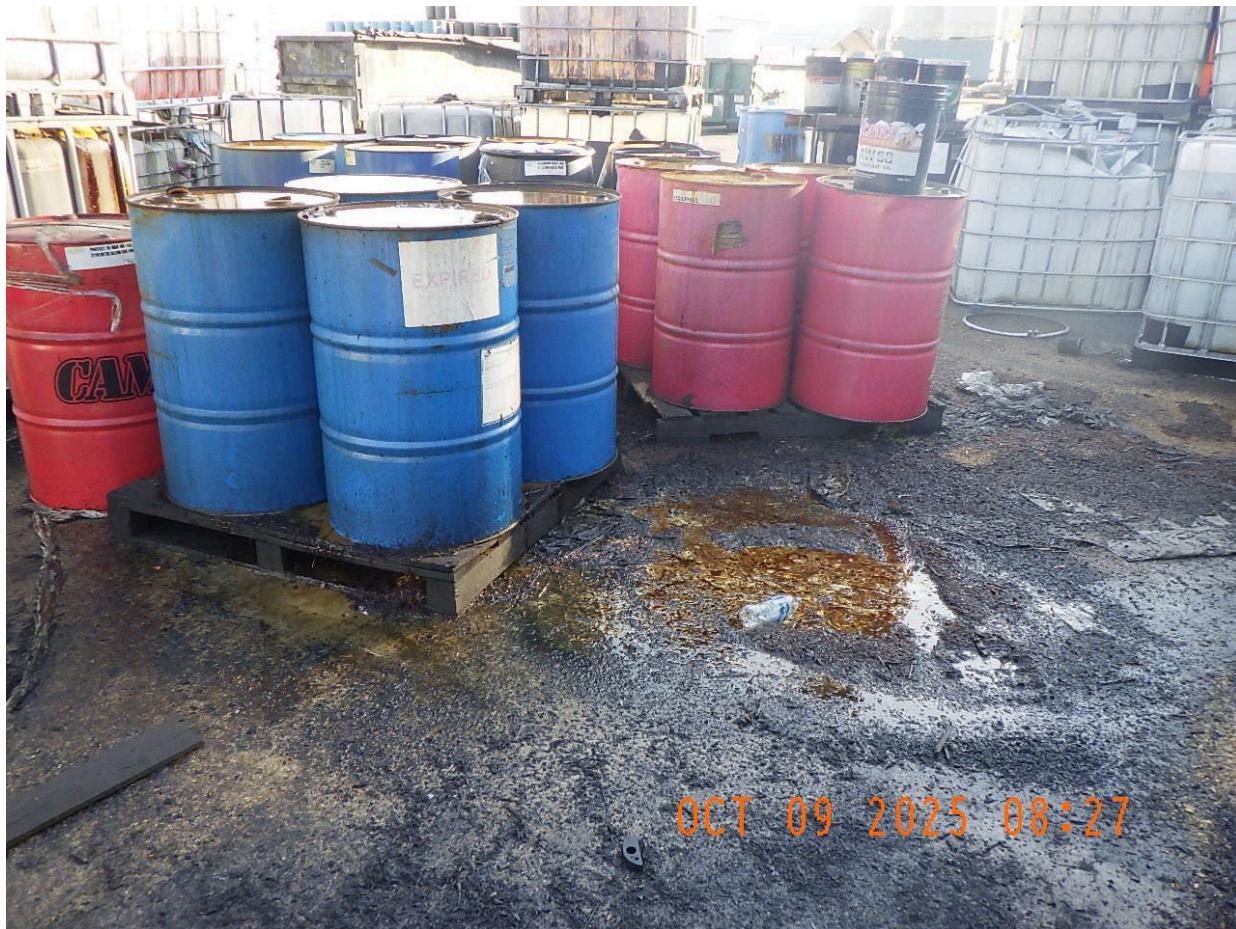
Description:	Outdoor Container Storage Area (Parking lot): Evidence of spill/releases. Oils have emulsified. Drums have oily liquids on top, some have open bungs. "EXPIRED" labels on blue drums. Totes are damaged.		
Latitude:	N/A	Longitude:	N/A

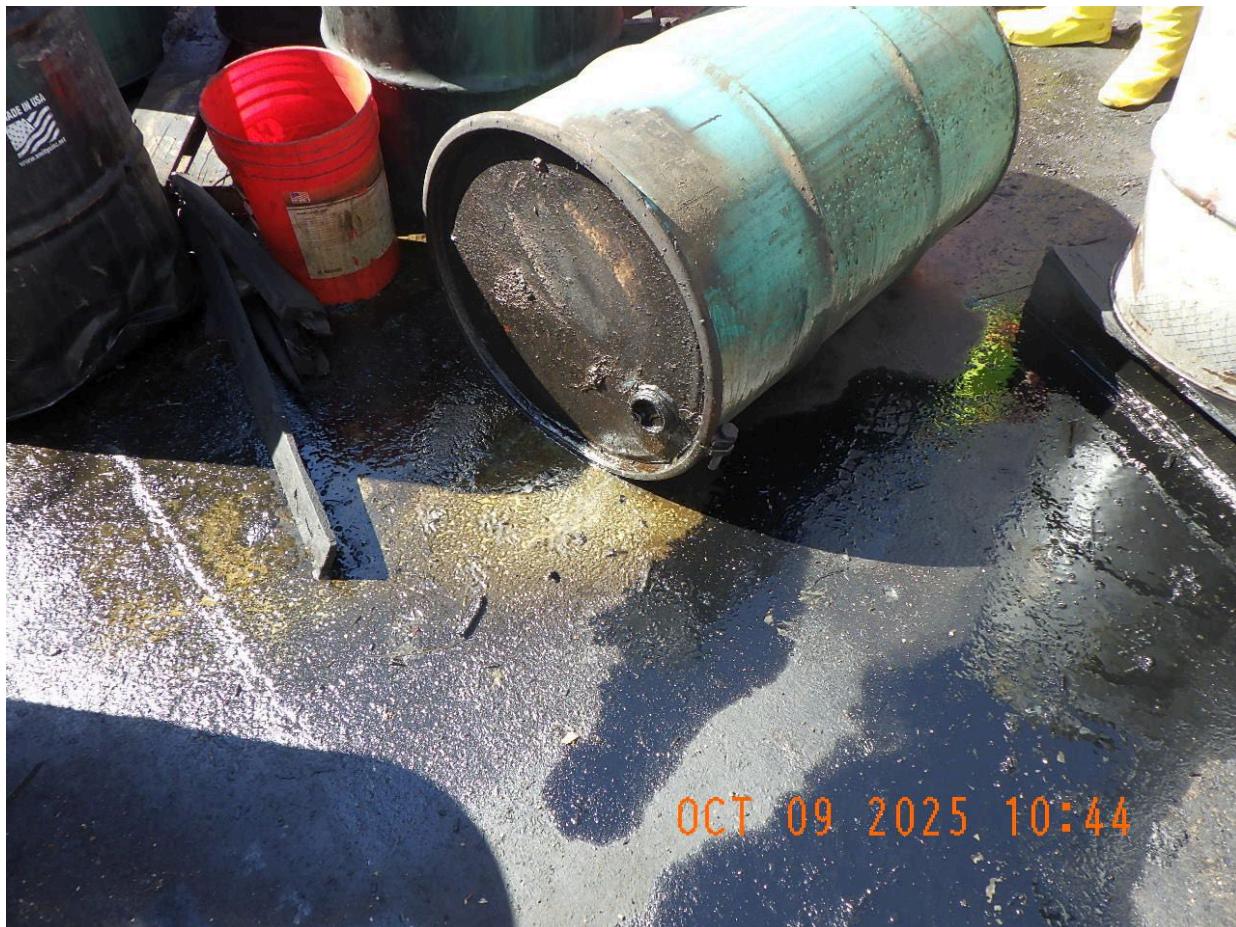
Description:	Outdoor Container Storage Area (Parking lot): Evidence of spill/releases. Oils have emulsified. Damaged drum on left – denting at bottom.		
Latitude:	N/A	Longitude:	N/A

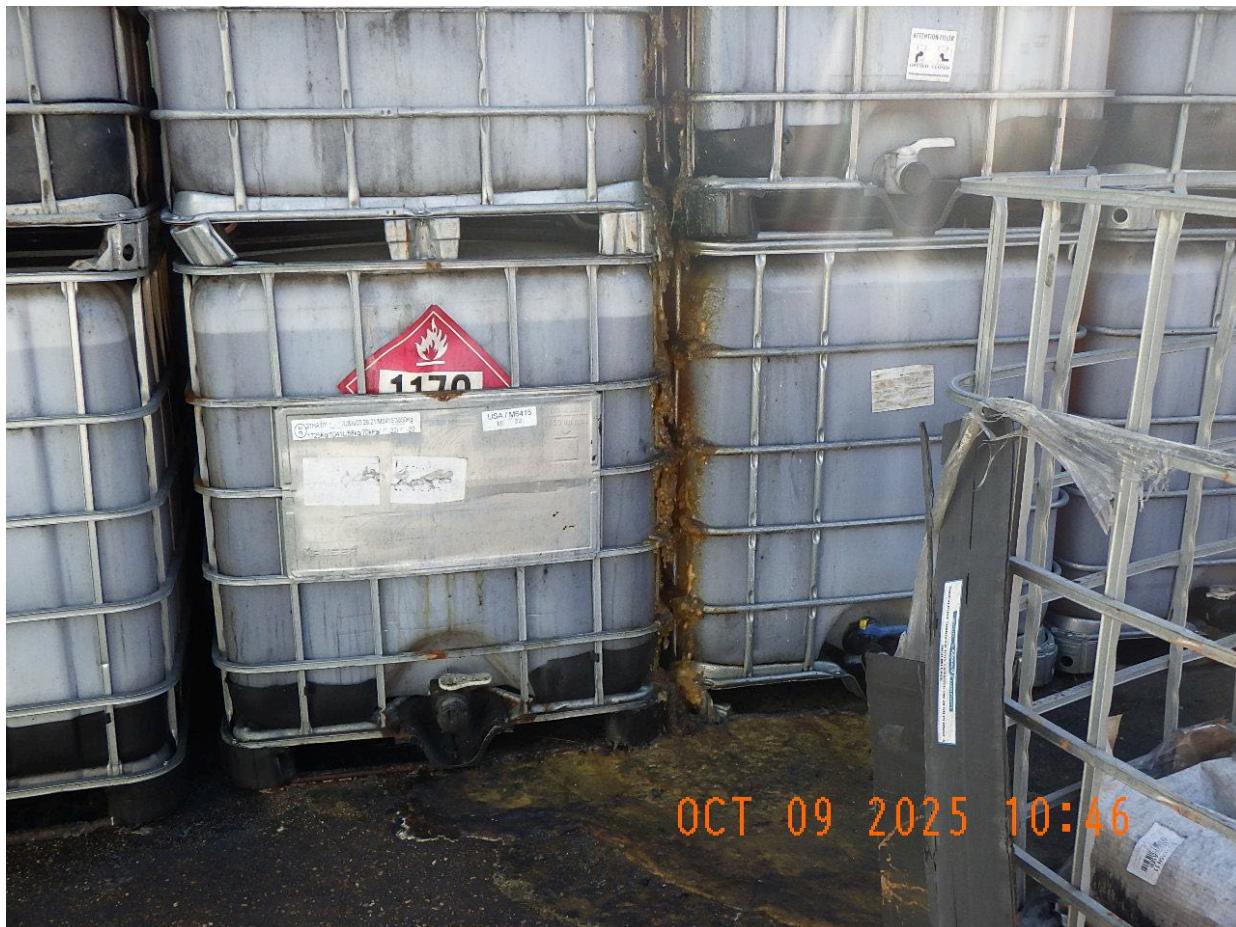
Photo No. 133

Description:	Outdoor Container Storage Area (Parking lot): Several totes stored in the outside storage area not labeled identifying contents. One tote labeled as "flammable." Release on the ground. Oily material on the outside of several totes.		
Latitude:	N/A	Longitude:	N/A

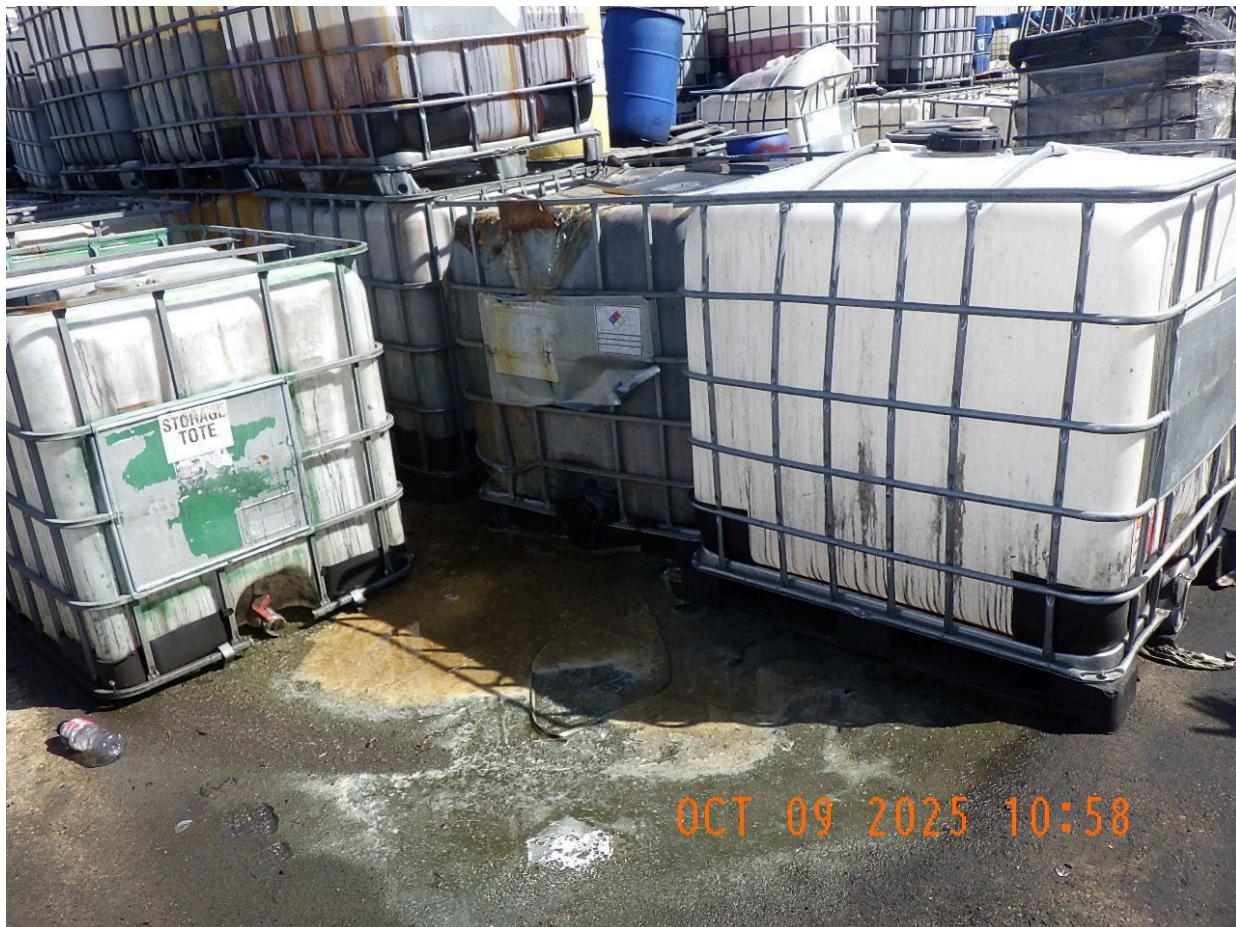
Photo No. 134

Description:	Outdoor Container Storage Area (Parking lot): Unmanaged spill. Oily emulsified oil on ground.		
Latitude:	N/A	Longitude:	N/A

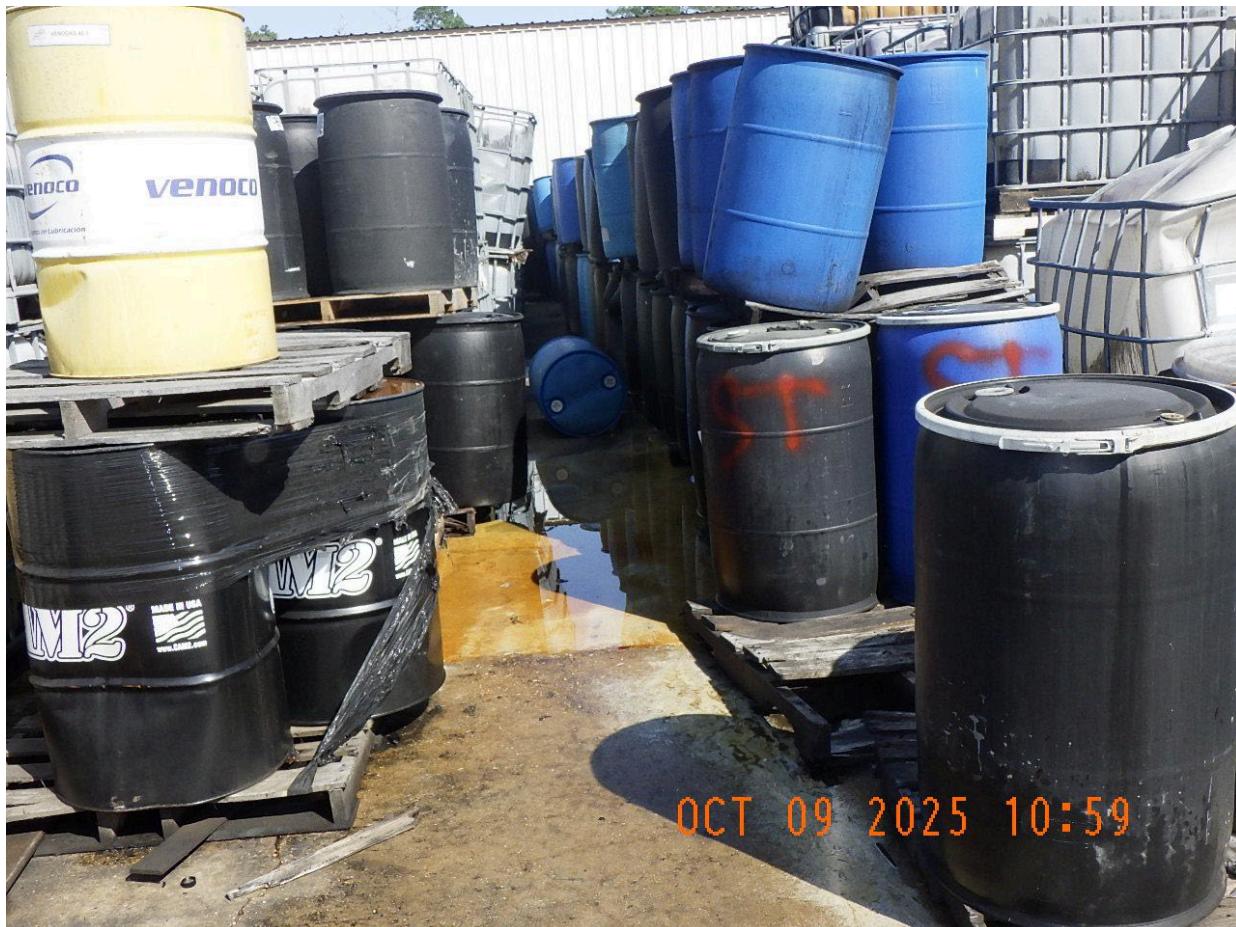
Description:	Outdoor Container Storage Area (Parking lot): Damaged drums and broken pallets. Containers not managed in a way to prevent falling with drum and tote leaning. One drum on side, unlabeled drums, and unmanaged spill on ground with emulsified oils.		
Latitude:	N/A	Longitude:	N/A

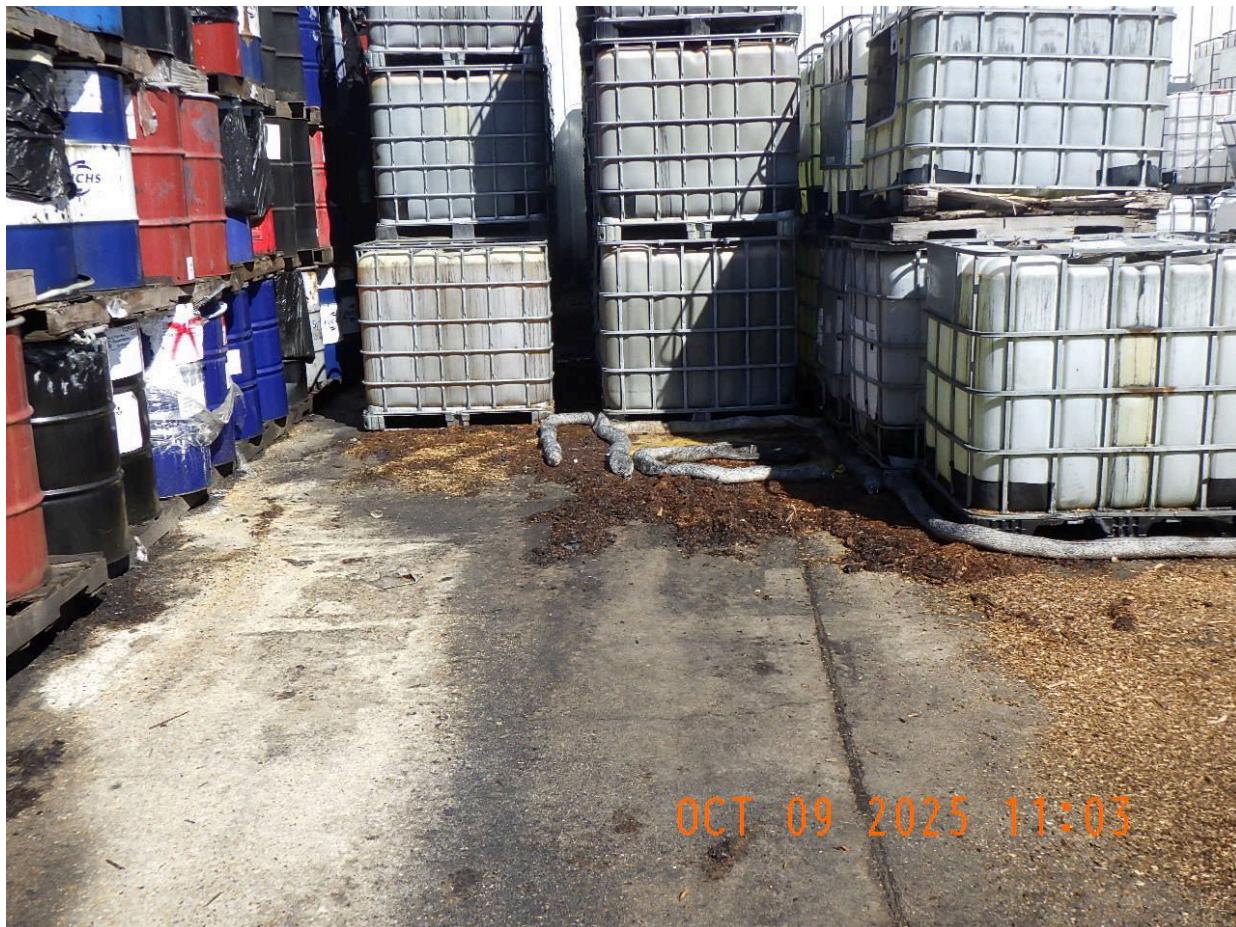
Description:	Outdoor Container Storage Area (Parking lot): Garbage bags placed around damaged drums. Broken pallets, old spills that have not been completely addressed with residual absorbent materials.		
Latitude:	N/A	Longitude:	N/A

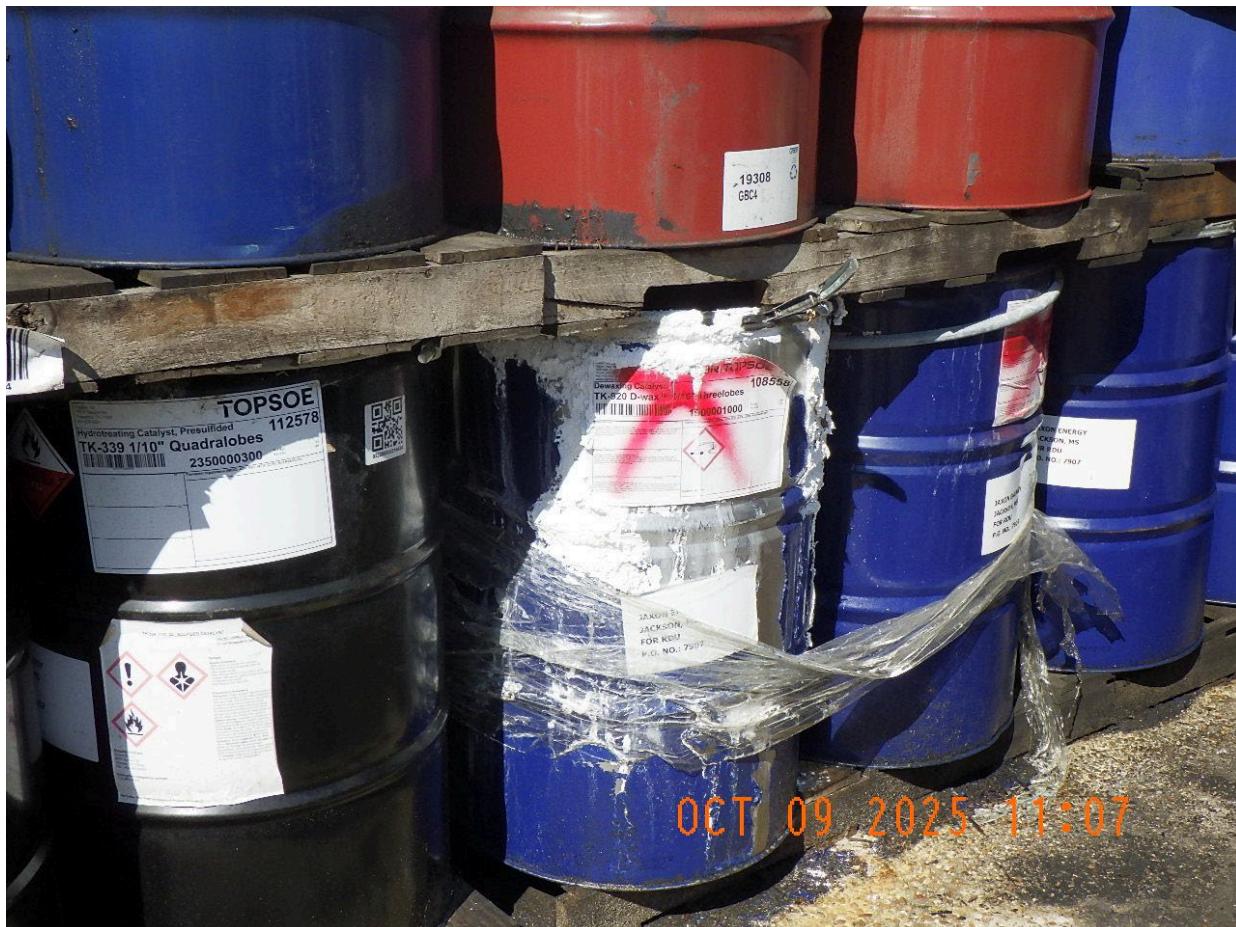
Description:	Outdoor Container Storage Area (Parking lot): Drum corroded with unknown white substance. The white residue is on the outside of the blue container. Black drum next to the corroded drum has a label reading "spontaneously combustible." Unmanaged, used absorbent material on the ground.		
Latitude:	N/A	Longitude:	N/A

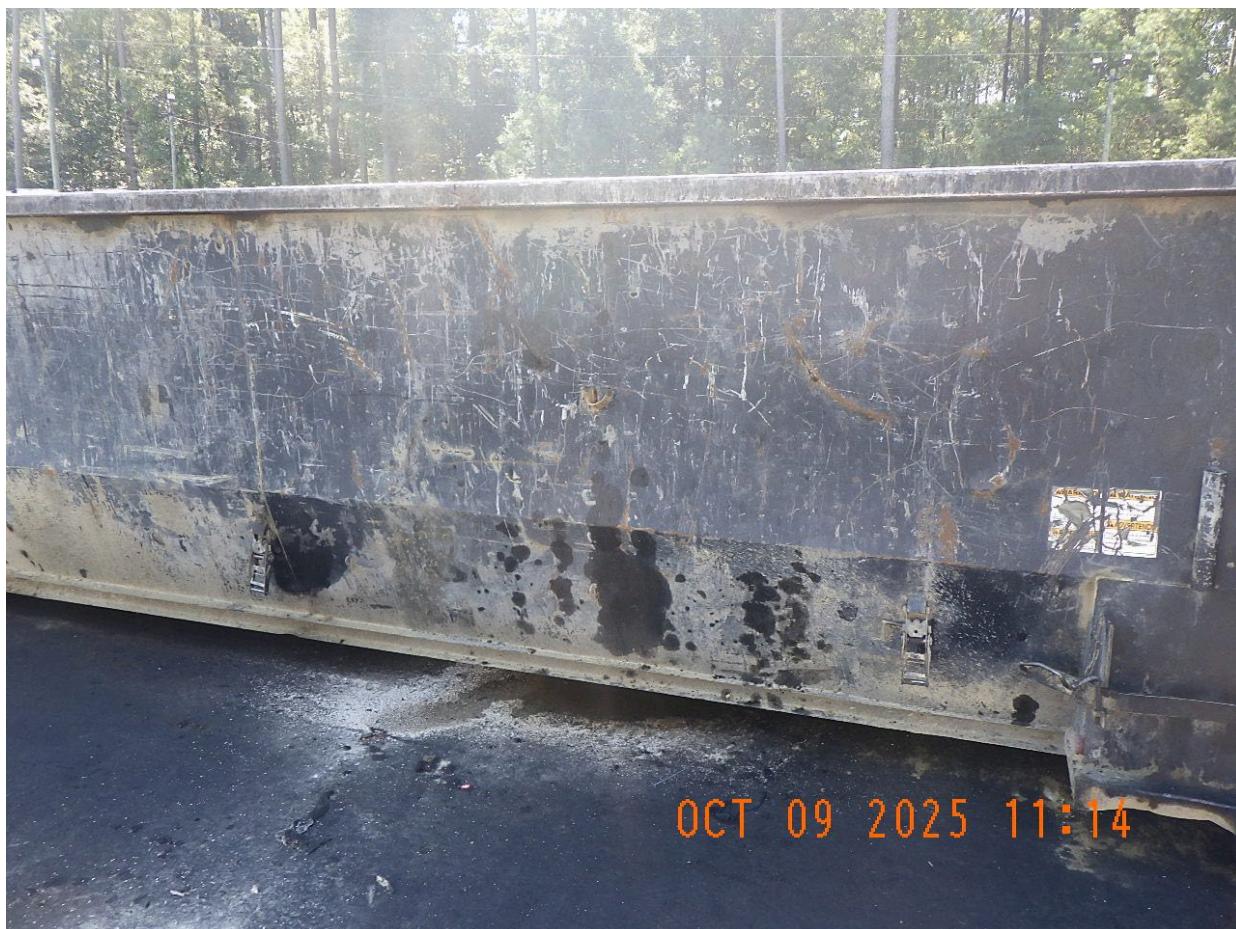
Photo No. 138

Description:	Outdoor Container Storage Area (Parking lot): A black roll-off container releasing an unknown liquid.		
Latitude:	N/A	Longitude:	N/A

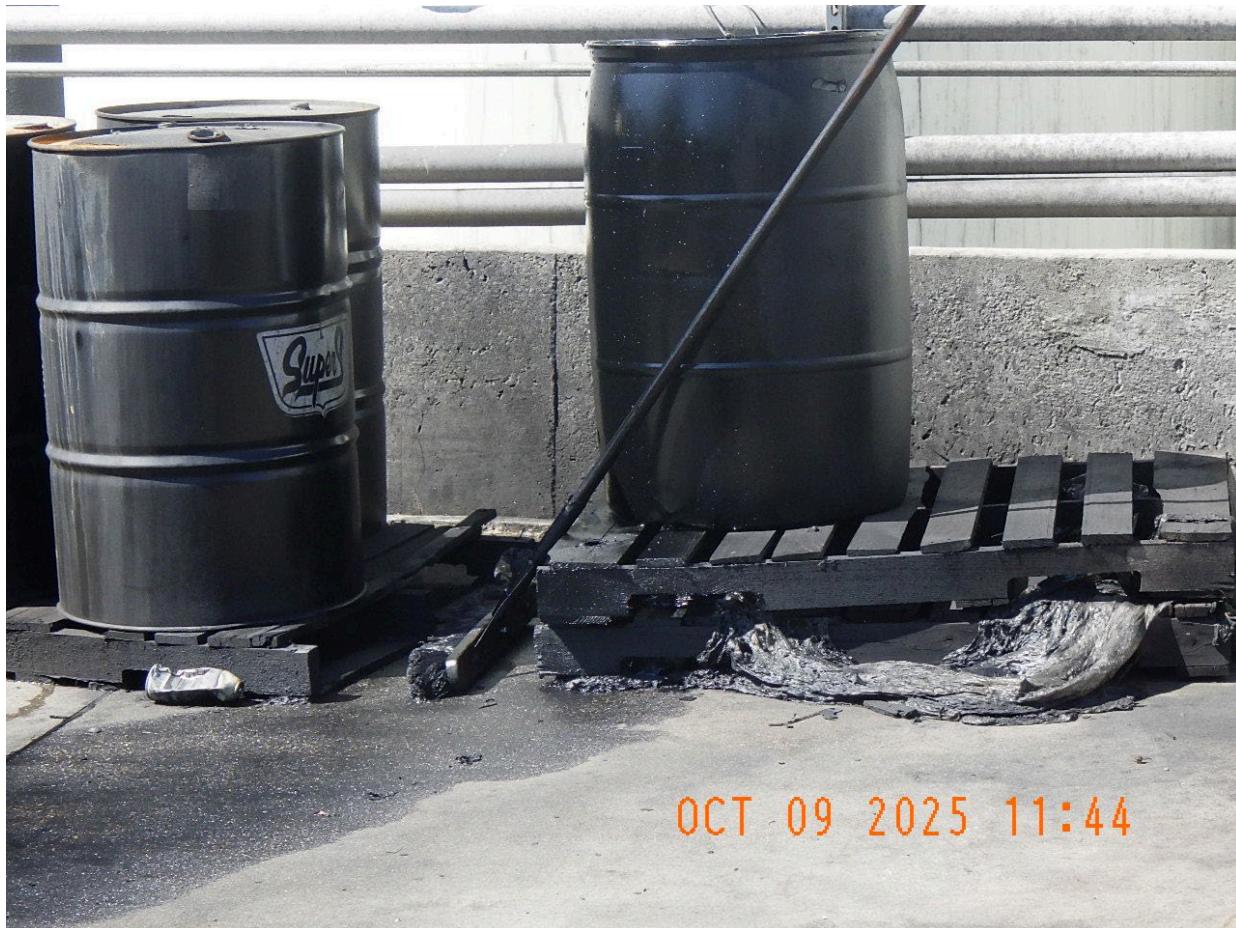
Photo No. 139

Description:	Outdoor Container Storage Area (Parking lot): Unmanaged spill of oil-based liquid. Drums have no identification labels.		
Latitude:	N/A	Longitude:	N/A

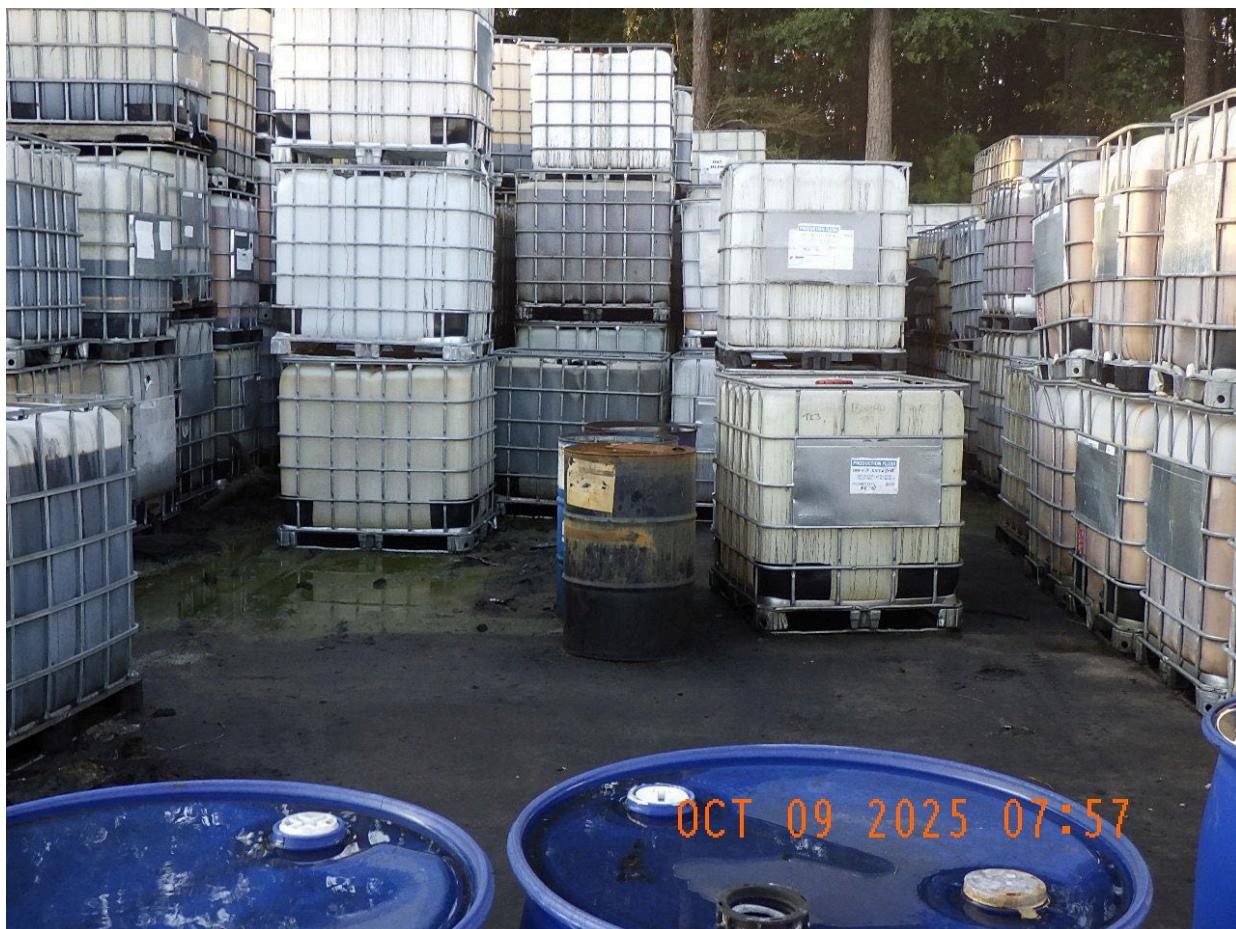
Description:	Outdoor Container Storage Area (Parking lot): Several totes of unknown oily liquids with releases/spills on the floor of the area. The sources of the release/spills are unknown. Totes are not labeled identifying the contents of each tote. Drums in the area are not labeled identifying the contents and are not on a pallet. Inadequate aisle space.		
Latitude:	N/A	Longitude:	N/A

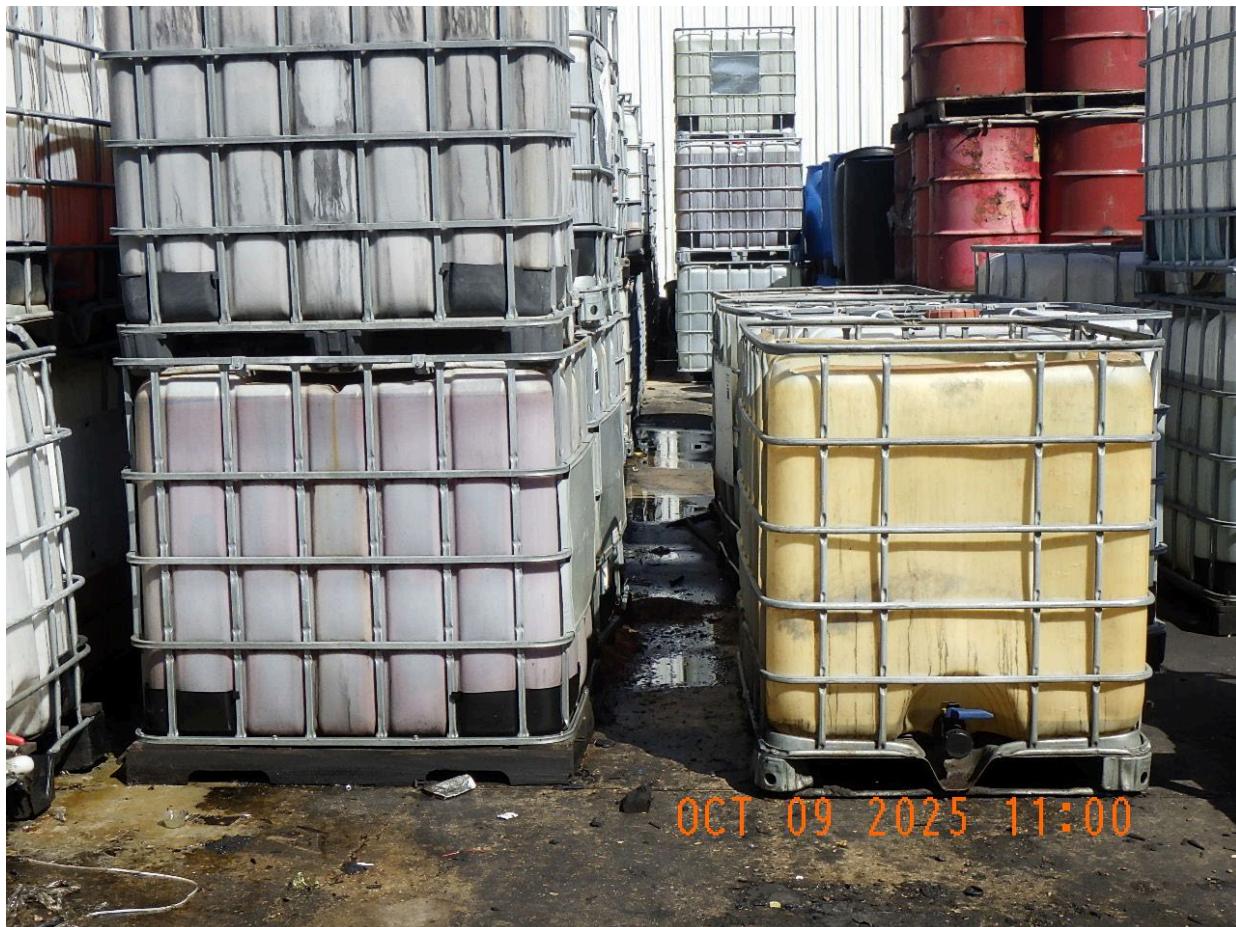
Photo No. 141

Description:	Outdoor Container Storage Area (Parking lot): Several totes of unknown oily liquids with releases/spills on the floor of the area. The sources of the release/spills are unknown. The totes are not labeled identifying the contents of each tote. No aisle space.		
Latitude:	N/A	Longitude:	N/A

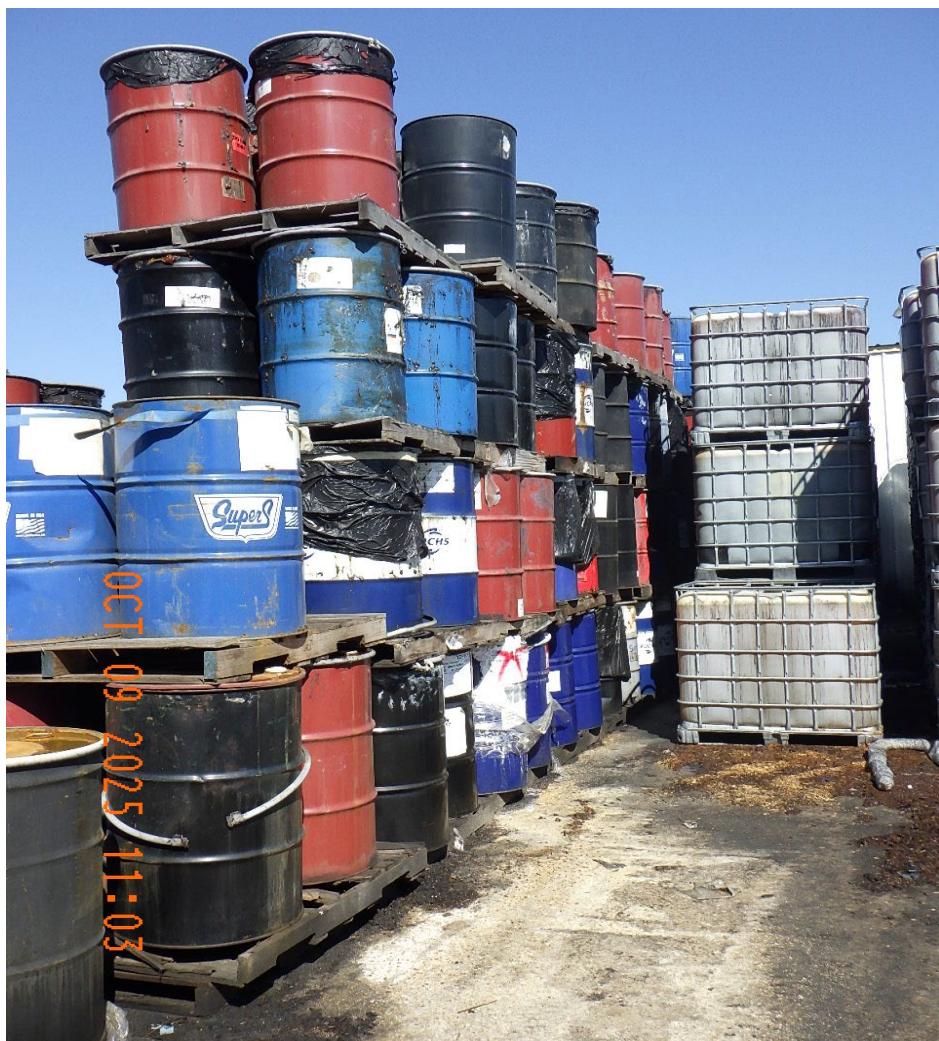
Description:	Outdoor Container Storage Area (Parking lot): Garbage bags placed around damaged drums. Broken pallets, old spills that have not been completely addressed.		
Latitude:	N/A	Longitude:	N/A

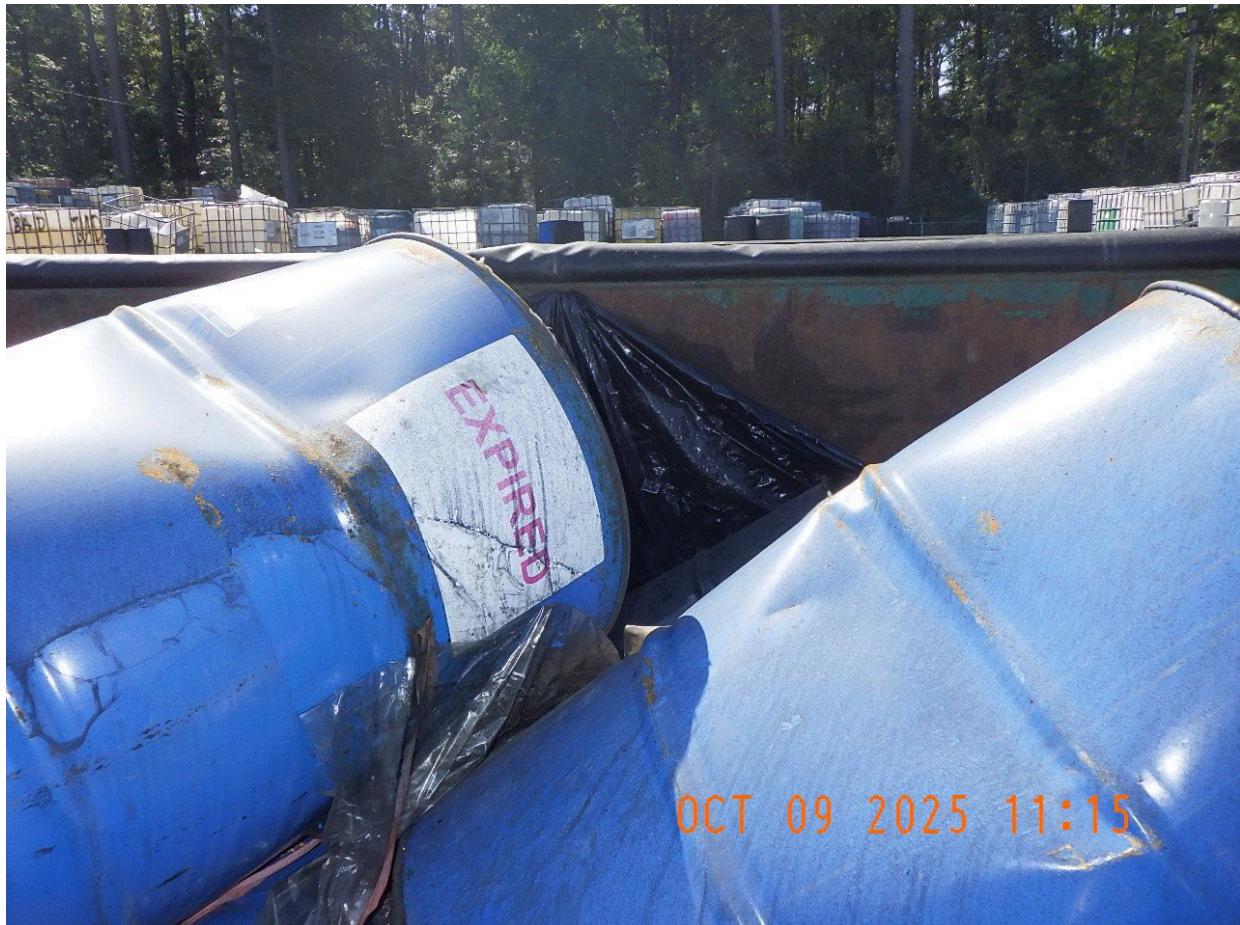
Description:	Outdoor Container Storage Area (Parking lot): Drums labeled "EXPIRED" found in a green roll-off box.		
Latitude:	N/A	Longitude:	N/A

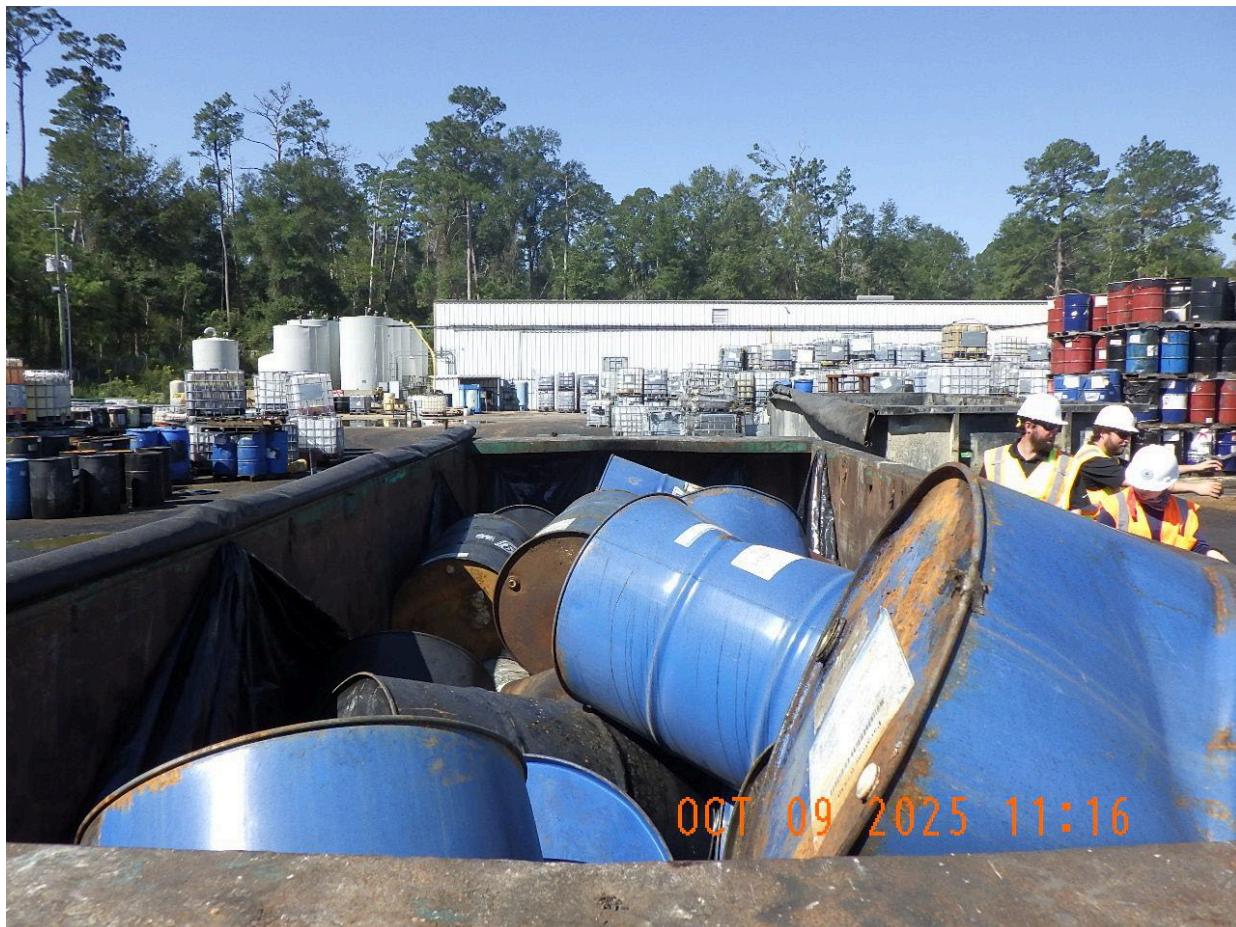
Photo No. 144

drums (one was labeled “expired”) and 6-8” of standing liquid at the bottom (Appendix 3: Photos 143, 144). While the dumpster had a liner, inspectors noted that the liner was damaged, and the contents of the dumpster were in danger of leaking. The black roll-off held various garbage items with standing liquid at the bottom that was leaking out of the dumpster (Appendix 3: Photo 138). Neither of the two roll-off boxes had any sort of labeling to identify their contents or provide evidence of waste determinations, even though one roll-off contained full, unlabeled drums and free liquids within a damaged liner.

Description:	Outdoor Container Storage Area (Parking lot): Overview of contents of green roll-off container - drums of unknown material labeled "expired."		
Latitude:	N/A	Longitude:	N/A

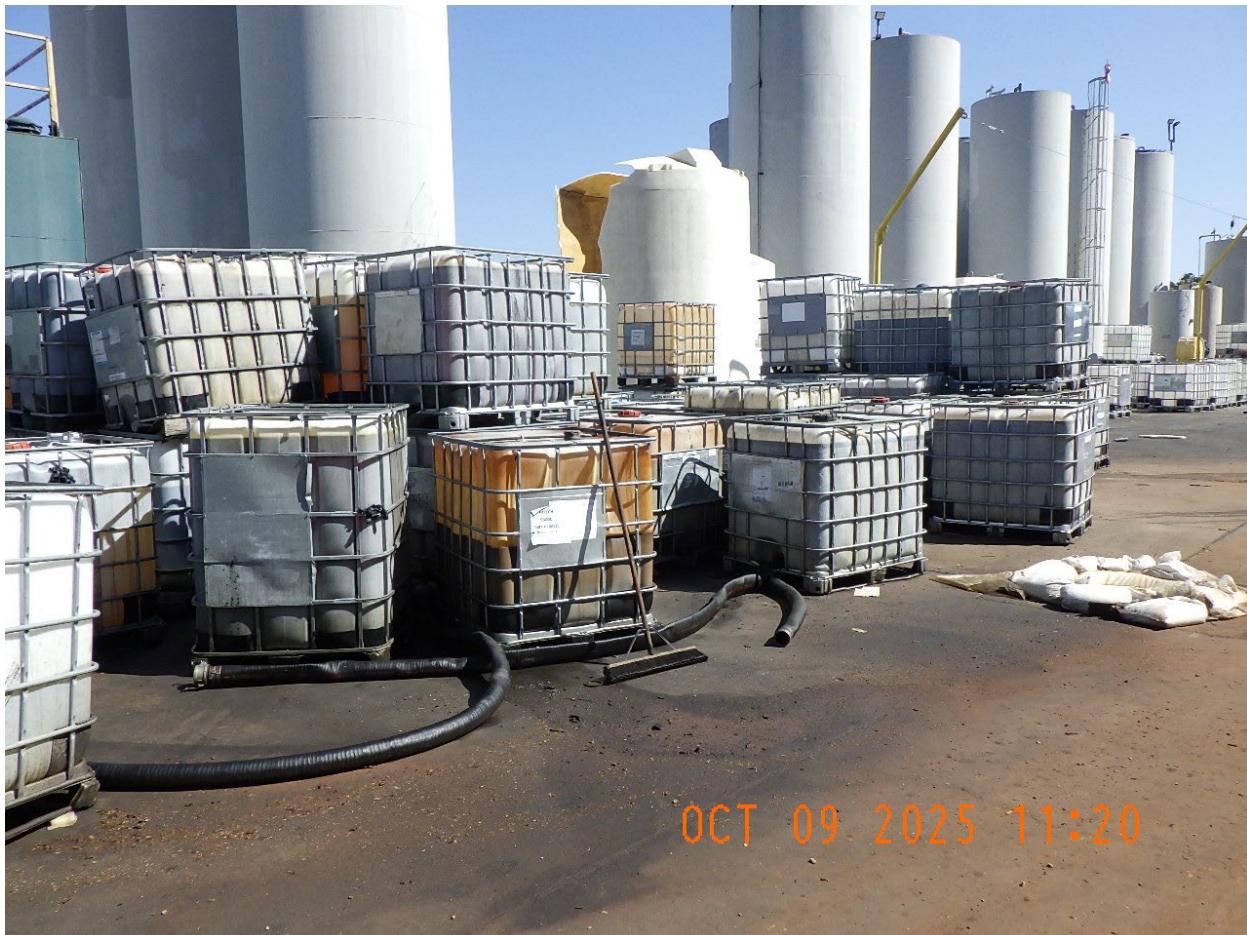
Description:	Outdoor Container Storage Area (Parking lot): Totes are placed haphazardly. One tote is stacked and tilted. Old spill stains and residue on ground.		
Latitude:	N/A	Longitude:	N/A

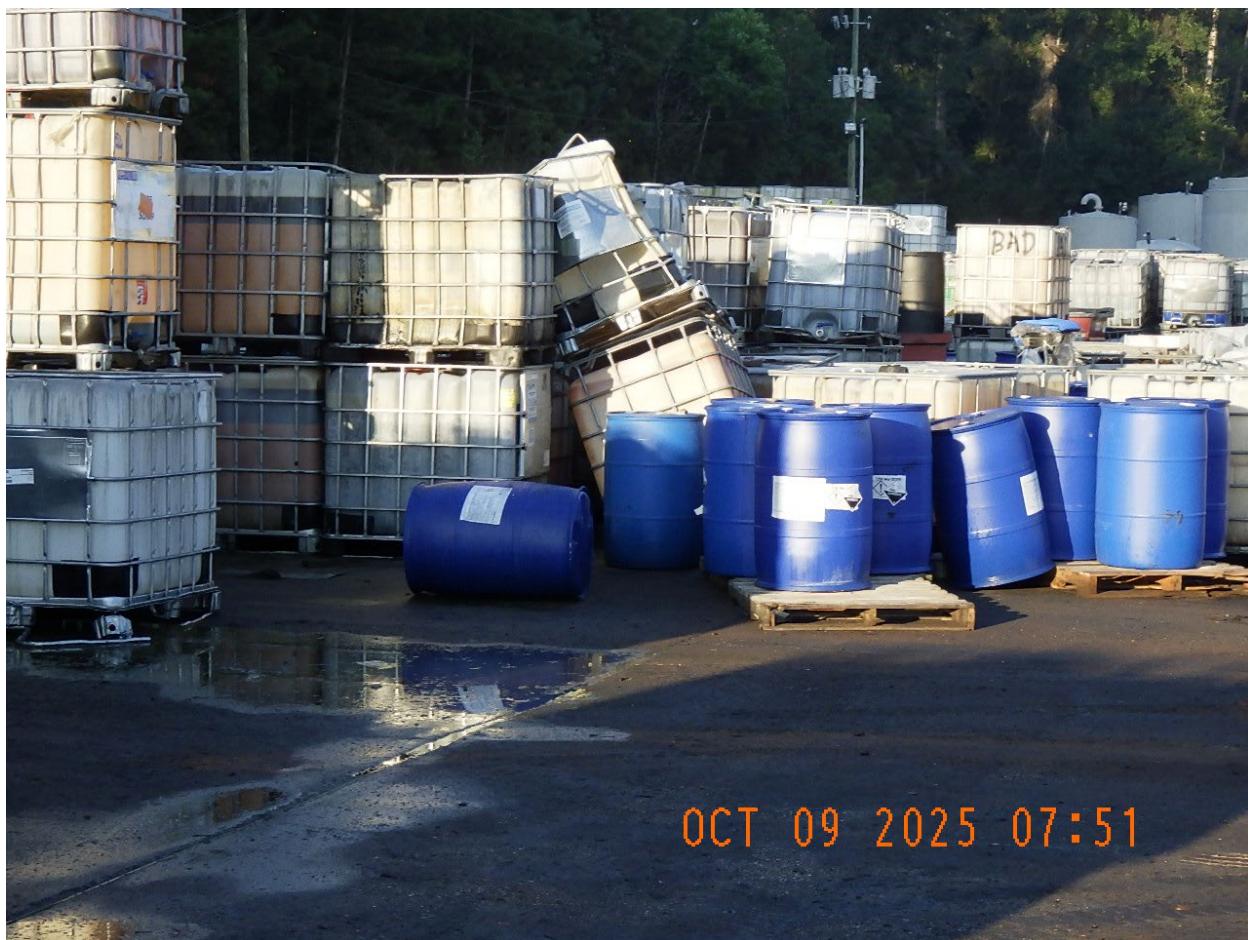
Photo No. 146

In addition to container placement concerns, inspectors also noticed well over 100 containers in poor condition, exhibiting varying degrees of denting, bulging, and corrosion (Appendix 3: Photos 120, 121, 123, 143, 146, 148, 149). Damaged containers included those that appeared to hold fresh product with drums wrapped and belted. Numerous totes had their tops cut off and were overfull with an oily material (Appendix 3: Photos 150 – 152). The totes appeared to overflow and release their contents with each rainfall.

Description:	Outdoor Container Storage Area (Parking lot): Tipped containers of totes and drums. Tote marked "BAD" without other indication of contents (center-right). Three drums not on pallet. Broken pallet. Unmanaged spill on ground.		
Latitude:	N/A	Longitude:	N/A

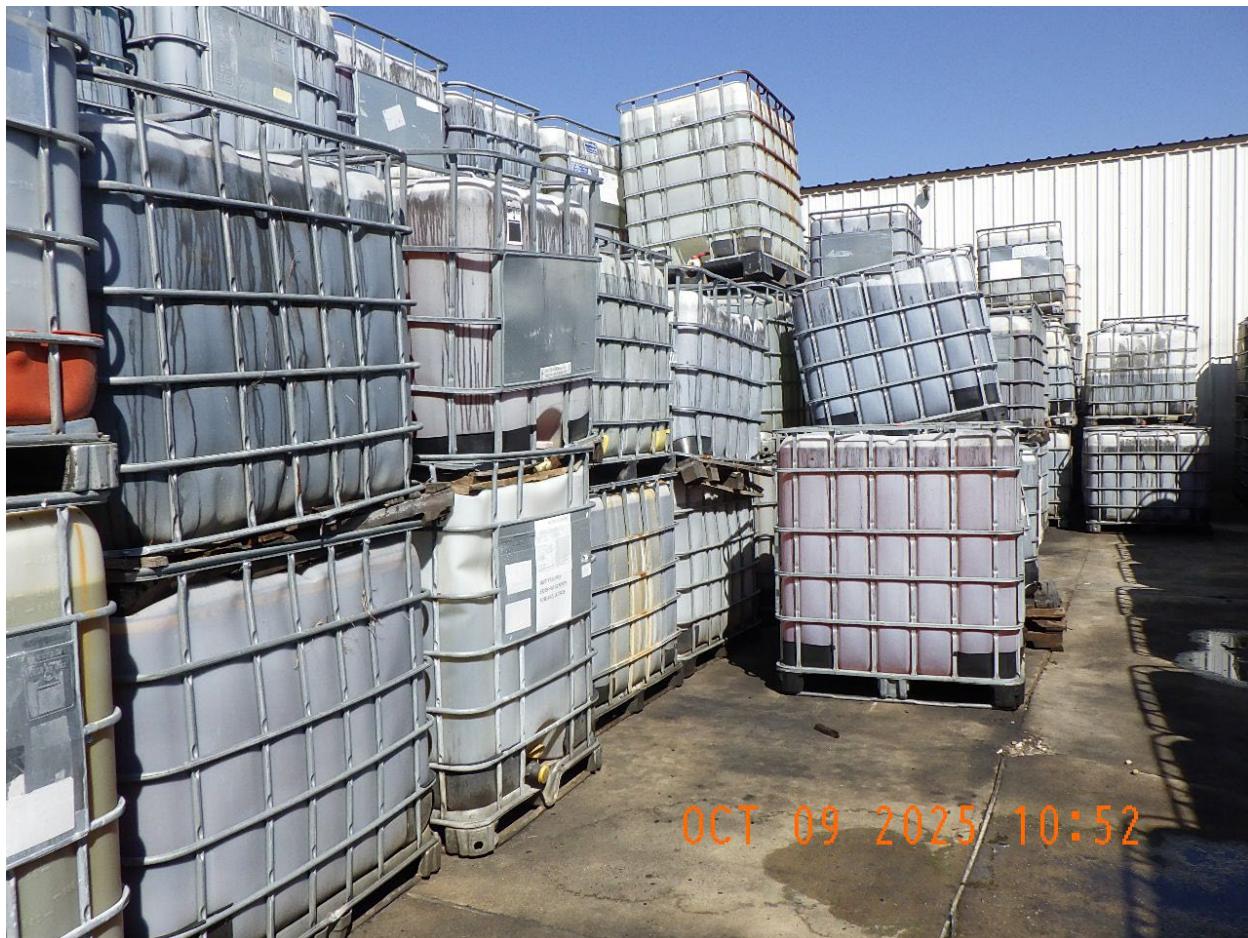
Photo No. 147

Description:	Outdoor Container Storage Area (Parking lot): Stacked totes are tilted. Broken pallets. Active and historic spills on ground.		
Latitude:	N/A	Longitude:	N/A

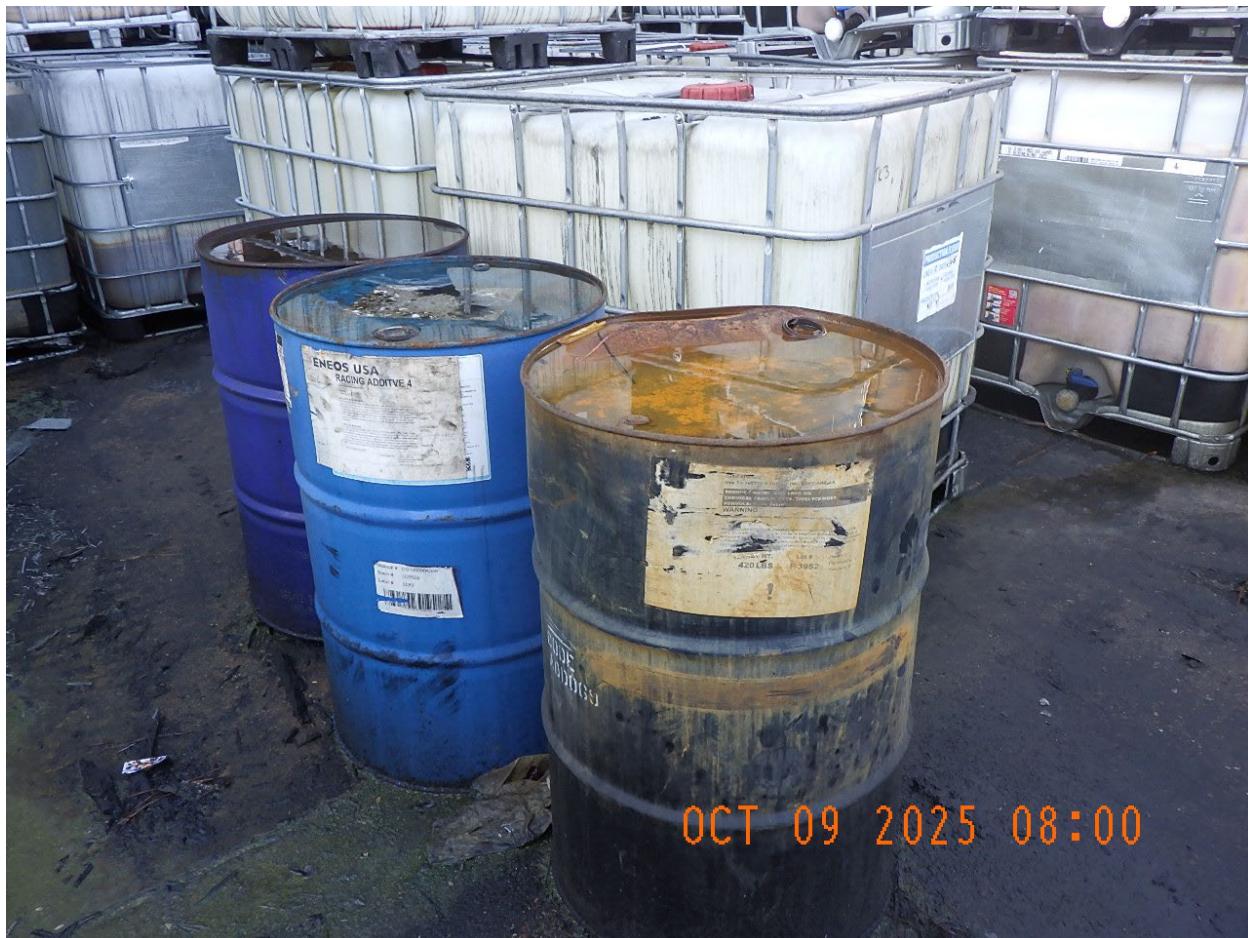
Photo No. 148

Description:	Outdoor Container Storage Area (Parking lot): Old releases on ground. Oil is emulsified. Drums are not on pallet.		
Latitude:	N/A	Longitude:	N/A
