Region 6 - Enforcement & Compliance Assurance Division
INSPECTION REPORT

Inspection Date(s):	10/07/2025 – 10/09/2025	
Media Program:	RCRA	
Regulatory Program(s)	Hazardous Waste, Used Oil	
Company Name:	Smitty's Supply, Inc.	
Facility Name:	Smitty's Supply Roseland	
Facility Physical Location:	63399 Highway 51 N	
(city, state, zip code)	Roseland LA 70456	
Mailing address:	PO Box 530	
(city, state, zip code)	Roseland LA 70456	
County/Parish:	Tangipahoa	
Facility Phone Number	1-800-256-7575	
Facility Contact:	Craig Ellison craigellison@smittysinc.net	
FRS Number:	110016753075	
EPA ID Number:	LAR000078691	
NAICS:	324191 - PETROLEUM LUBRICATING OIL AND GREASE MANUFACTURING	
SIC:	2992 – LUBRICATING OILS AND GREASES 4952 – SEWERAGE SYSTEMS	
Personnel participating in inspection:		
Angela Hays	U.S. EPA – Region 6	Inspector
Erin Young-Dahl	U.S. EPA – Region 6	Inspector
AD Talton	U.S. EPA – Region 6	Inspector
Jimbo Earles	LDEQ	Senior Environmental Scientist
Craig Easley	LDEQ	Senior Environmental Scientist

Section I – INTRODUCTION

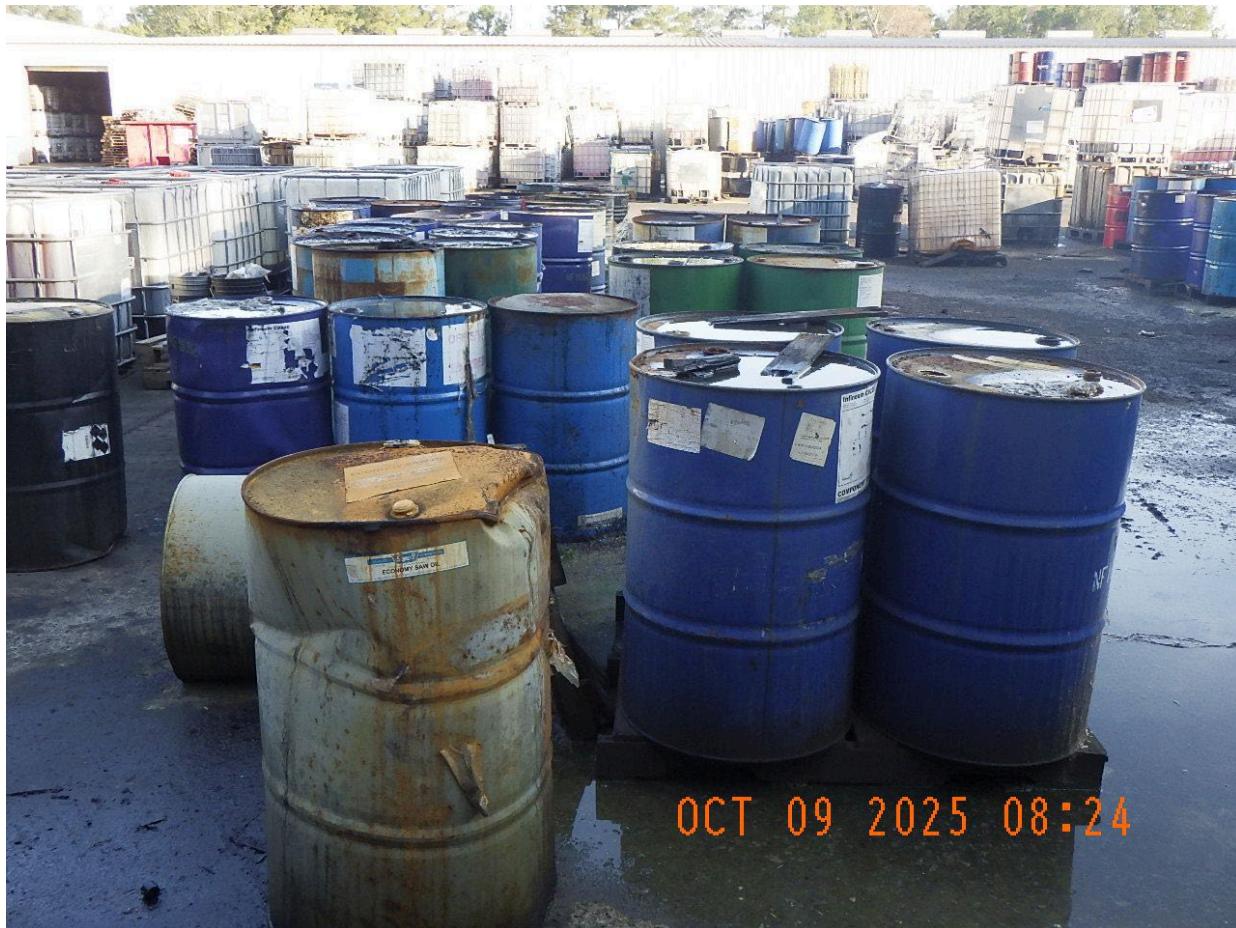
Photo No. 149

In addition to container placement concerns, inspectors also noticed well over 100 containers in poor condition, exhibiting varying degrees of denting, bulging, and corrosion (Appendix 3: Photos 120, 121, 123, 143, 146, 148, 149). Damaged containers included those that appeared to hold fresh product with drums wrapped and belted. Numerous totes had their tops cut off and were overfull with an oily material (Appendix 3: Photos 150 – 152). The totes appeared to overflow and release their contents with each rainfall.

Description:	Outdoor Container Storage Area (Parking lot): Heavily damaged drum (foreground). Six drums not on pallets. Unmanaged spills on ground. One drum on side.		
Latitude:	N/A	Longitude:	N/A

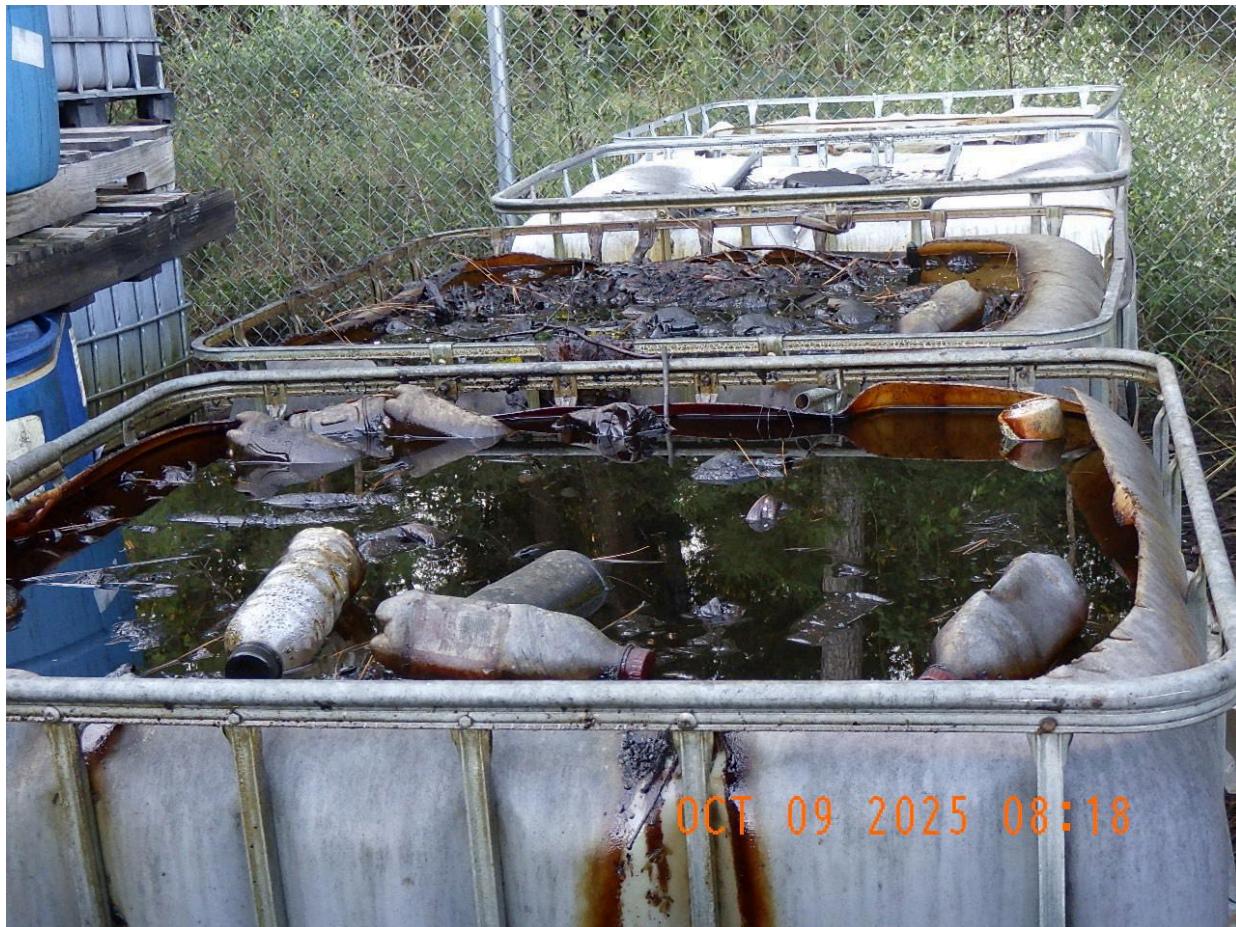
Photo No. 150

Description:	Outdoor Container Storage Area (Parking lot): Totes with tops cut off containing oily liquid and miscellaneous debris.		
Latitude:	N/A	Longitude:	N/A

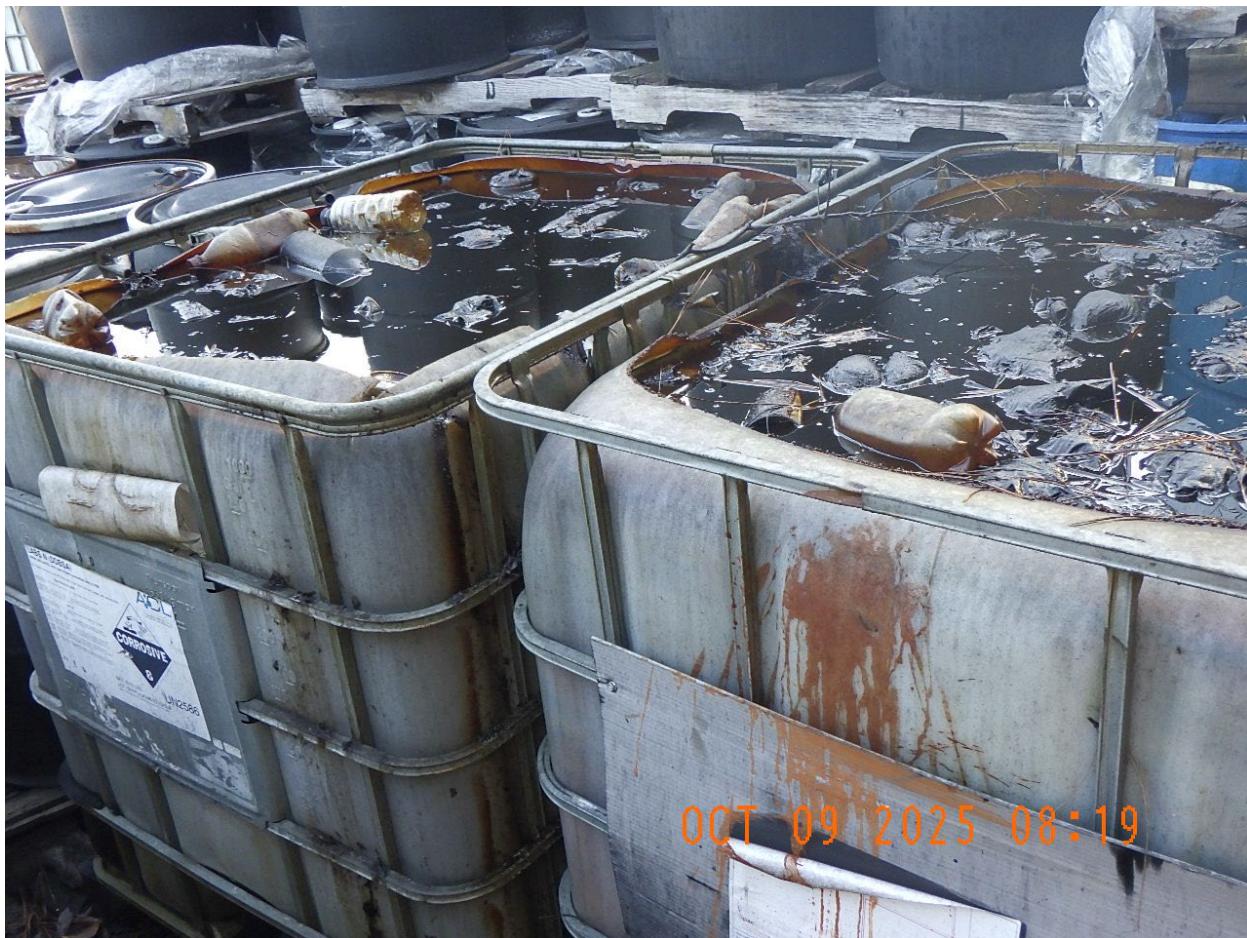
Photo No. 151

Description:	Outdoor Container Storage Area (Parking lot): The top of two totes are cut open. Inside the open tote is an oily liquid with debris. Corrosive placard on left tote.		
Latitude:	N/A	Longitude:	N/A

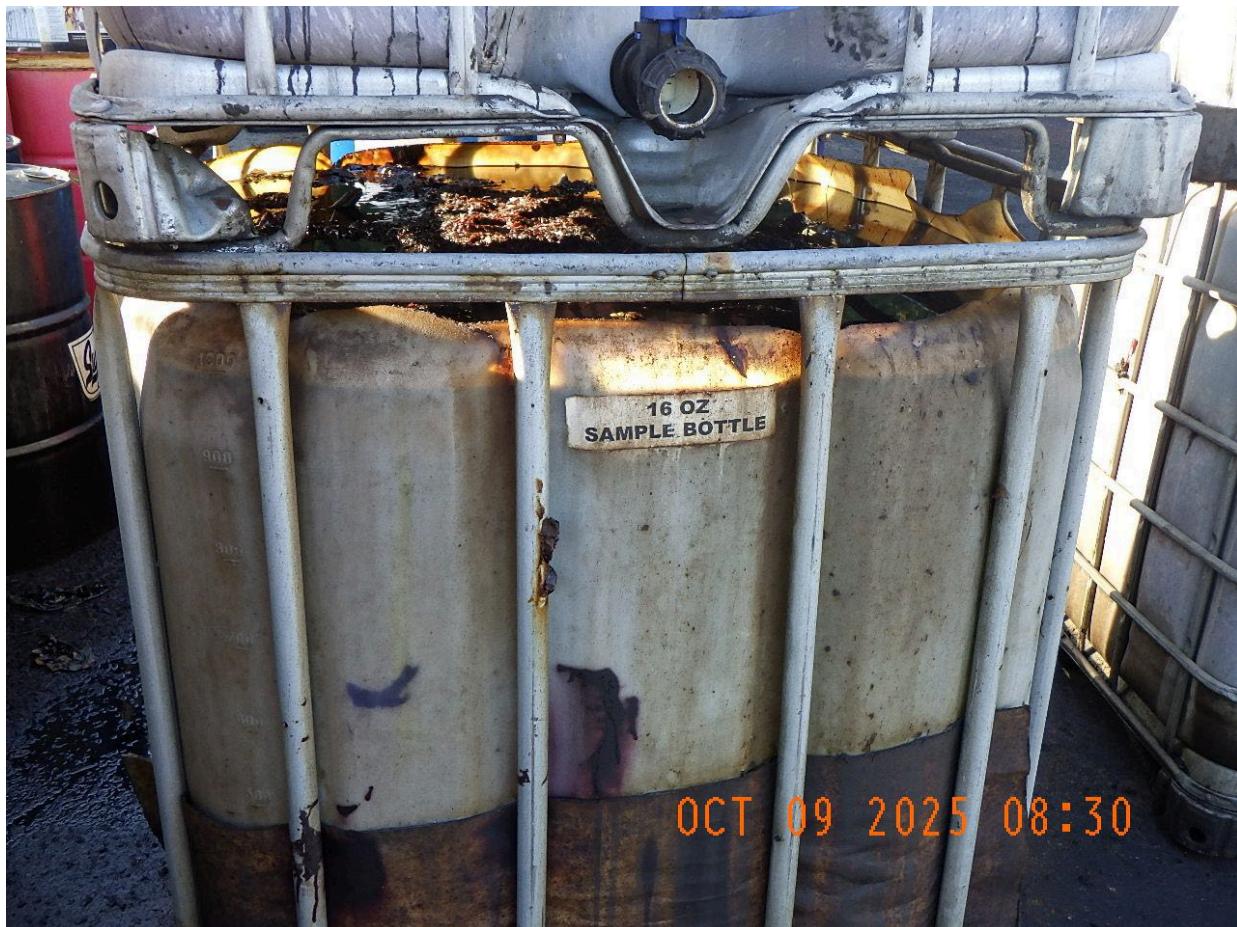
Photo No. 152

Description:	Outdoor Container Storage Area (Parking lot): Tote with top cut open. Inside the open tote is an oily liquid with debris. Labeled as "16 oz sample bottles."		
Latitude:	N/A	Longitude:	N/A

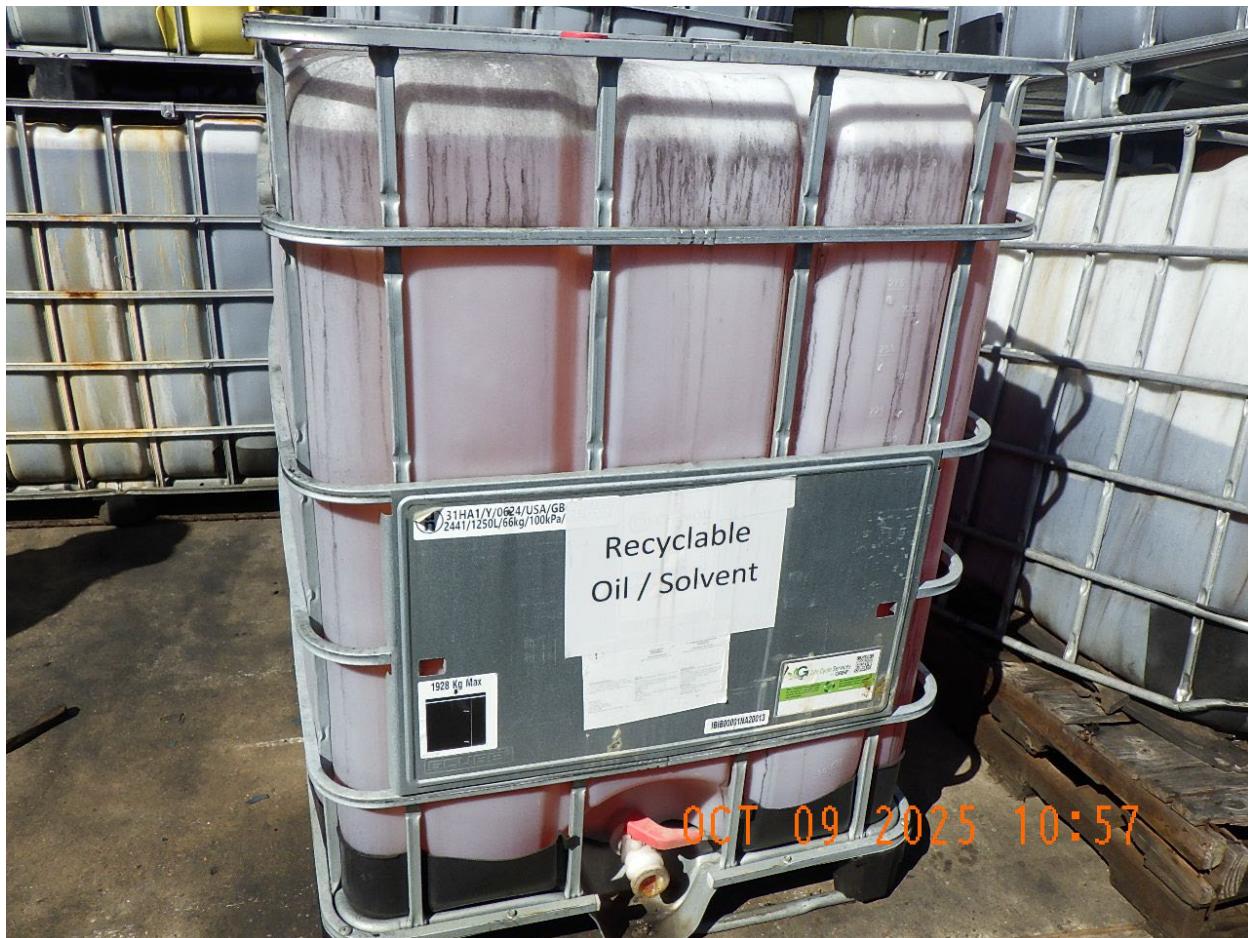
Photo No. 153

Most containers in the outdoor storage area were unlabeled or had old or illegible labeling from previous use (Appendix 3: Photos 153 – 155). At least 100 containers were marked “off spec,” “do not use,” “bad,” “expired,” “approved for disposal,” or had other waste-suggestive labeling (Appendix 3: Photos 156 – 172). Inspectors found one tote labeled “recyclable oil and solvent,” which brought up concerns that some of the used oil onsite at Smitty’s may be contaminated with solvents (Appendix 3: Photo 153). Based on legible labels, inspectors identified some examples of potentially incompatible storage, including an instance where a container with crystalline residue on the outside was placed directly next to a container affixed with a “spontaneously combustible” label (Appendix 3: Photo 137).

Description:	Outdoor Container Storage Area (Parking lot): Tote labeled recyclable oil / solvent. Not properly labeled with date of accumulation for recycling tracking.		
Latitude:	N/A	Longitude:	N/A

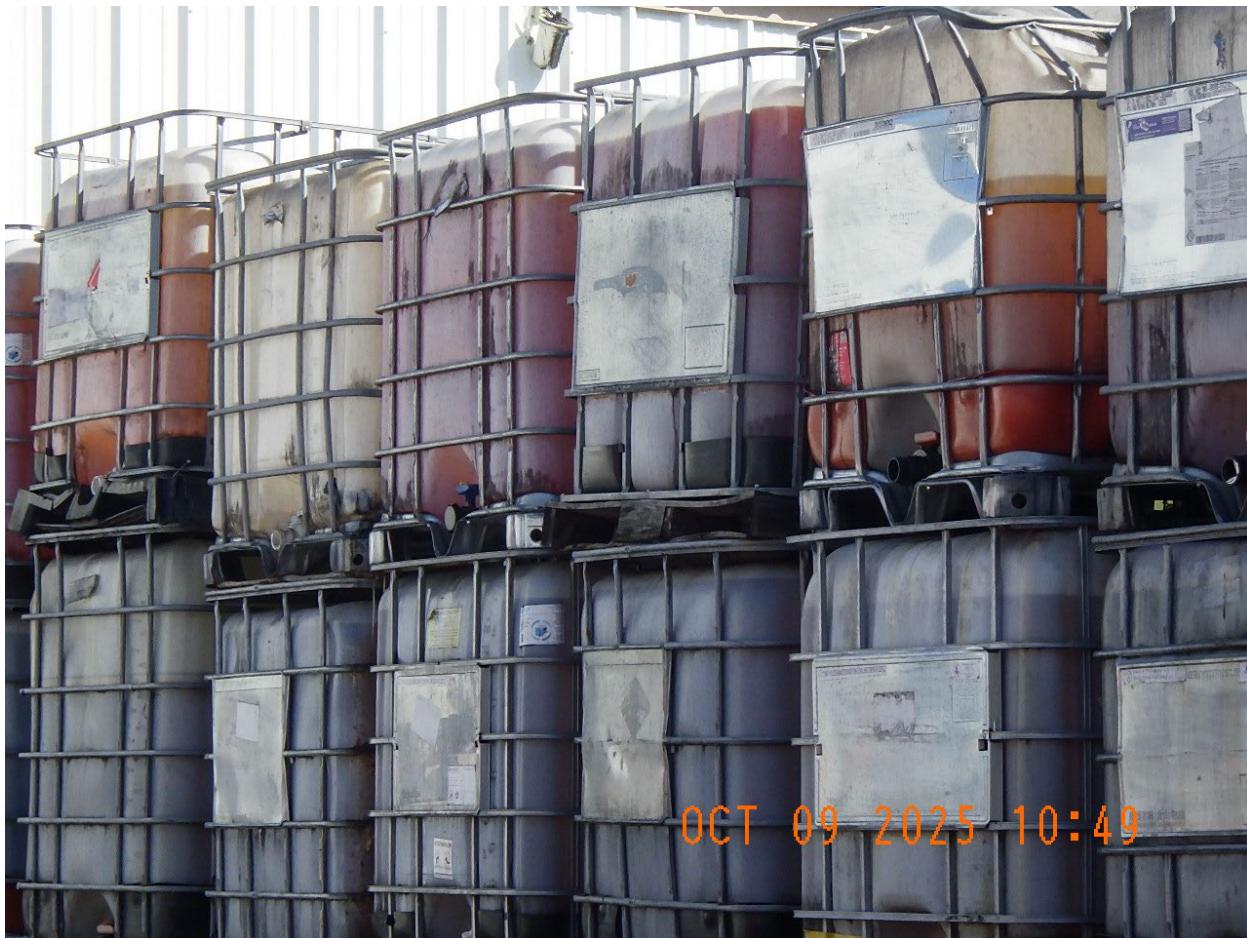
Photo No. 154

Description:	Outdoor Container Storage Area (Parking lot): Totes with no labeling.		
Latitude:	N/A	Longitude:	N/A

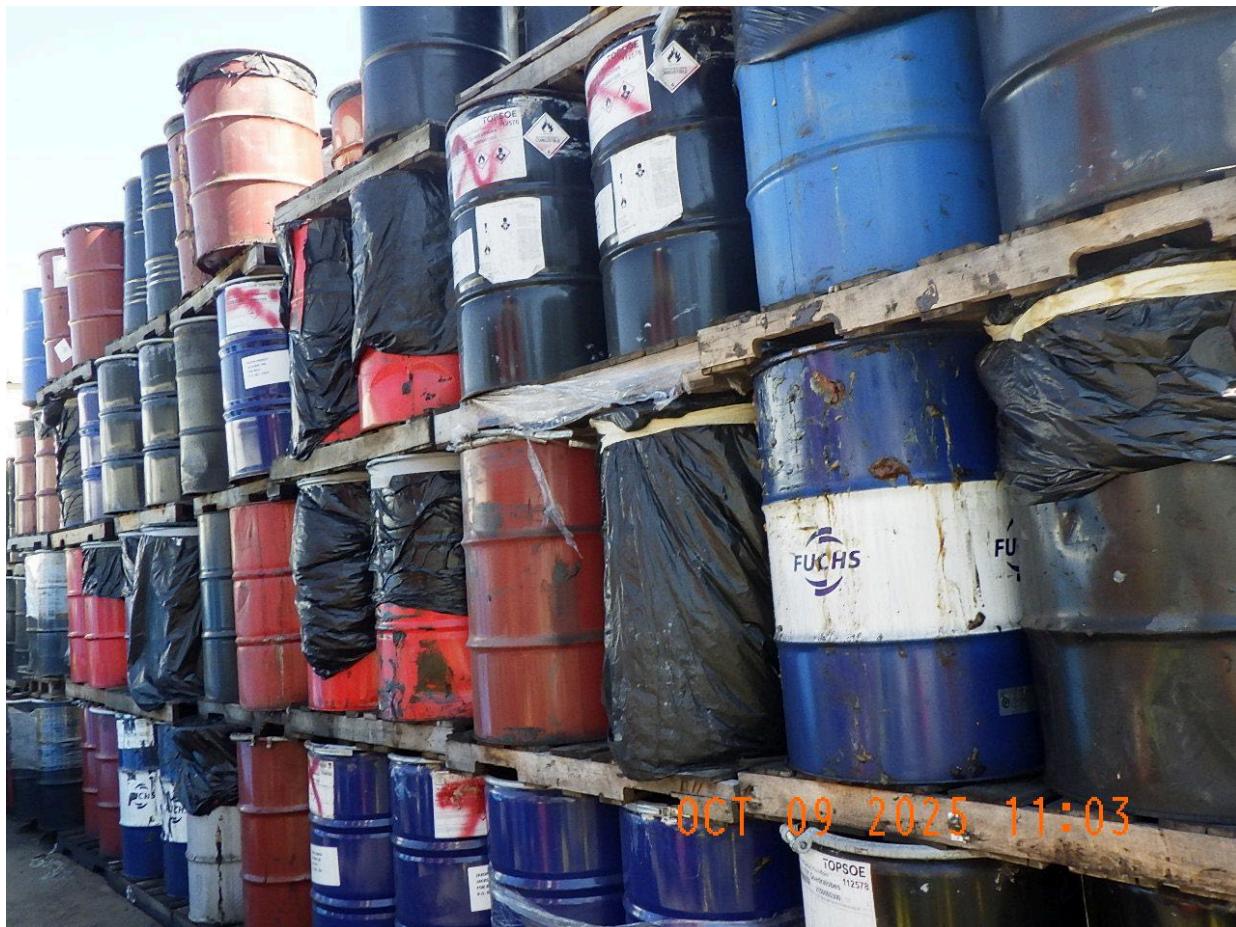
Photo No. 155

Description:	Outdoor Container Storage Area (Parking lot): Drums stacked 4 levels high without clear labels and limited aisle spacing. Labels on many drums are crudely crossed out, and most are not visibly labeled. Some of the drums are covered with trash bags.		
Latitude:	N/A	Longitude:	N/A

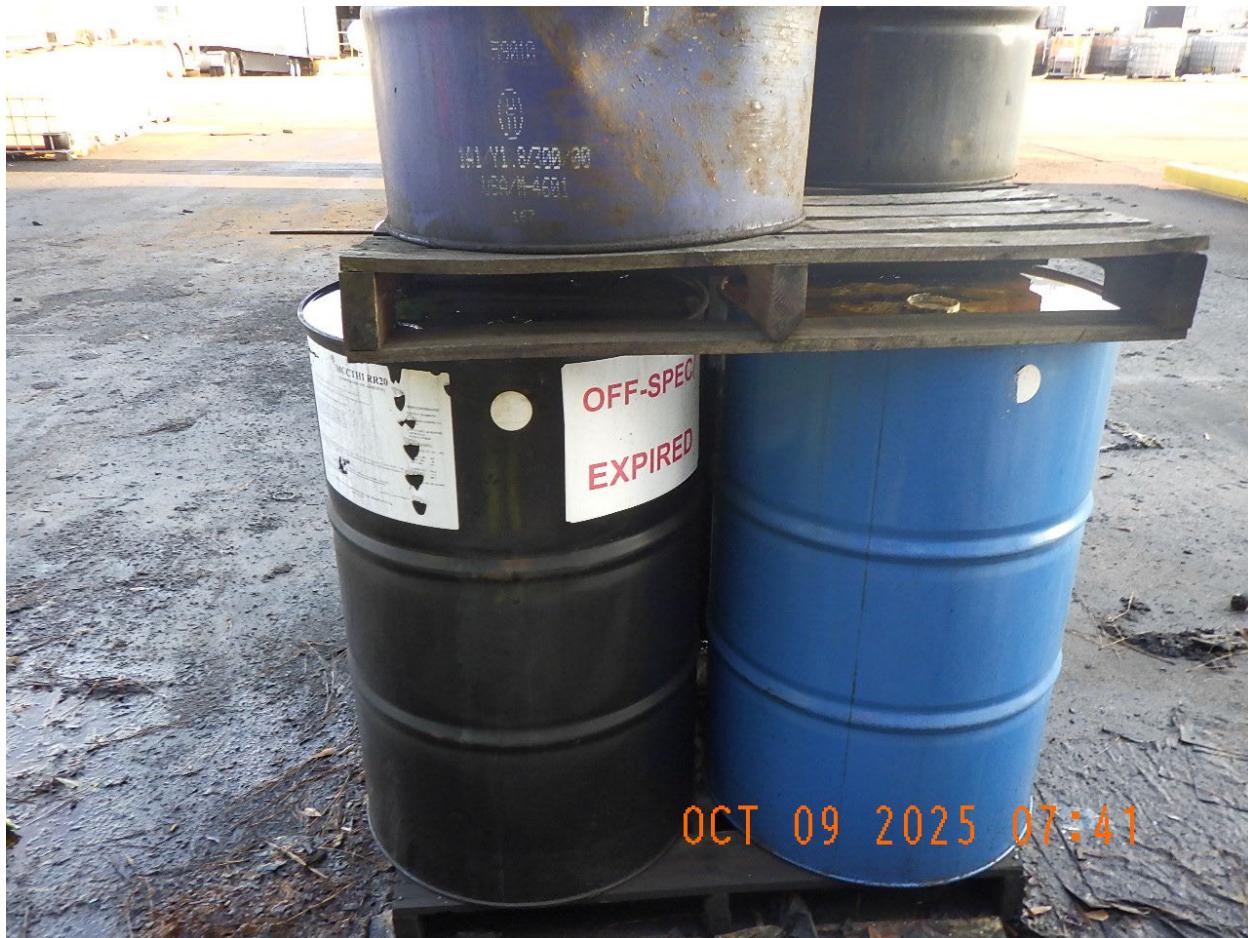
Photo No. 156

Description:	Outdoor Container Storage Area (Parking lot): Drum labeled "OFF-SPEC/EXPIRED." No accumulation date. Historic unmanaged spills on ground.		
Latitude:	N/A	Longitude:	N/A

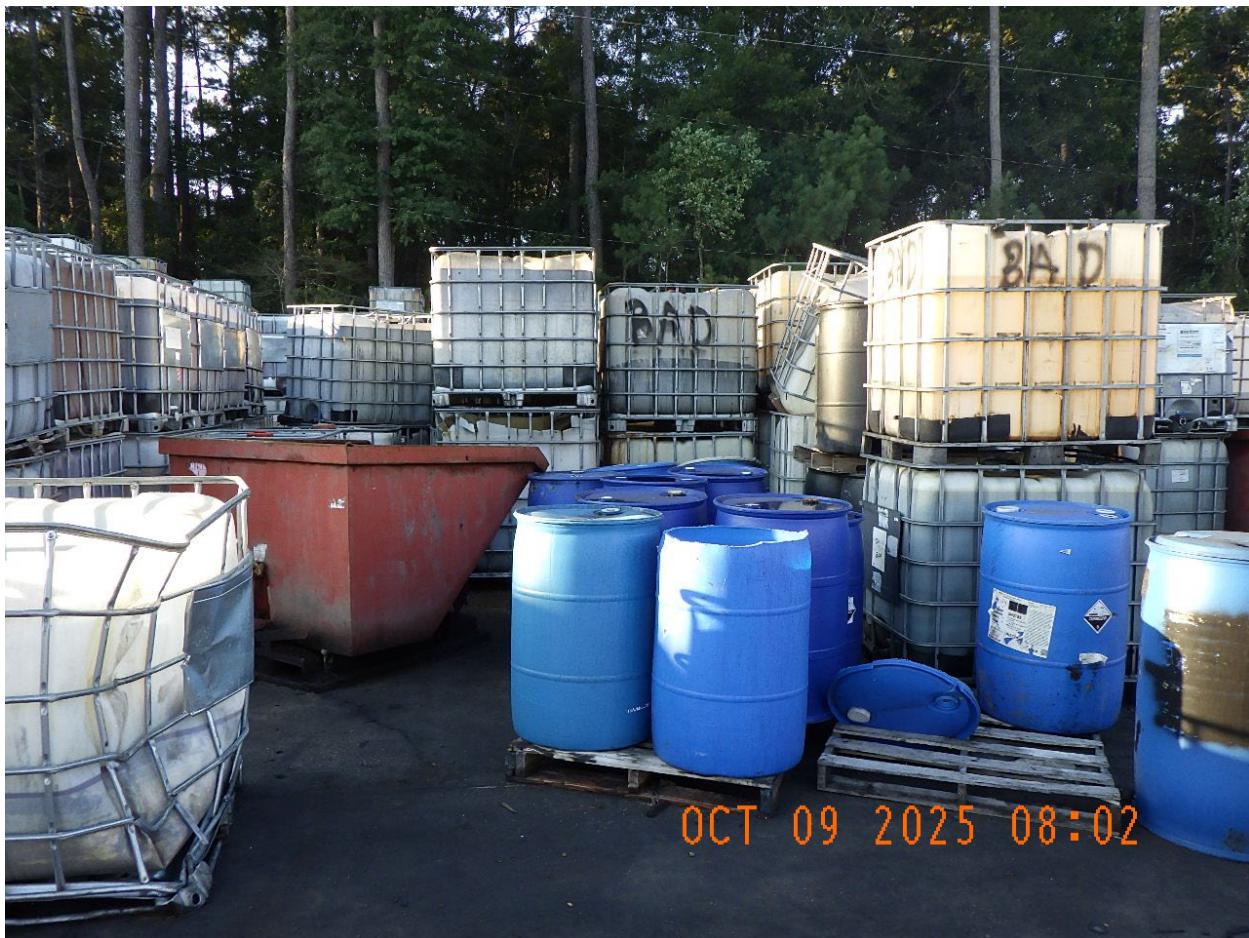
Photo No. 157

Description:	Outdoor Container Storage Area (Parking lot): Damaged containers, tilting tote, two totes marked "BAD" with no additional labeling.		
Latitude:	N/A	Longitude:	N/A

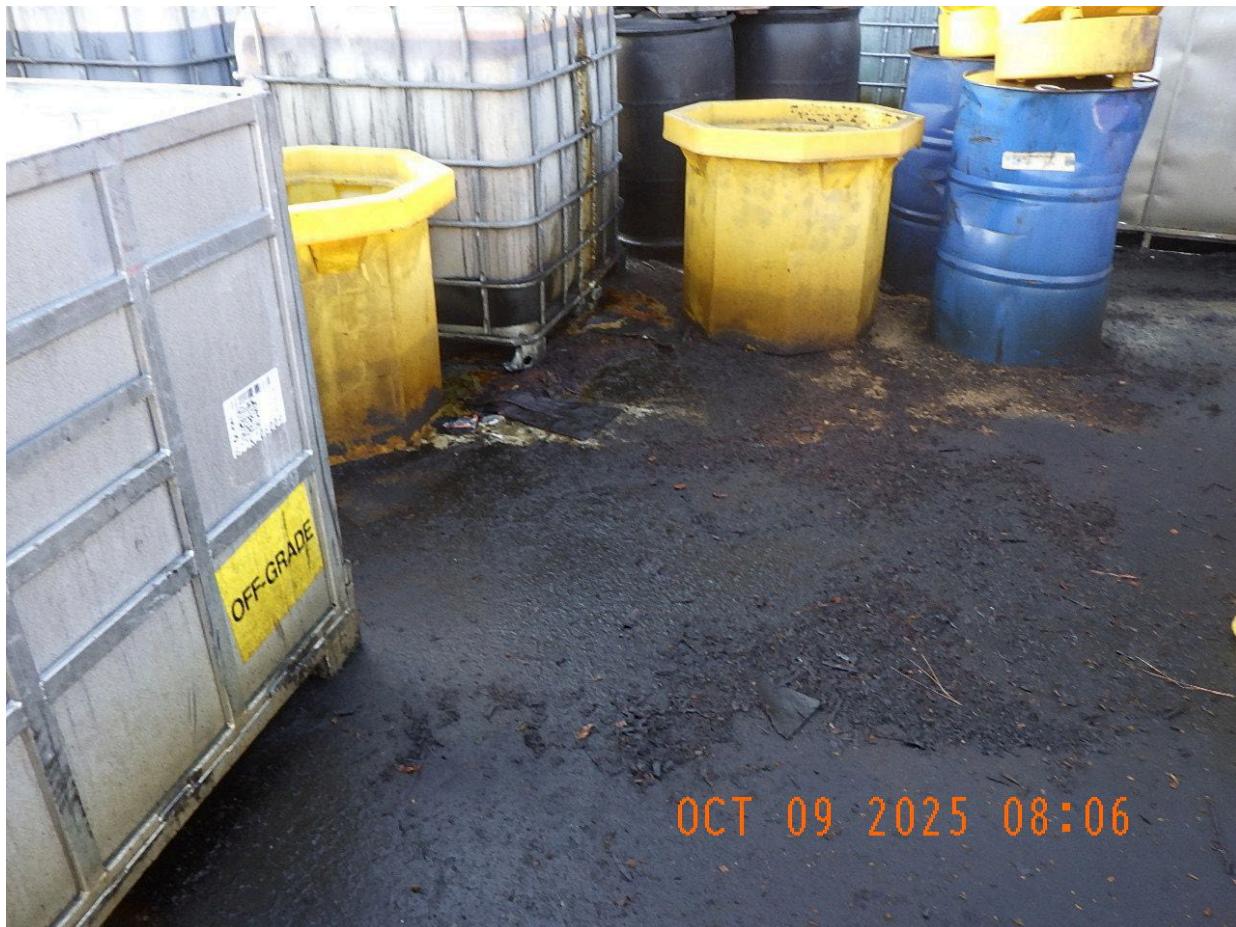
Photo No. 158

Description:	Outdoor Container Storage Area (Parking lot): Historic, unmanaged spill on ground. Metal box marked "OFF-GRADE." Four drums not on pallet, two appear damaged. Yellow overpack drums are unlabeled and contain unidentified material.		
Latitude:	N/A	Longitude:	N/A

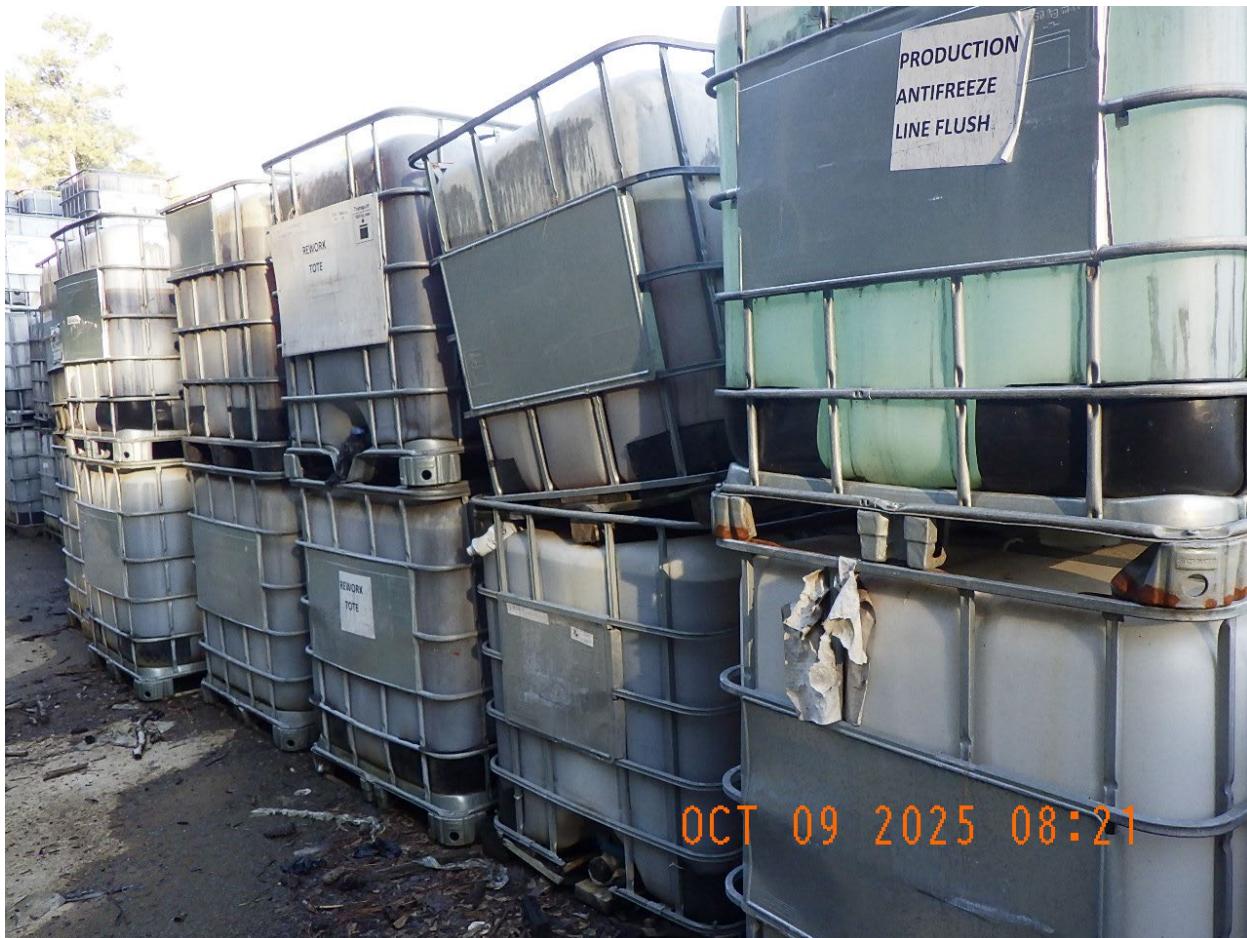
Photo No. 159

Description:	Outdoor Container Storage Area (Parking lot): Tilted stacked tote. Historic, unmanaged spills on ground. Unidentifiable totes with two marked "rework" and one "production antifreeze line flush".		
Latitude:	N/A	Longitude:	N/A

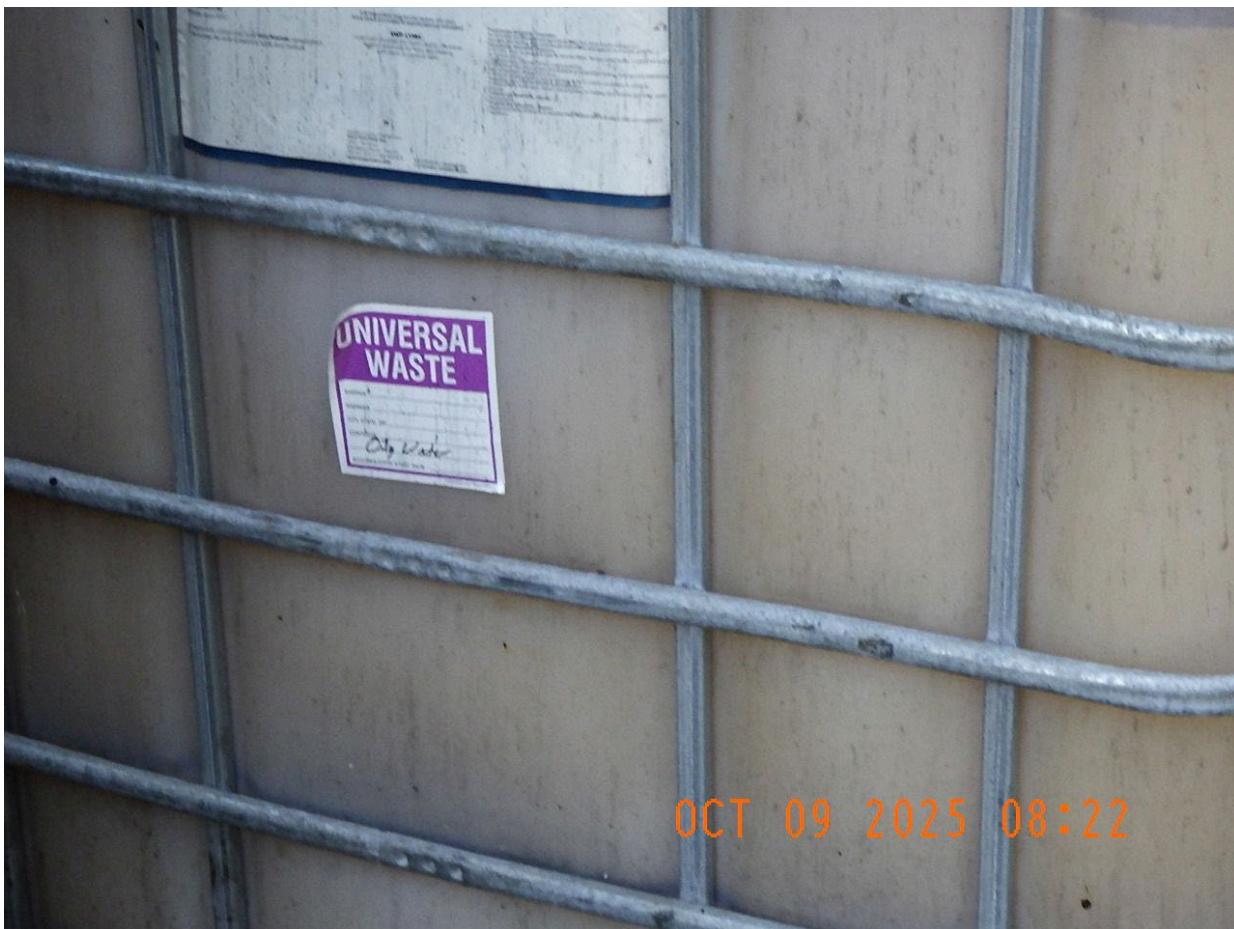
Photo No. 160

Description:	Outdoor Container Storage Area (Parking lot): A tote of unknown oily liquid labeled "Universal Waste" and "Oily Water." Oily water is not considered a universal waste.		
Latitude:	N/A	Longitude:	N/A

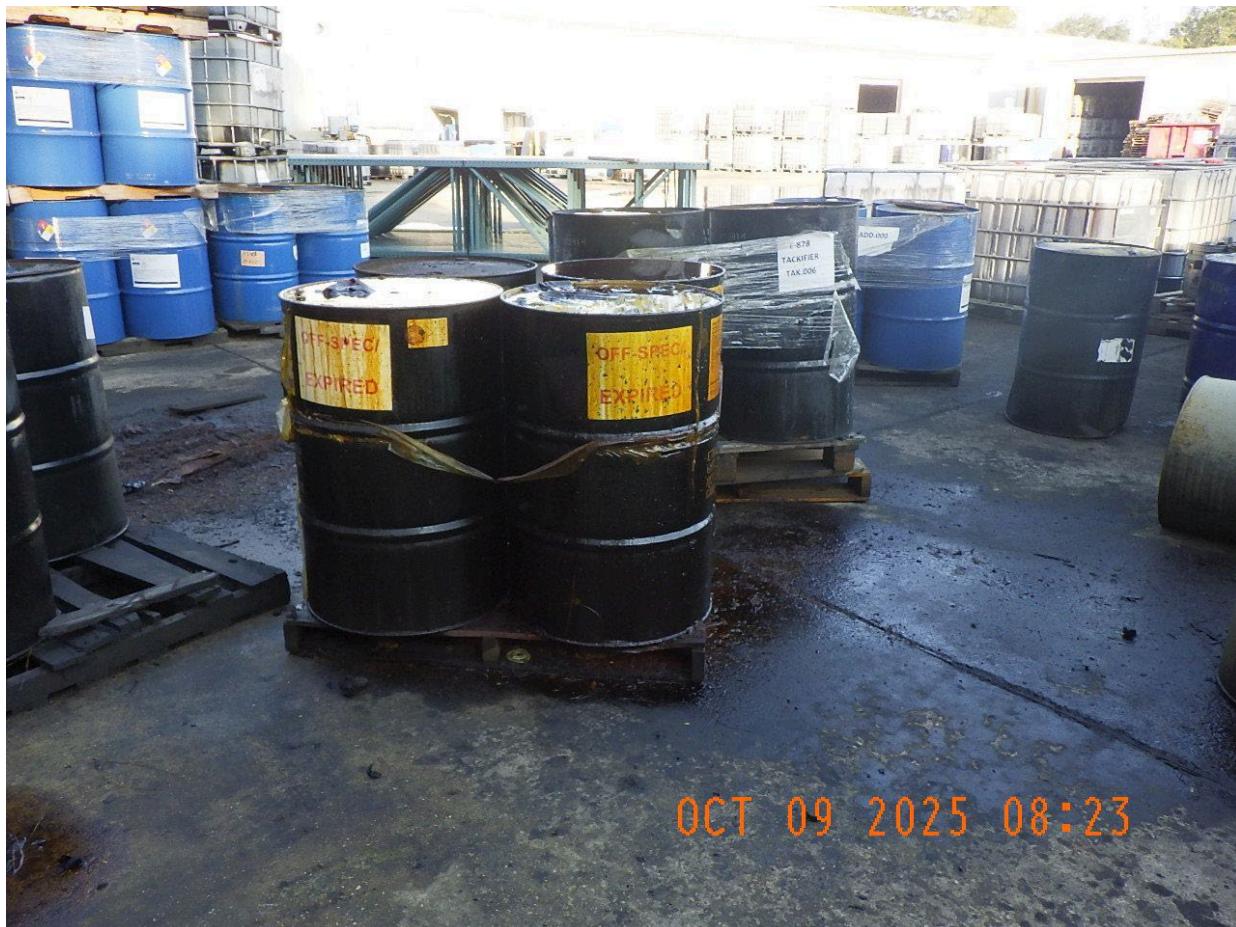
Photo No. 161

Description:	Outdoor Container Storage Area (Parking lot): A wooden pallet of four black 55-gal drum of unknown material labeled "OFF-SPEC/EXPIRED." Drums are not otherwise labeled identifying the contents of the containers. Active and historic releases on ground.		
Latitude:	N/A	Longitude:	N/A

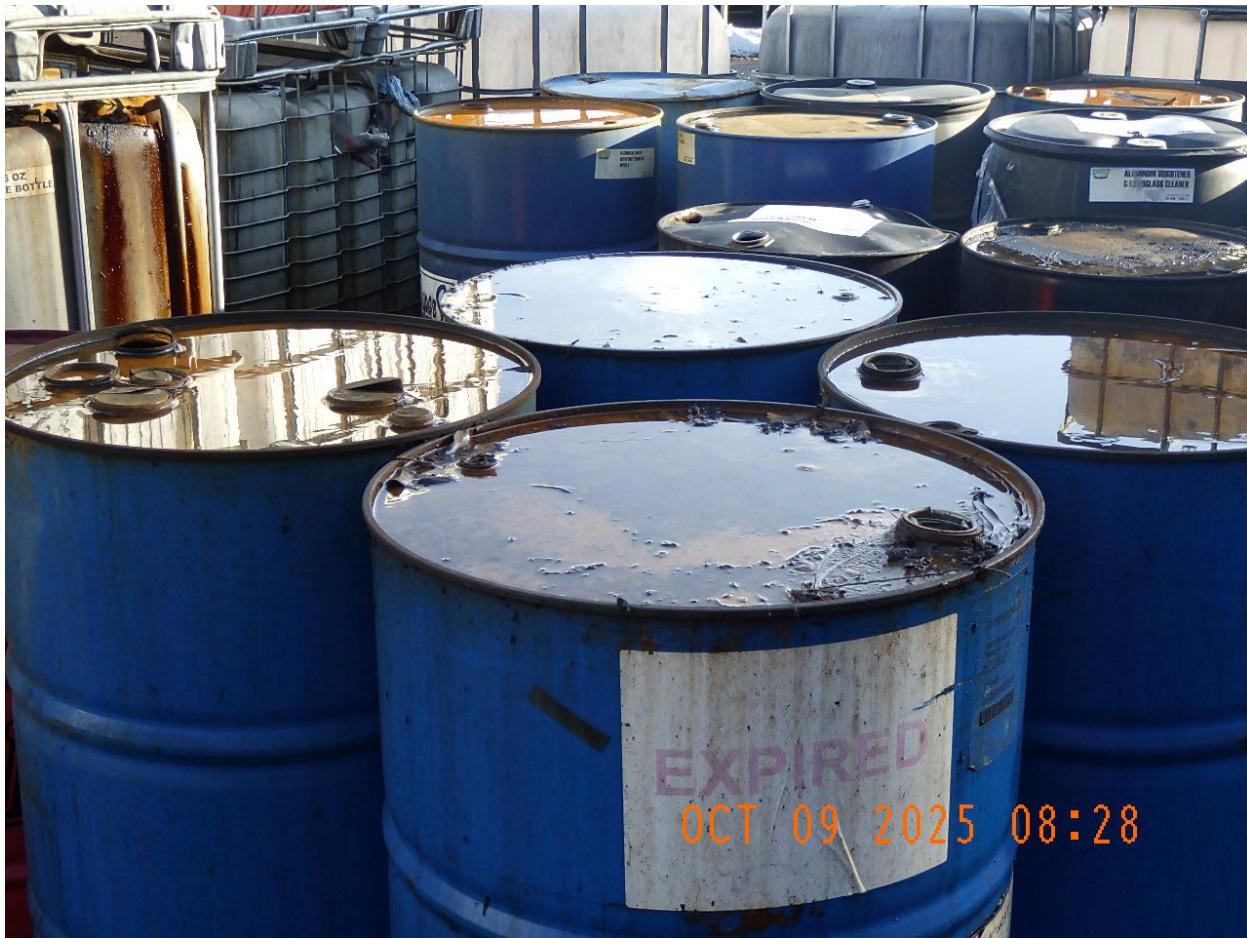
Photo No. 162

Description:	Outdoor Container Storage Area (Parking lot): Four (4) blue 55-gal drum of unknown material labeled "EXPIRED." Drums are not labeled identifying the contents of the containers. Three open drums. Bulging drum lid in middleground.		
Latitude:	N/A	Longitude:	N/A

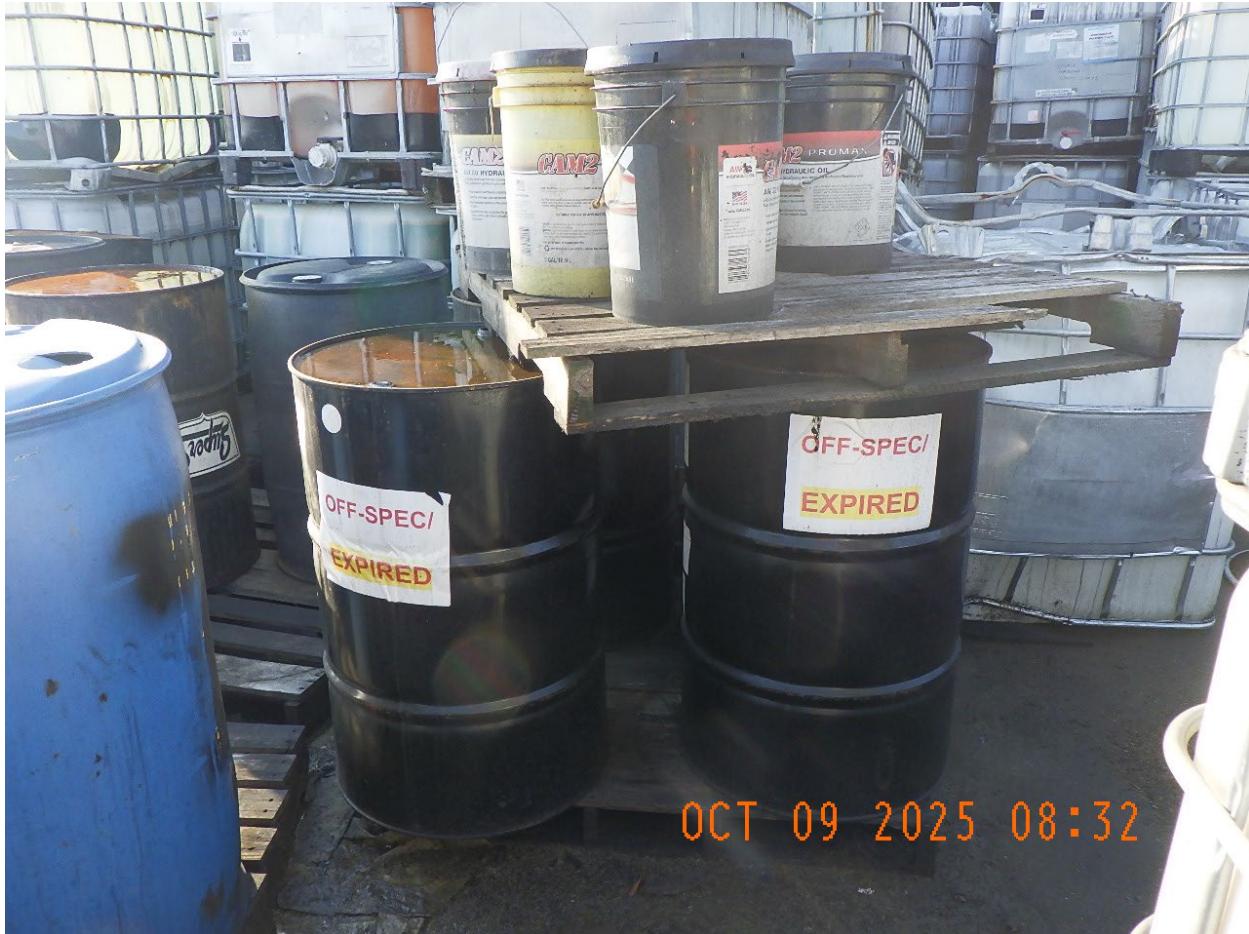
Photo No. 163

Description:	Outdoor Container Storage Area (Parking lot): A wooden pallet of three black 55-gal drum of unknown material labeled "OFF-SPEC/EXPIRED." Drums are not labeled identifying their contents. Pallet with additional 5-gallon buckets balanced on top.		
Latitude:	N/A	Longitude:	N/A

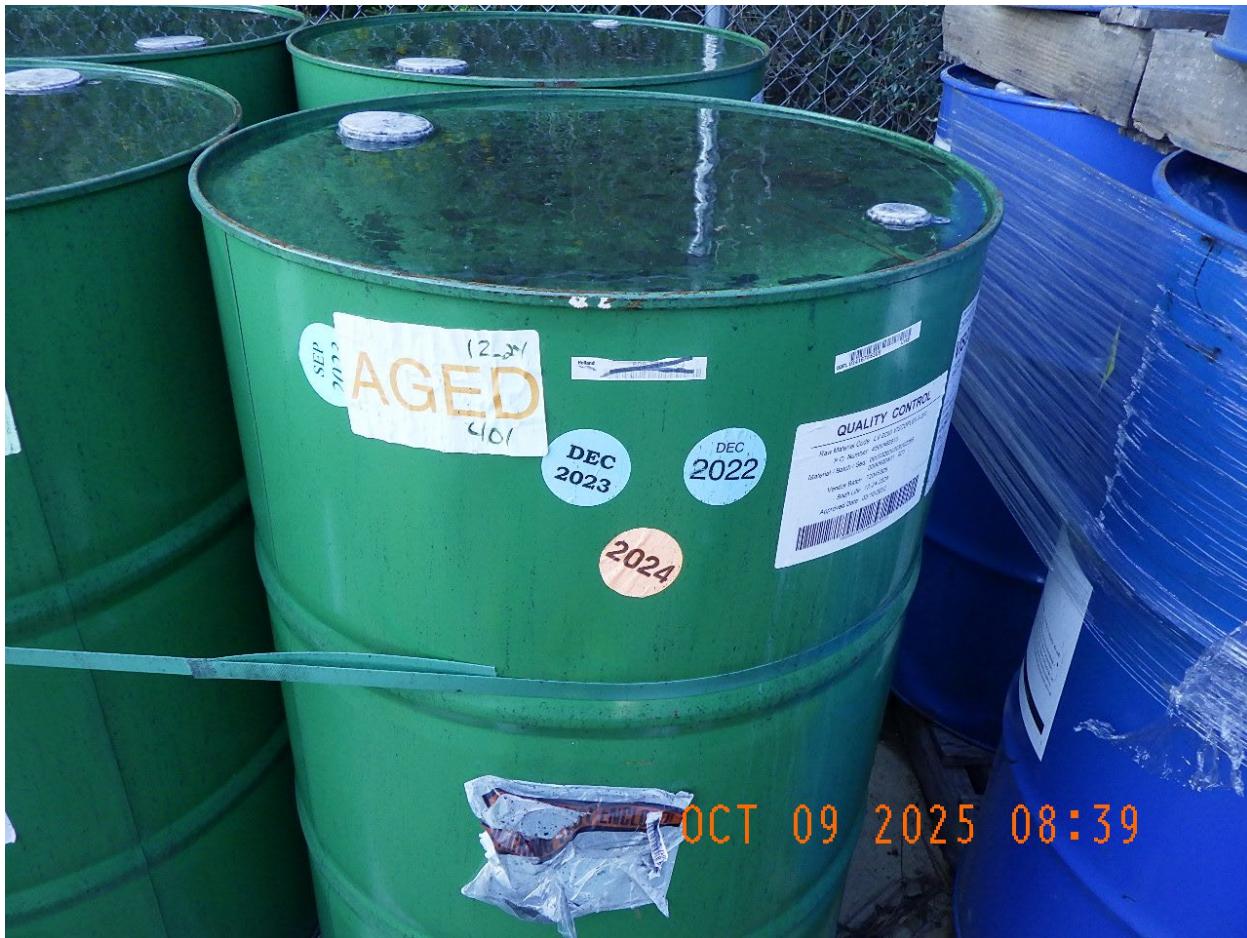
Photo No. 164

Description:	Outdoor Container Storage Area (Parking lot): Four green 55-gallon drums labeled "AGED" with stickers dated 2022, 2023, and 2024. Quality control label lists a shelf life of until December 2024.		
Latitude:	N/A	Longitude:	N/A

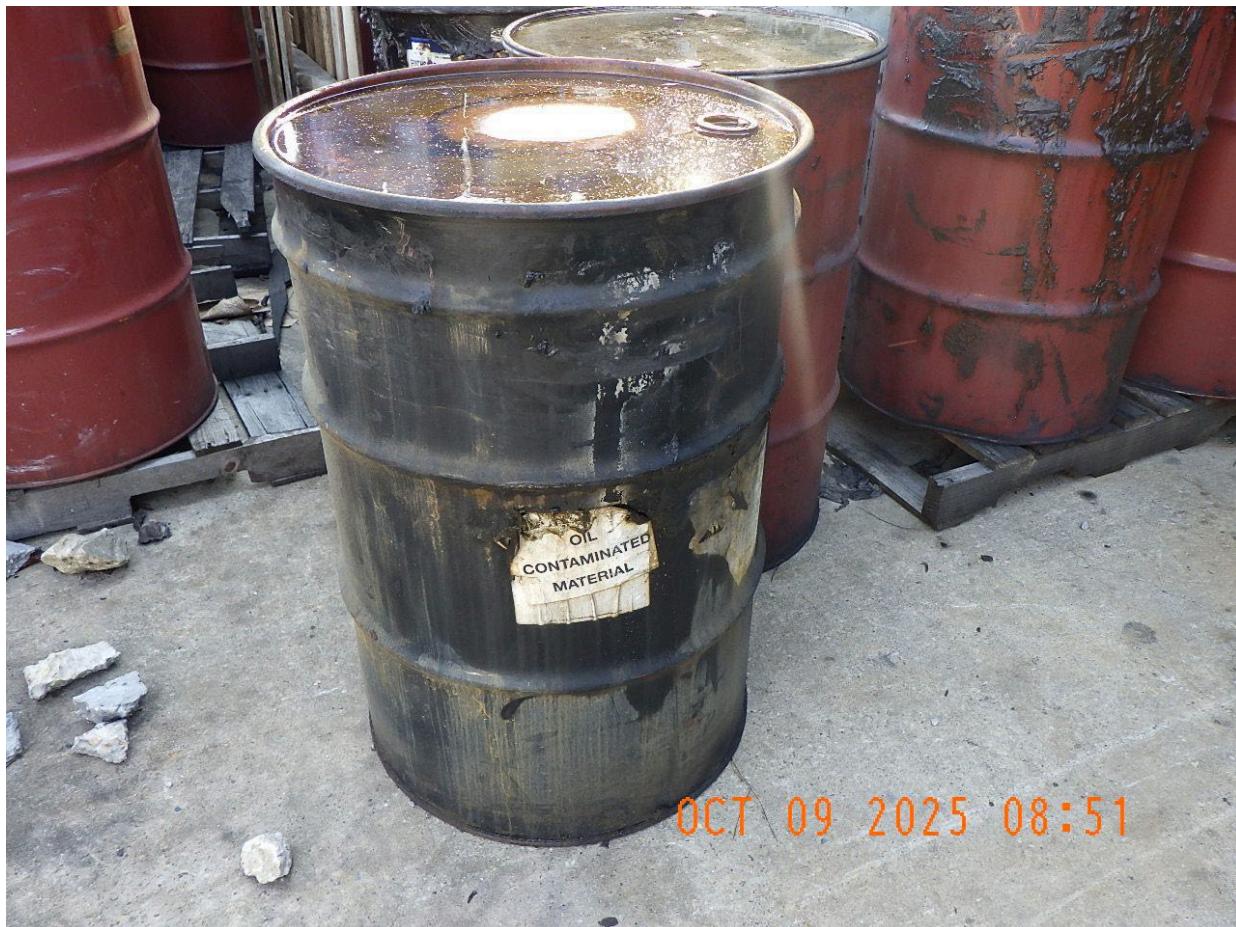
Photo No. 165

Description:	Outdoor Container Storage Area (Parking lot): A black 55-gal drum labeled as "oil-contaminated material." No other identification of contents. Drums not on pallet. Red drum, on right, has spill on outside of container.		
Latitude:	N/A	Longitude:	N/A

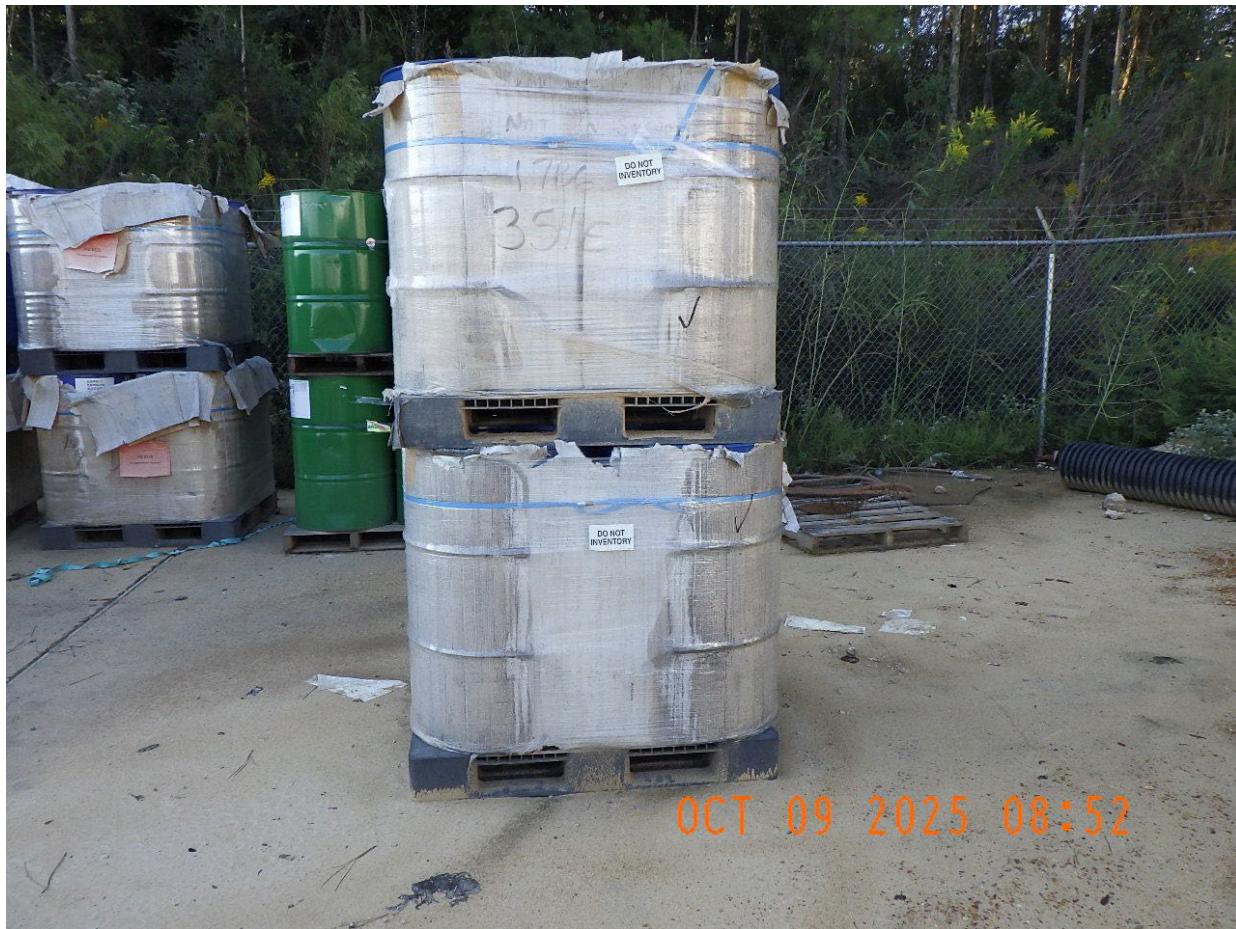
Photo No. 166

Description:	Outdoor Container Storage Area (Parking lot): A pallet on top of a pallet of drums labeled "DO NOT INVENTORY." No labels. Black checkmarks drawn on outside of packaging. Weathered condition of the cardboard beneath the plastic wrap suggests long-term placement.		
Latitude:	N/A	Longitude:	N/A
