Region 6 - Enforcement & Compliance Assurance Division
INSPECTION REPORT

Inspection Date(s):	10/07/2025 – 10/09/2025	
Media Program:	RCRA	
Regulatory Program(s)	Hazardous Waste, Used Oil	
Company Name:	Smitty's Supply, Inc.	
Facility Name:	Smitty's Supply Roseland	
Facility Physical Location:	63399 Highway 51 N	
(city, state, zip code)	Roseland LA 70456	
Mailing address:	PO Box 530	
(city, state, zip code)	Roseland LA 70456	
County/Parish:	Tangipahoa	
Facility Phone Number	1-800-256-7575	
Facility Contact:	Craig Ellison craigellison@smittysinc.net	
FRS Number:	110016753075	
EPA ID Number:	LAR000078691	
NAICS:	324191 - PETROLEUM LUBRICATING OIL AND GREASE MANUFACTURING	
SIC:	2992 – LUBRICATING OILS AND GREASES 4952 – SEWERAGE SYSTEMS	
Personnel participating in inspection:		
Angela Hays	U.S. EPA – Region 6	Inspector
Erin Young-Dahl	U.S. EPA – Region 6	Inspector
AD Talton	U.S. EPA – Region 6	Inspector
Jimbo Earles	LDEQ	Senior Environmental Scientist
Craig Easley	LDEQ	Senior Environmental Scientist

Section I – INTRODUCTION

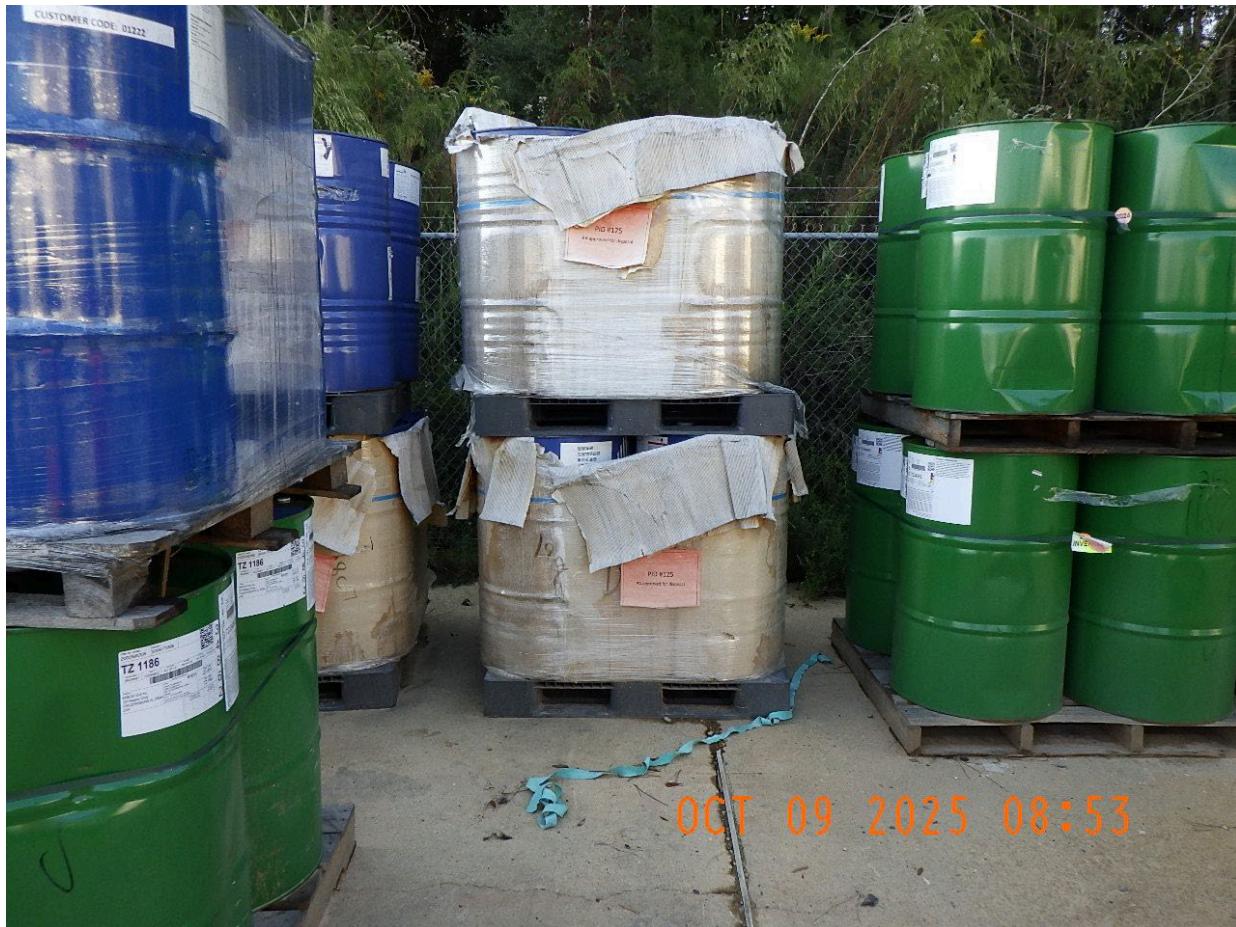
Photo No. 167

Description:	Outdoor Container Storage Area (Parking lot): A pallet on top of a pallet of drums labeled "PID #125 PA approved for disposal."		
Latitude:	N/A	Longitude:	N/A

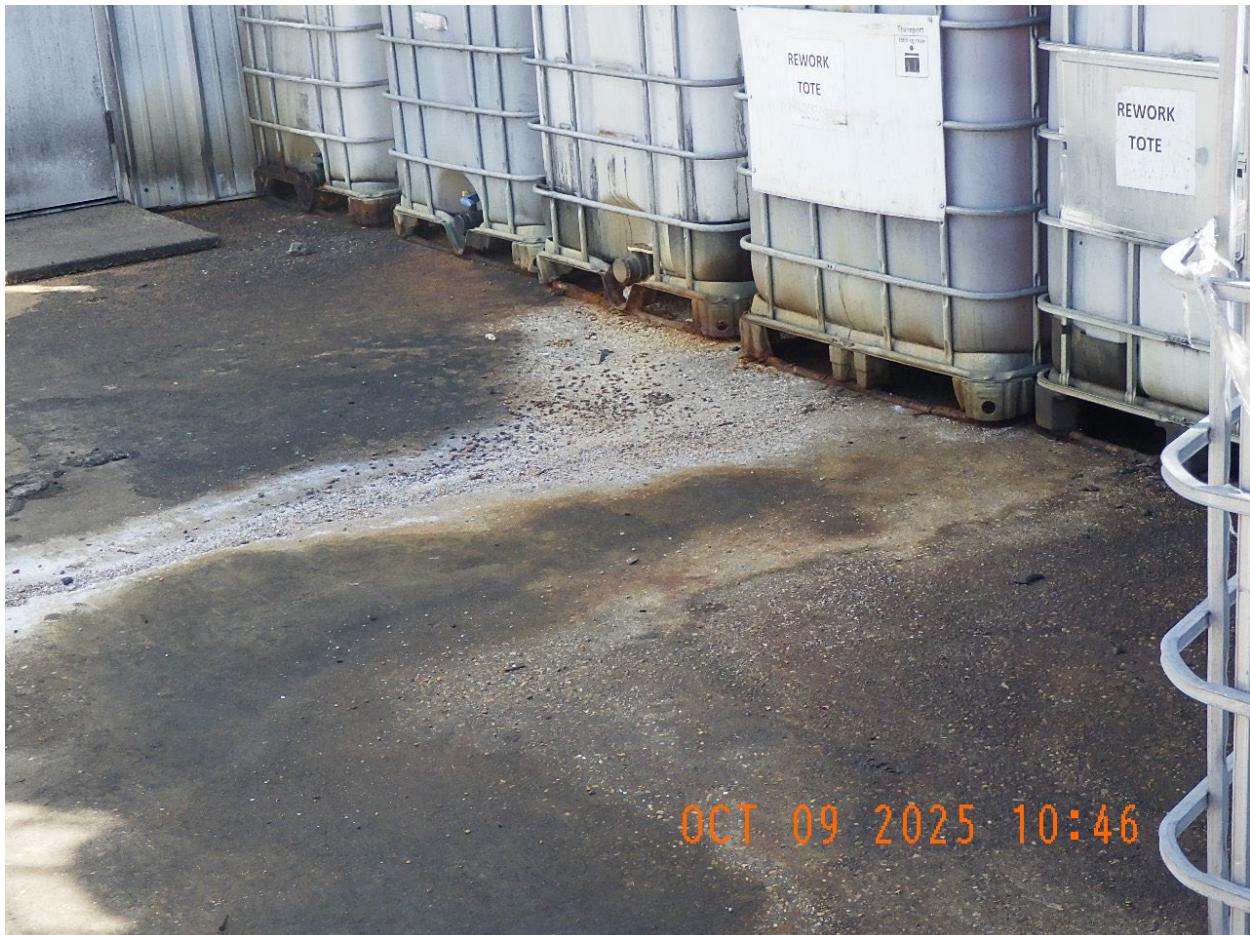
Photo No. 168

Description:	Outdoor Container Storage Area (Parking lot): Residue and staining from historic spills. Unlabeled totes with two containers marked "rework."		
Latitude:	N/A	Longitude:	N/A

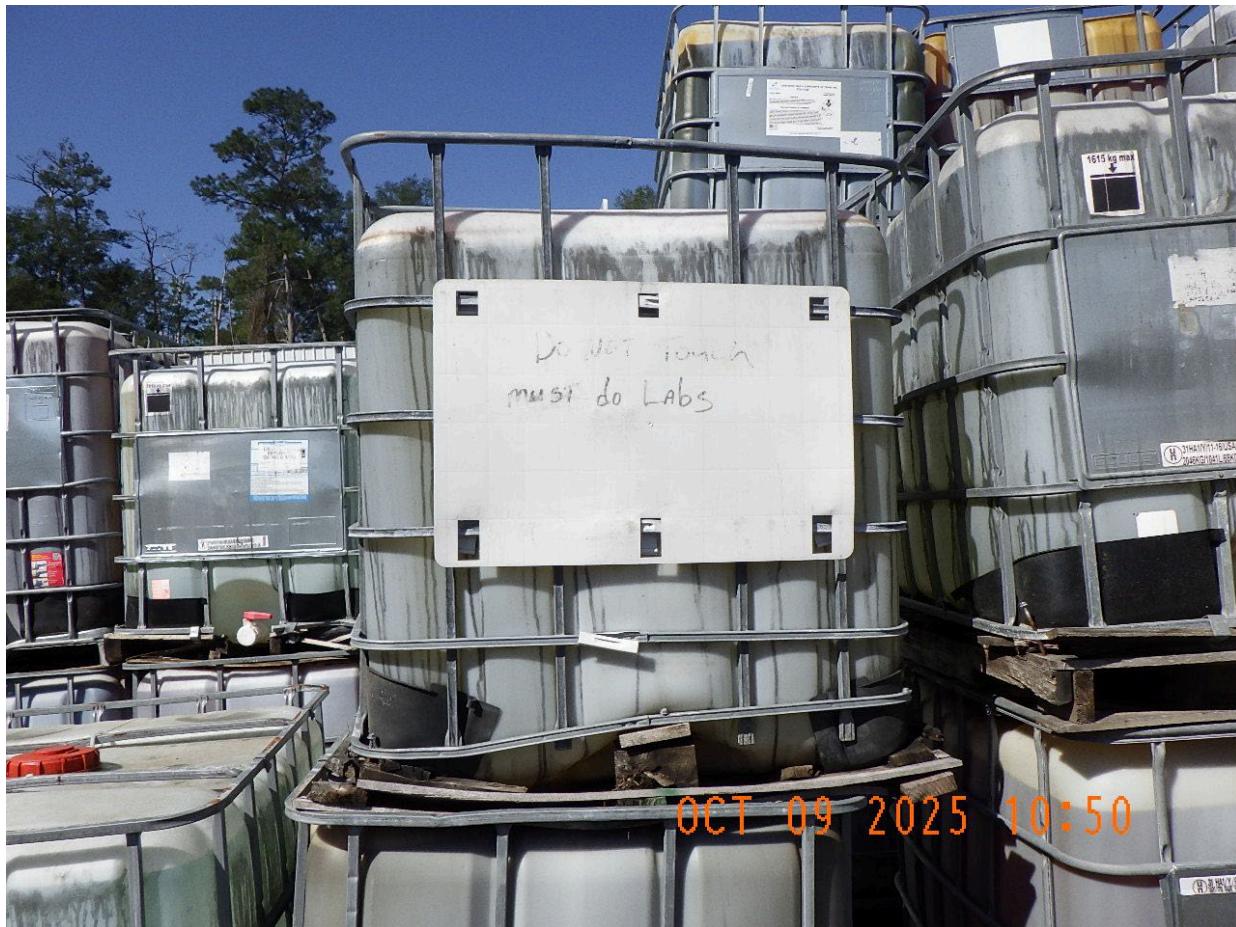
Photo No. 169

Description:	Outdoor Container Storage Area (Parking lot): A tote labeled "do not touch must do labs." No other labeling or date. Damaged pallet and tote cage.		
Latitude:	N/A	Longitude:	N/A

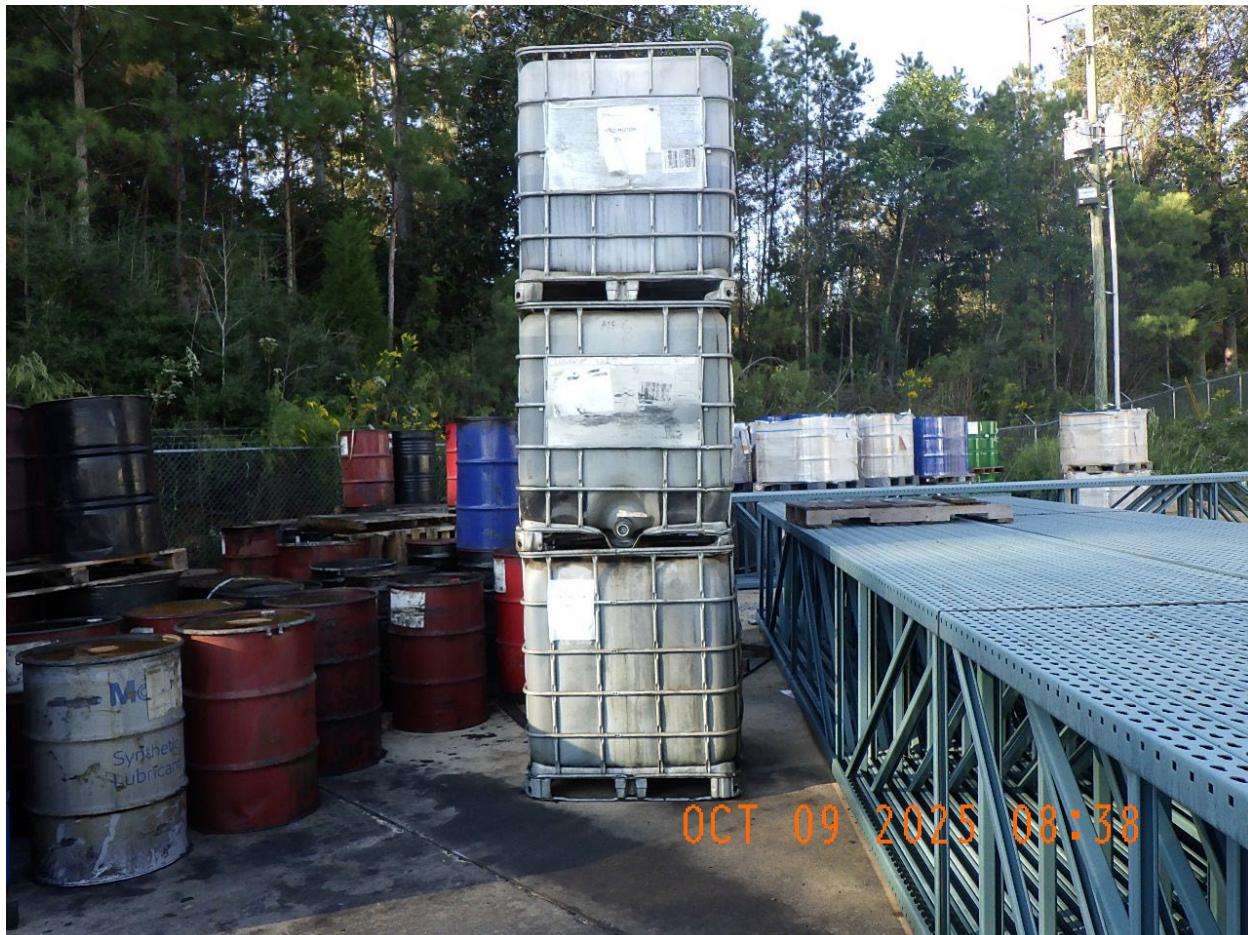
Photo No. 170

Description:	Outdoor Container Storage Area (Parking lot): Staining from historic spills on ground. Unpalletized drums. Three totes marked "USED MOTOR OIL."		
Latitude:	N/A	Longitude:	N/A

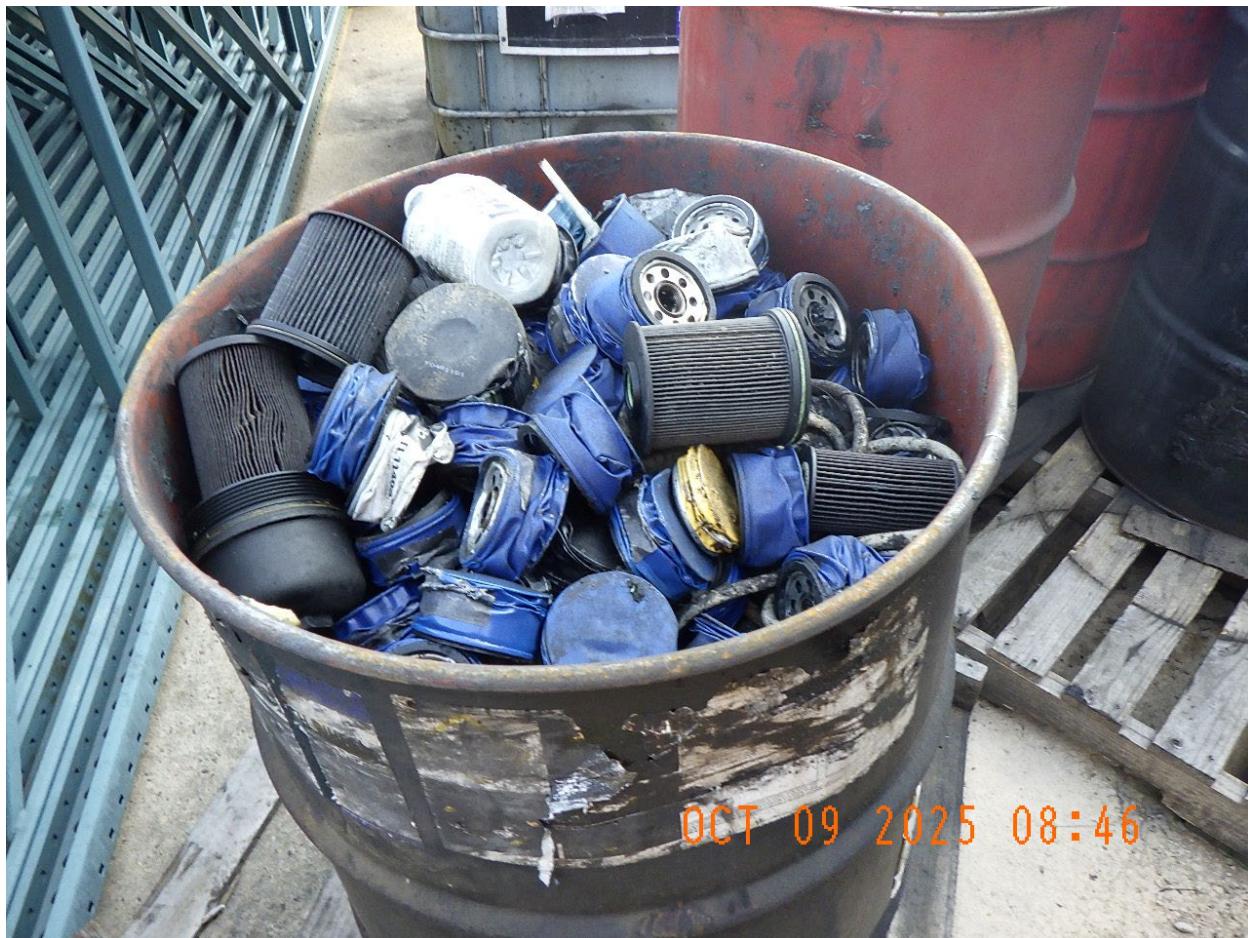
Photo No. 171

Description:	Outdoor Container Storage Area (Parking lot): 55-gallon drum of draining used oil filters, unlabeled.		
Latitude:	N/A	Longitude:	N/A

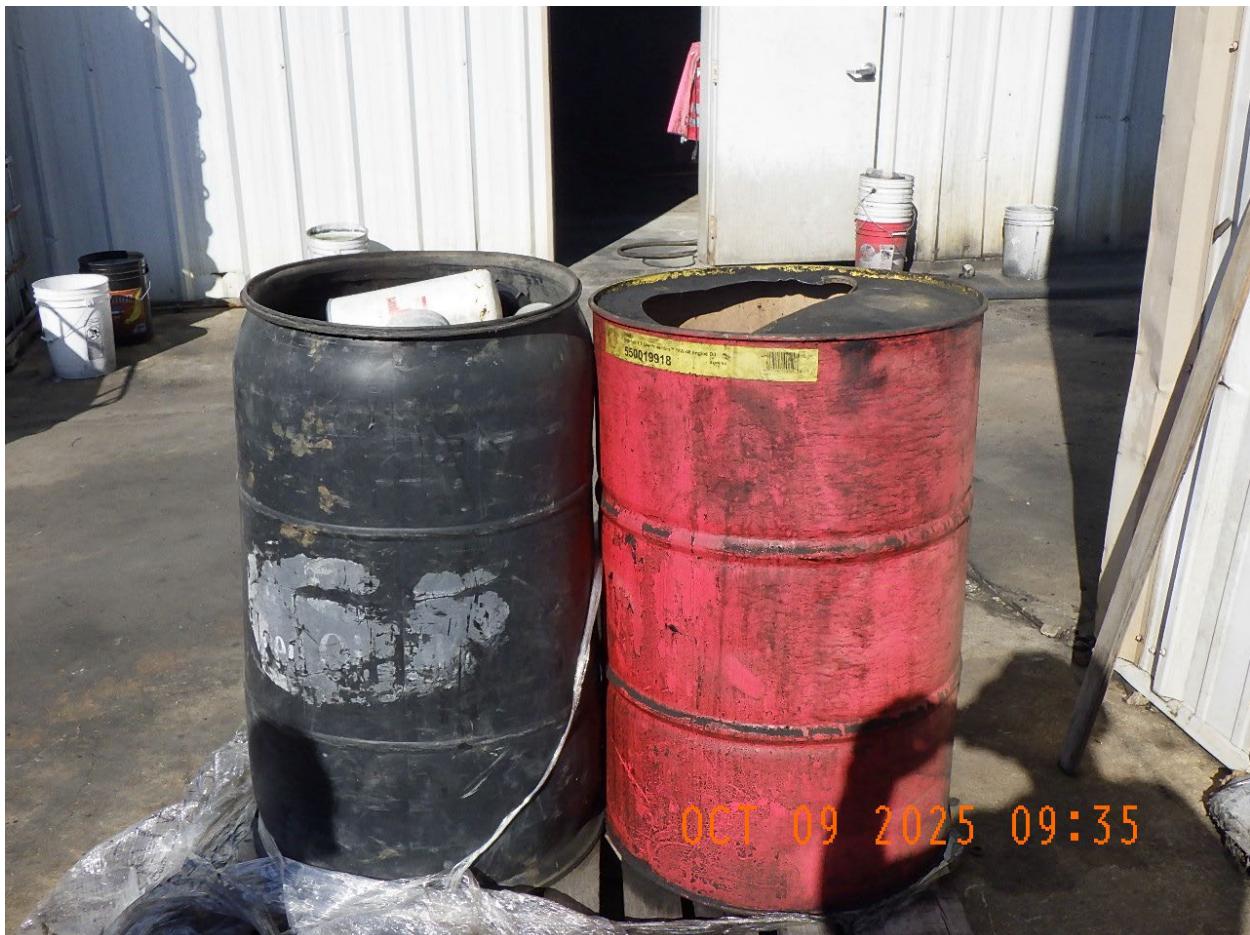
Photo No. 172

Description:	Outdoor Container Storage Area (Parking Lot): Two 55-gallon drums of draining oil filters. The words "used oil" are barely legible on the black drum.		
Latitude:	N/A	Longitude:	N/A

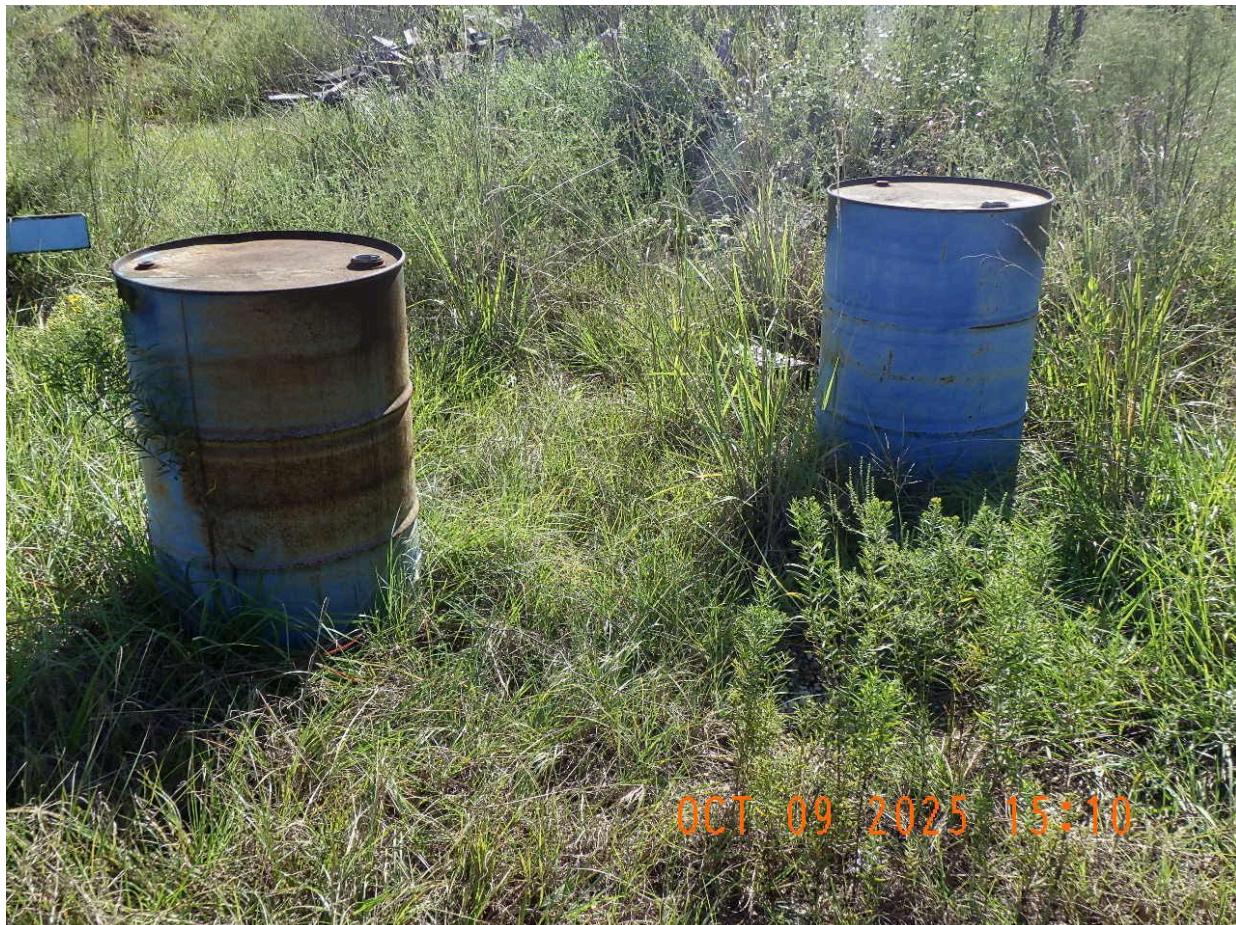
Photo No. 173

The final location the inspection team visited was the “Boneyard,” which lies to the north of Warehouse 6 and west of Warehouse 5. There, inspectors noted 11 abandoned drums, seven of which were full (Appendix 3: Photos 173, 174). No labels or markings of any sort identified their contents. Inspectors also identified one abandoned lead-acid battery that lacked labeling (Appendix 3: Photo 175). Multiple decommissioned trucks had been placed in the Boneyard, stored by Smitty’s for parts pulling. Batteries and fluids were never taken/emptied from the vehicles, and the ground beneath and next to the truck cabs was stained from oil leakage (Appendix 3: Photo 176 – 178). Inspectors identified at least eight separate spills onsite.

Description:	Boneyard Area: Abandoned drums of unknown material. No labels or dates marking transfer date to the Boneyard. No presence of a secondary containment to prevent potential release to the environment.		
Latitude:	N/A	Longitude:	N/A

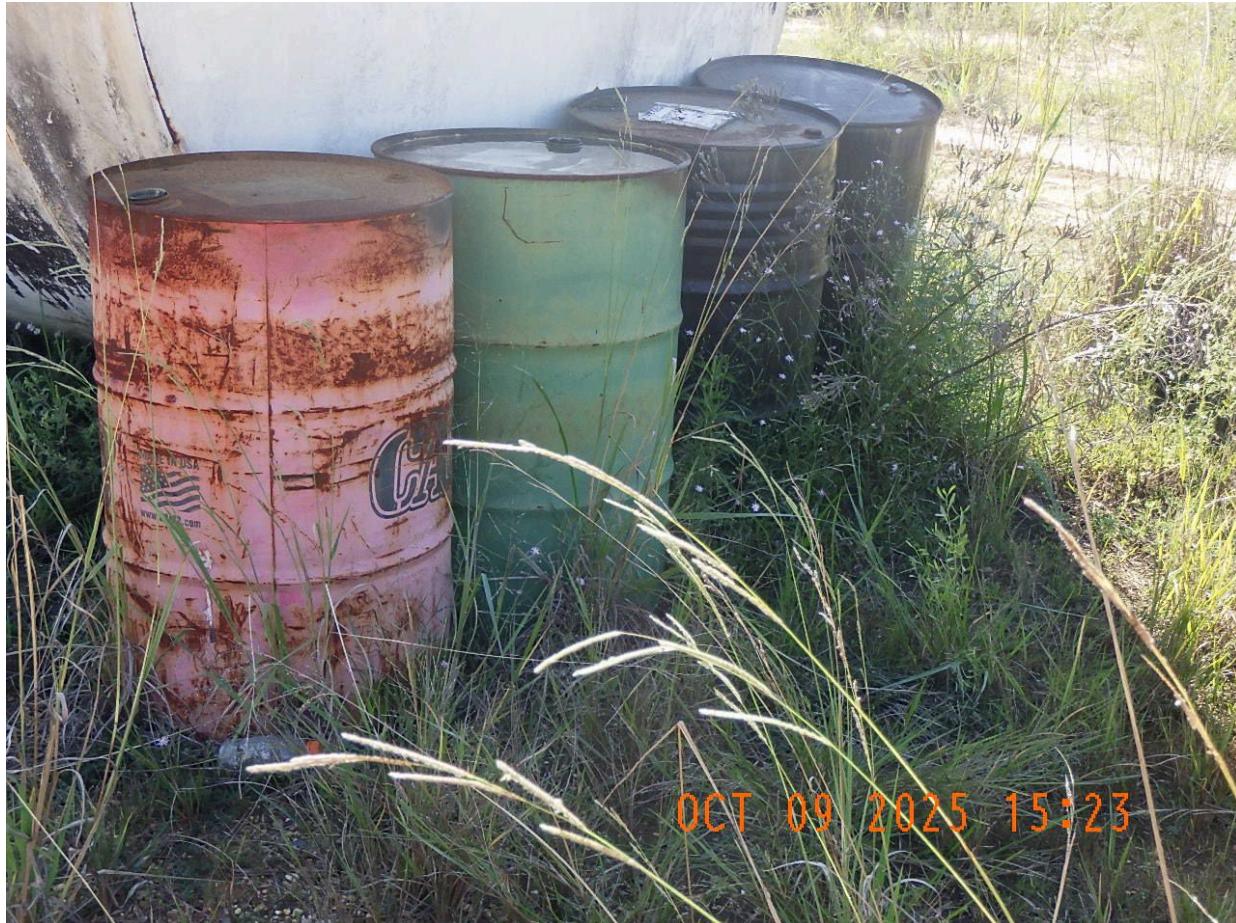
Photo No. 174

Description:	Boneyard Area: Abandoned drums of unknown material. No labels or dates marking transfer date to the Boneyard. No presence of a secondary containment to prevent potential release to the environment.		
Latitude:	N/A	Longitude:	N/A

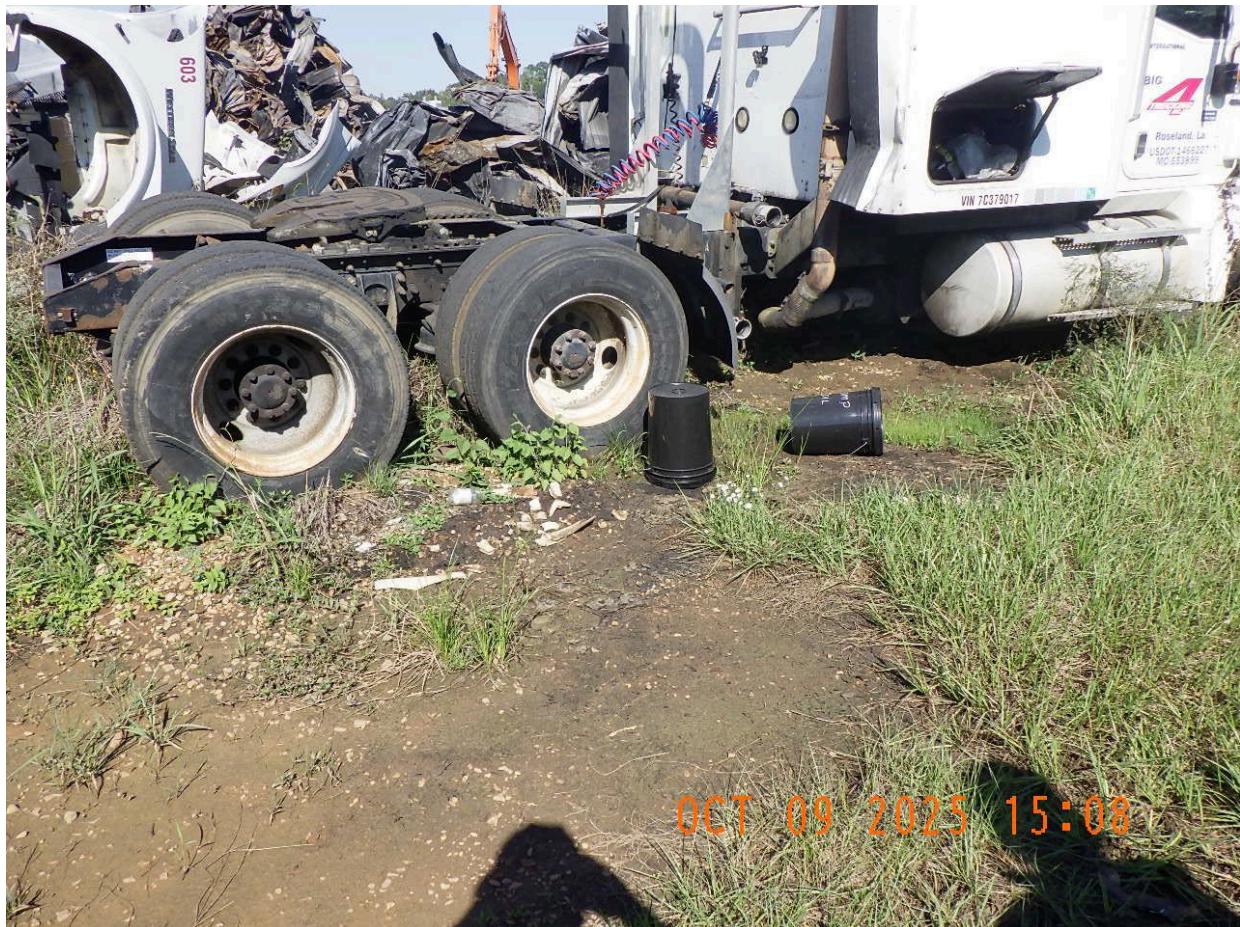
Photo No. 176

Description:	Boneyard Area: Area saturated with spills/release of unknown oily material on ground.		
Latitude:	N/A	Longitude:	N/A

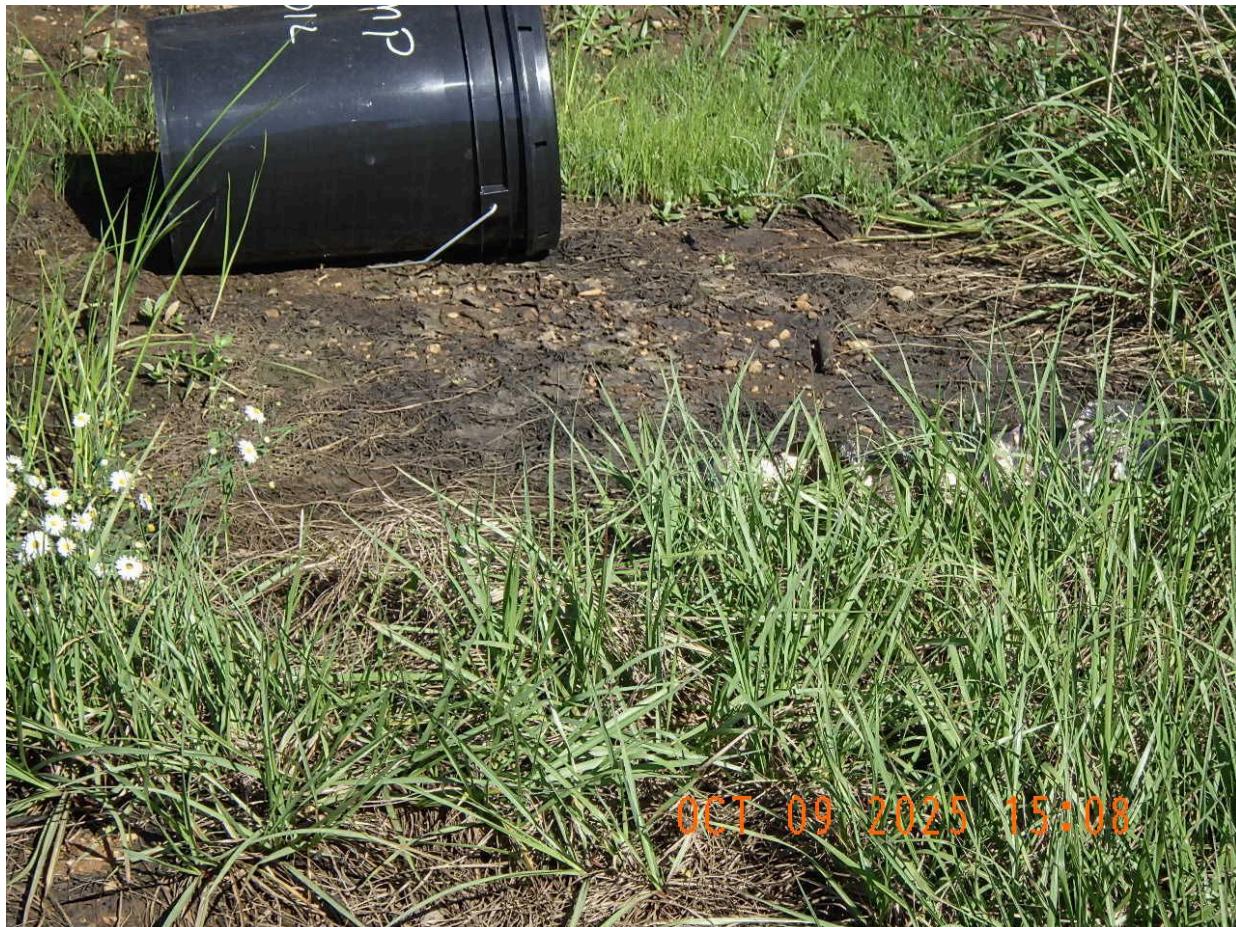
Photo No. 177

Description:	Boneyard Area: Area saturated with spills/release of unknown oily material.		
Latitude:	N/A	Longitude:	N/A

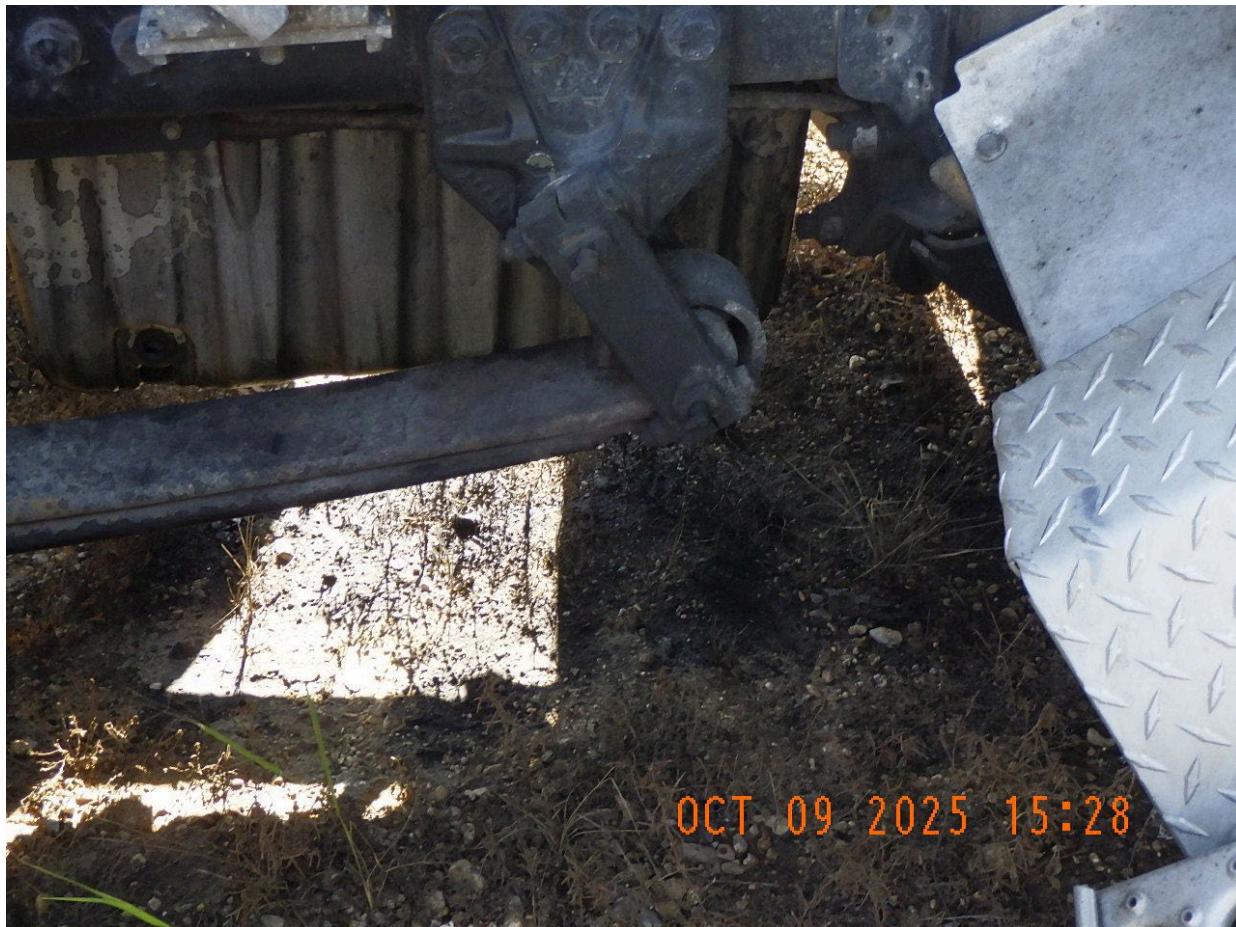
Photo No. 178

Description:	Boneyard Area: Area saturated with spills/release of unknown oily material.		
Latitude:	N/A	Longitude:	N/A

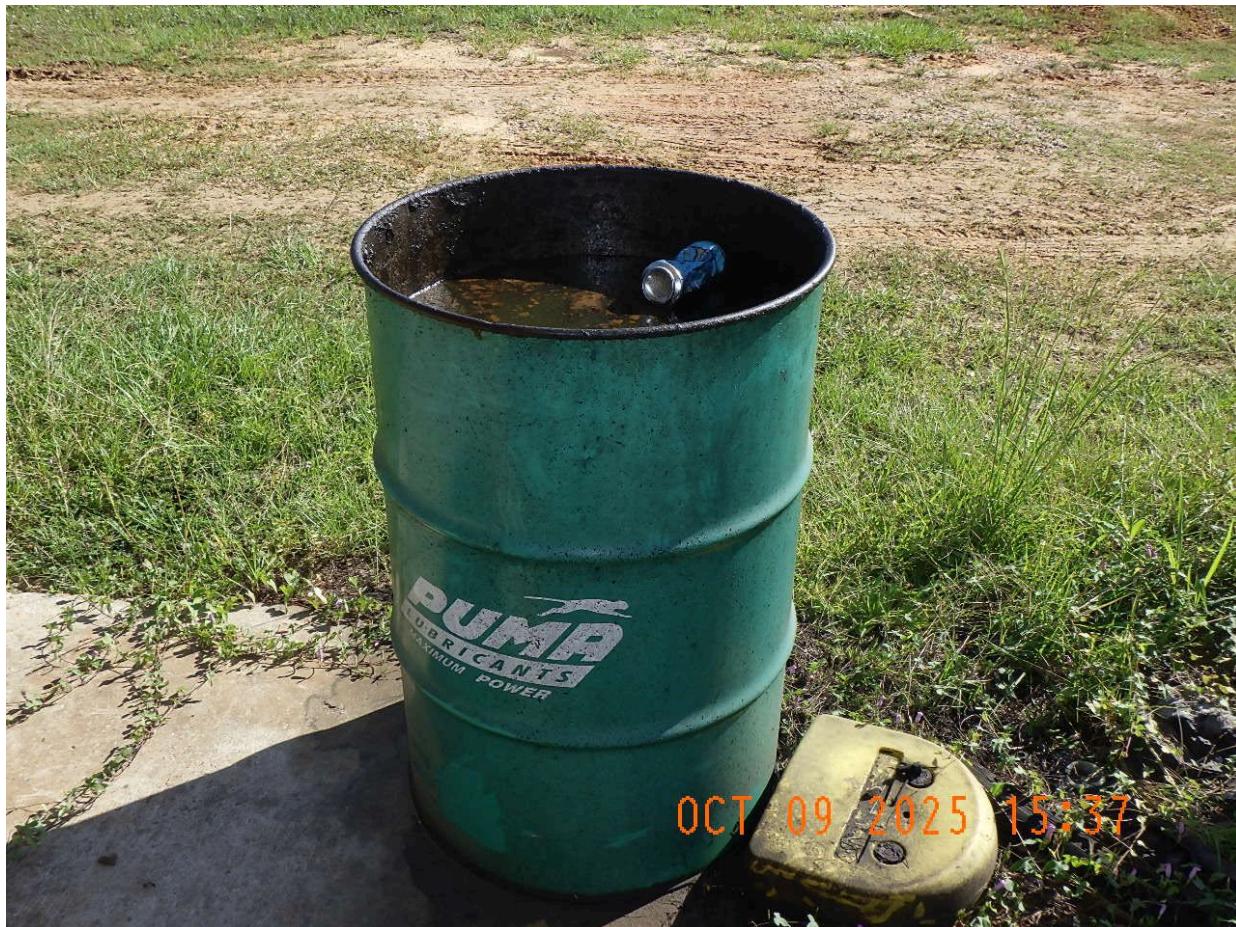
Photo No. 179

At the north end of the Boneyard, inspectors noted several open containers of oil near a small storage barn. None of the containers were labeled (Appendix 3: Photos 179, 180). Three pallet jacks, set aside for parts pulling, still held batteries, and one loose battery was sitting in the grass under the awning (Appendix 3: Photo 181, 182). A metal trash box held household/office garbage, but it also held a filled gasoline canister discarded with the rest of the box's contents (Appendix 3: Photo 183). Two open five-gallon buckets and at least 10 other buckets were partially full of an oily material (Appendix 3: Photo 184). All were unlabeled. Across from the storage barn in the Boneyard, inspectors noted another warehouse-like building that was inaccessible due to overgrowth. When asked about its contents, facility representatives were unsure of the materials stored inside. Near the storage barn, a shallow drainage ditch as well as a separate puddle in the gravel parking lot off of Steptoe Rd were both filled with standing oil (Appendix 3: Photos 185, 186).

Description:	Boneyard Area: Oily liquid in open drum, unlabeled.		
Latitude:	N/A	Longitude:	N/A

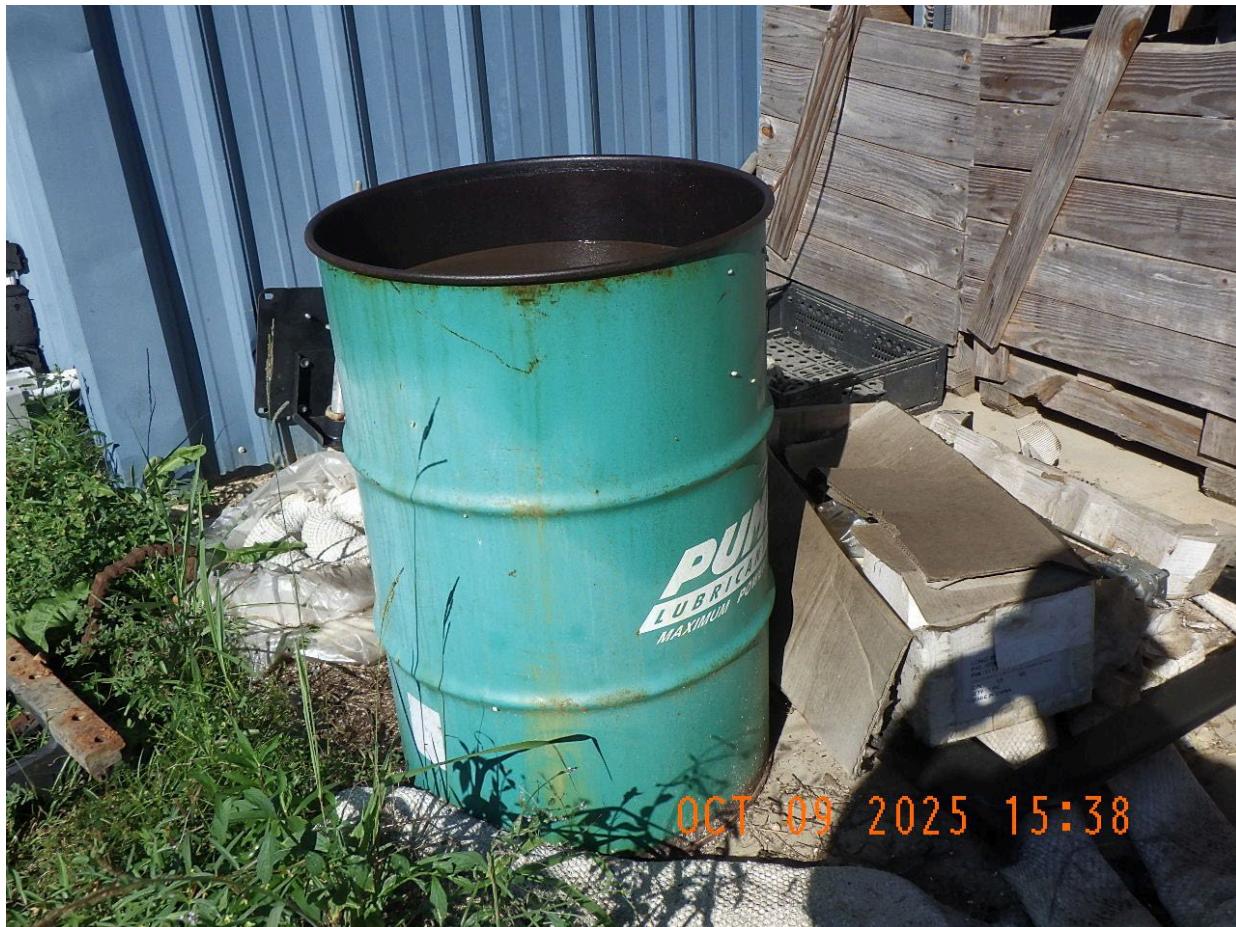
Photo No. 180

Description:	Boneyard Area: Oily liquid in open drum, unlabeled.		
Latitude:	N/A	Longitude:	N/A

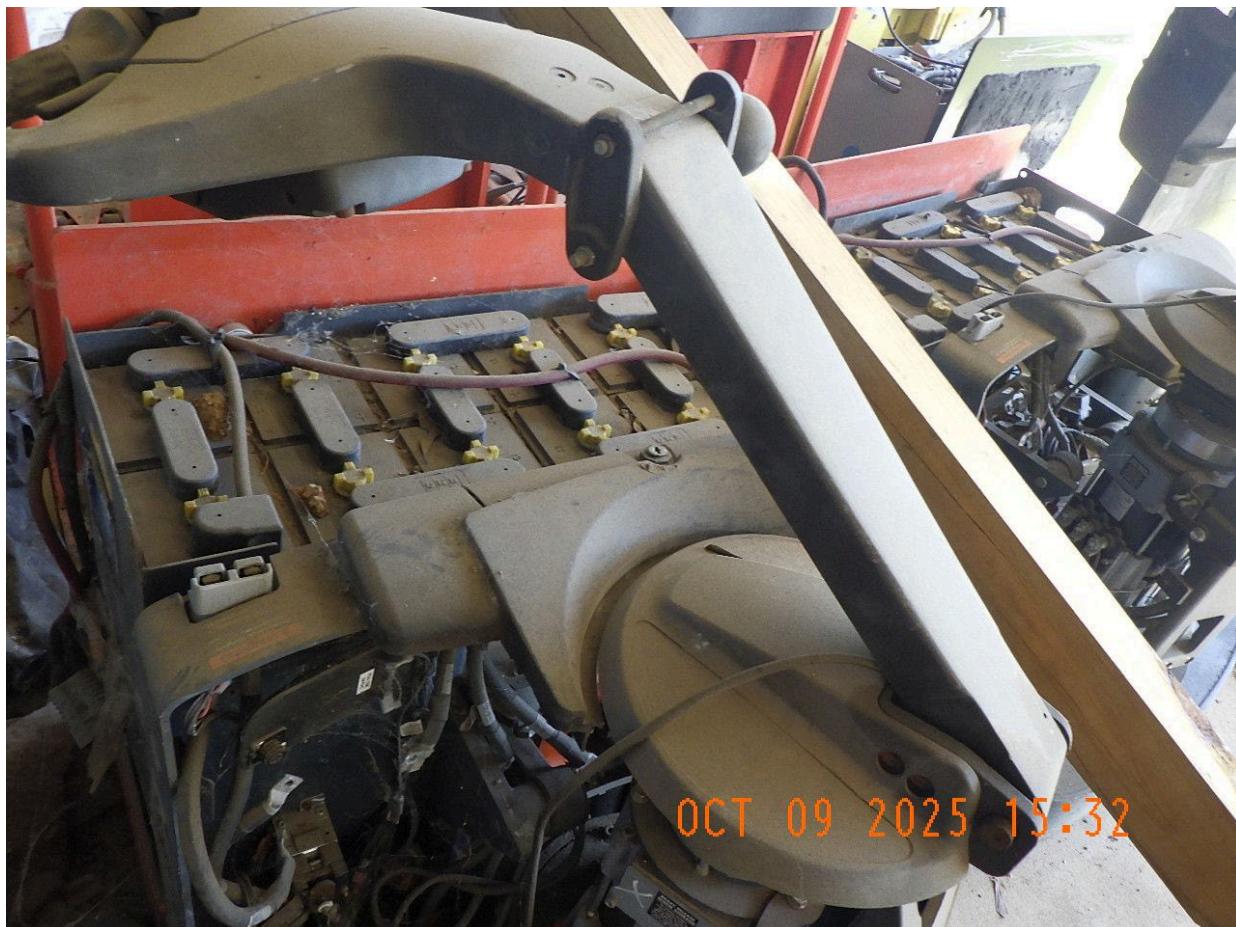
Photo No. 181

Description:	Boneyard Area: Lead batteries still housed in a pallet jack. Batteries are abandoned within decommissioned equipment.		
Latitude:	N/A	Longitude:	N/A

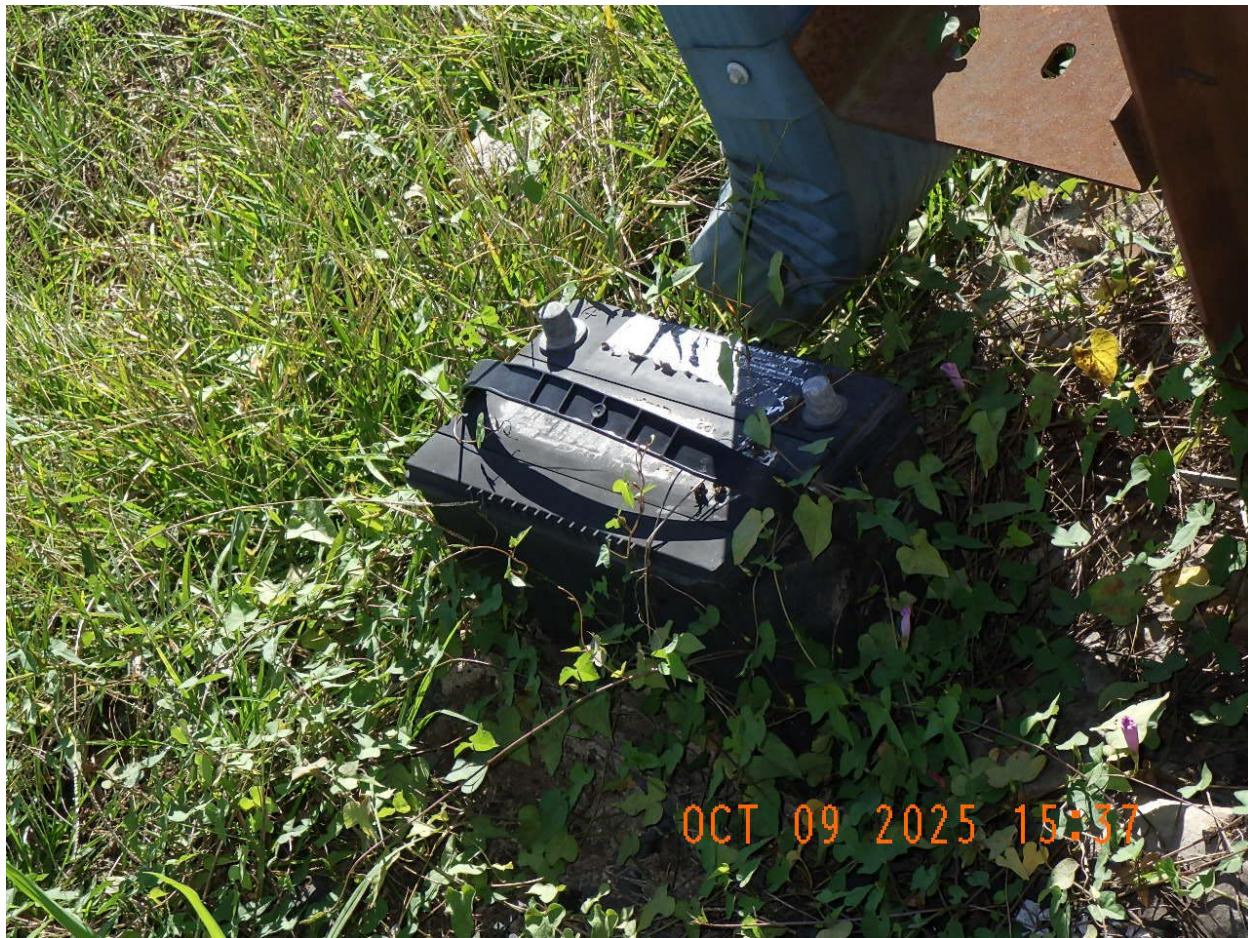
Photo No. 182

Description:	Boneyard Area: Discarded lead battery, undated and unlabeled.		
Latitude:	N/A	Longitude:	N/A

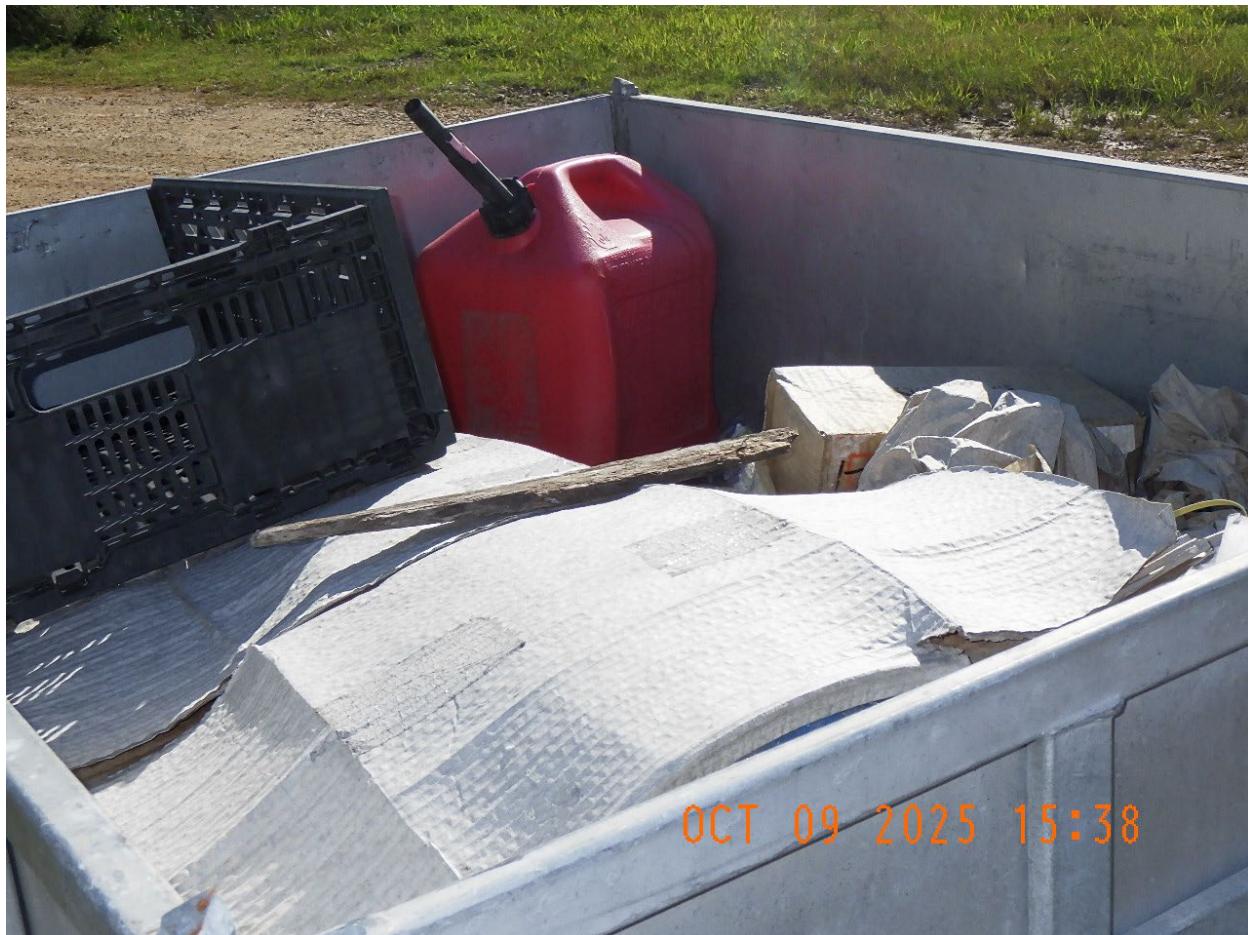
Photo No. 183

Description:	Boneyard Area: Plastic gas can containing liquid found within municipal trash.		
Latitude:	N/A	Longitude:	N/A

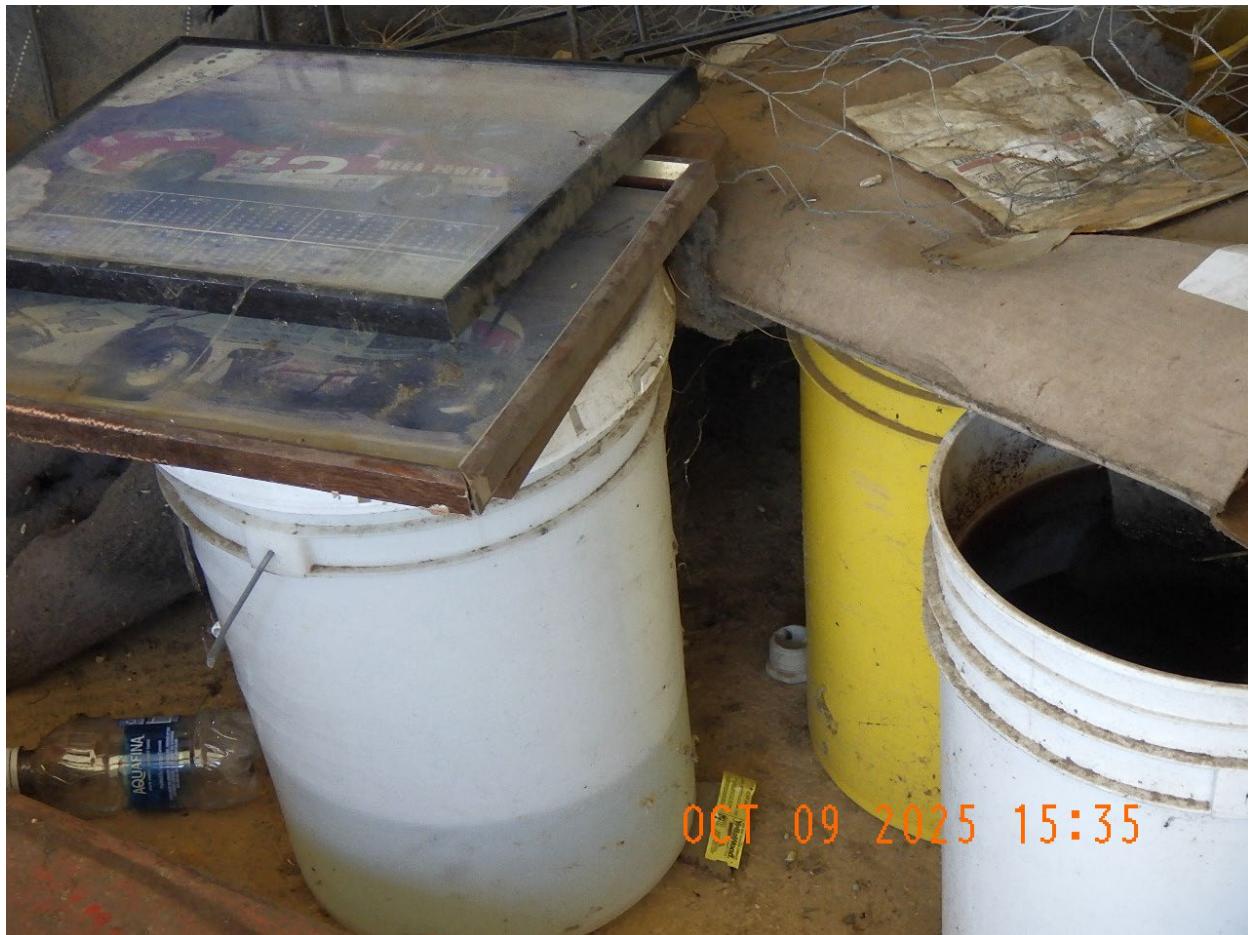
Photo No. 184

Description:	Boneyard Area: Three unlabeled, five-gallon buckets holding used oil.		
Latitude:	N/A	Longitude:	N/A

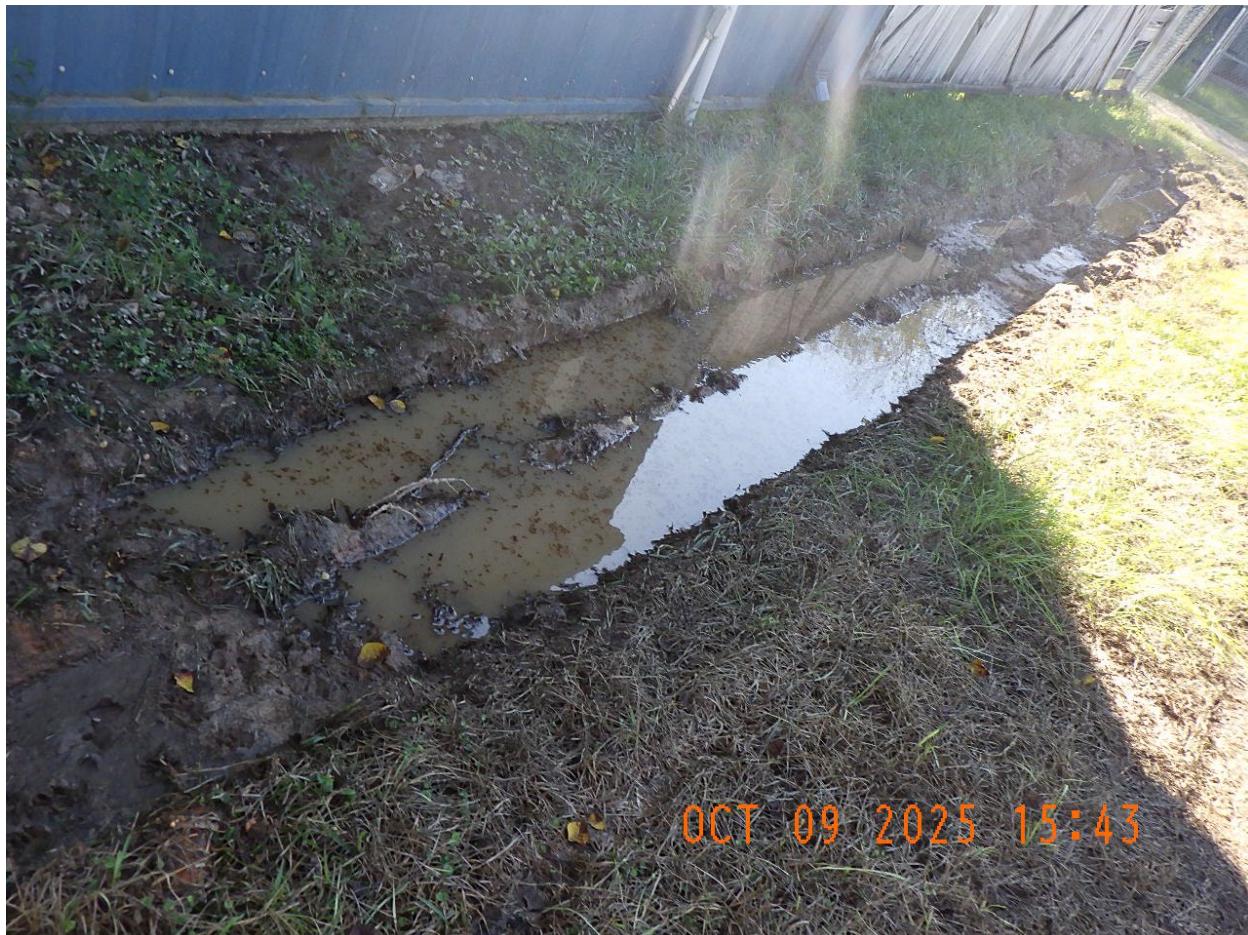
Photo No. 185

Description:	Boneyard Area: Oily sheen on water in ditch.		
Latitude:	N/A	Longitude:	N/A
