Region 6 - Enforcement & Compliance Assurance Division
INSPECTION REPORT

Inspection Date(s):	10/07/2025 – 10/09/2025	
Media Program:	RCRA	
Regulatory Program(s)	Hazardous Waste, Used Oil	
Company Name:	Smitty's Supply, Inc.	
Facility Name:	Smitty's Supply Roseland	
Facility Physical Location:	63399 Highway 51 N	
(city, state, zip code)	Roseland LA 70456	
Mailing address:	PO Box 530	
(city, state, zip code)	Roseland LA 70456	
County/Parish:	Tangipahoa	
Facility Phone Number	1-800-256-7575	
Facility Contact:	Craig Ellison craigellison@smittysinc.net	
FRS Number:	110016753075	
EPA ID Number:	LAR000078691	
NAICS:	324191 - PETROLEUM LUBRICATING OIL AND GREASE MANUFACTURING	
SIC:	2992 – LUBRICATING OILS AND GREASES 4952 – SEWERAGE SYSTEMS	
Personnel participating in inspection:		
Angela Hays	U.S. EPA – Region 6	Inspector
Erin Young-Dahl	U.S. EPA – Region 6	Inspector
AD Talton	U.S. EPA – Region 6	Inspector
Jimbo Earles	LDEQ	Senior Environmental Scientist
Craig Easley	LDEQ	Senior Environmental Scientist

Section I – INTRODUCTION

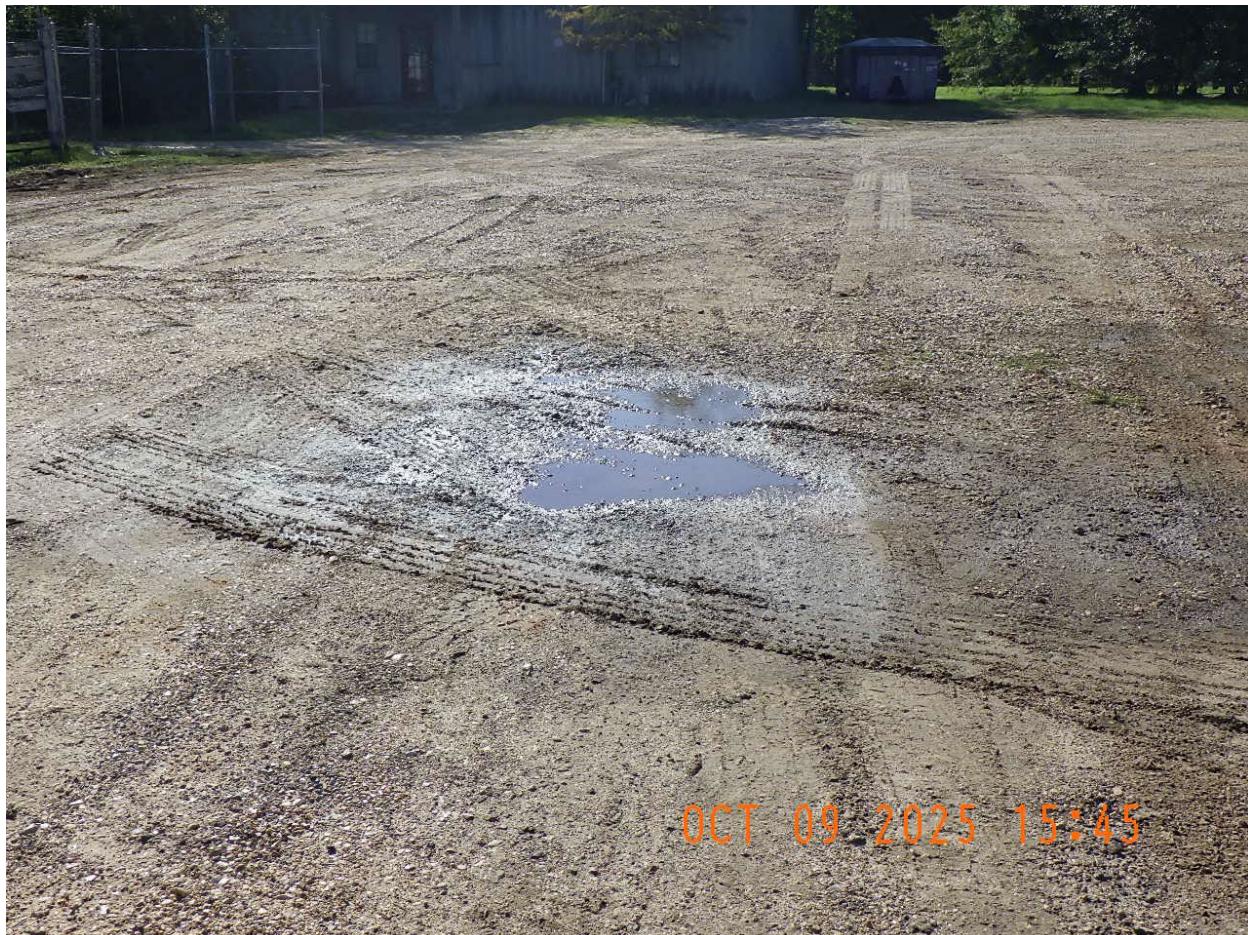
Photo No. 186

At the north end of the Boneyard, inspectors noted several open containers of oil near a small storage barn. None of the containers were labeled (Appendix 3: Photos 179, 180). Three pallet jacks, set aside for parts pulling, still held batteries, and one loose battery was sitting in the grass under the awning (Appendix 3: Photo 181, 182). A metal trash box held household/office garbage, but it also held a filled gasoline canister discarded with the rest of the box's contents (Appendix 3: Photo 183). Two open five-gallon buckets and at least 10 other buckets were partially full of an oily material (Appendix 3: Photo 184). All were unlabeled. Across from the storage barn in the Boneyard, inspectors noted another warehouse-like building that was inaccessible due to overgrowth. When asked about its contents, facility representatives were unsure of the materials stored inside. Near the storage barn, a shallow drainage ditch as well as a separate puddle in the gravel parking lot off of Steptoe Rd were both filled with standing oil (Appendix 3: Photos 185, 186).

Description:	Boneyard Area: Oily accumulation of liquid in the dirt lot south of Steptoe Rd.		
Latitude:	N/A	Longitude:	N/A
